Internal system malfunction of an anaesthesia workstation due to improper ambient conditions of the operating theatre

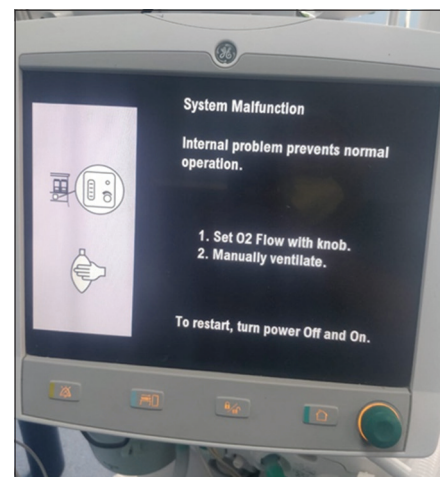
We report a technical glitch that occurred in a GE Avance CS² anaesthesia workstation (Datex-Ohmeda Inc., Madison, USA) when a middle-aged male patient was undergoing laparoscopic cholecystectomy under general anaesthesia. The workstation passed the built-in electronic self-test without any leak in the breathing circuit. General anaesthesia was administered as per the standard protocol of the institution. As the surgery began, the ambient temperature and humidity started increasing due to the failure of the air conditioning system. The workstation then suddenly stopped working, with its monitor displaying 'system malfunction-internal problem prevents normal operation-set oxygen flow with knob-manually ventilate' [Figure 1].

Figure 1: The anaesthesia workstation monitor displaying the system malfunction

A Bain circuit was attached to ventilate the lungs until an alternate workstation was arranged. Meanwhile, the workstation was switched off and restarted as per the advice displayed on the monitor. The operating theatre (OT) power supply was checked. The technical

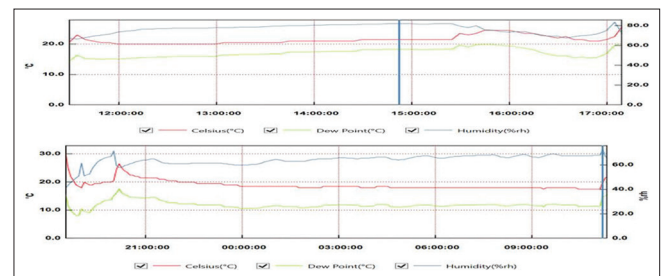
Figure 2: Data logger reading operating rooms

condition, the OT temperature should be 20°C–22°C and humidity should be between 40% and 60%. However, it was found that OT humidity remained above 60% and went up to 90% with varying temperatures. An internal audit was planned. The temperature and humidity data were collected from two OTs every two hourly for 12 hours. It was observed that the humidity remained above 60% and reached a maximum of 82% in OT 1. Similarly, it remained above 60% and reached 72.5% in OT 2, and temperature also varied between 17.5°C and 30°C [Figure 2].
