Case Report

Experimental Analysis of a Failed Gamma Nail: A Case Report and Literature Review

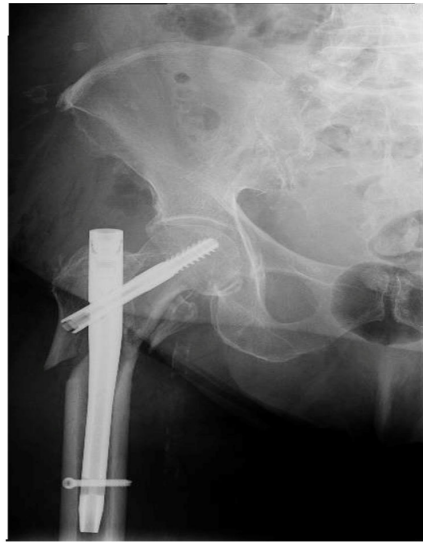
The reported case presents a 69-year-old woman who suffered a polytrauma as a result of a road accident. The patient suffered a right trochanter femoral fracture that was surgically treated with a Gamma 3 Locking Nail System 11 × 180/125°, lag screw, distal locking screw of 3.5 mm, and Gamma 3 End Cap made of titanium. After the surgical intervention, an X-ray was performed which is shown in (Figure 2).

Figure 2. Post surgery X-ray showing the fracture and the position of the implant within the bone.

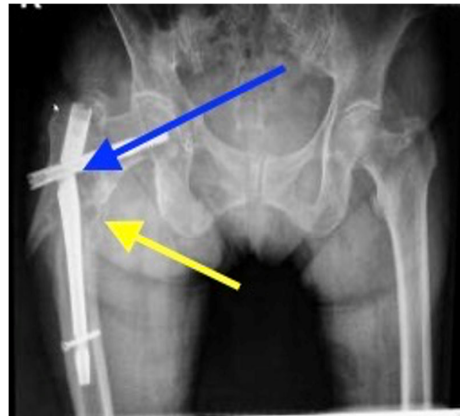
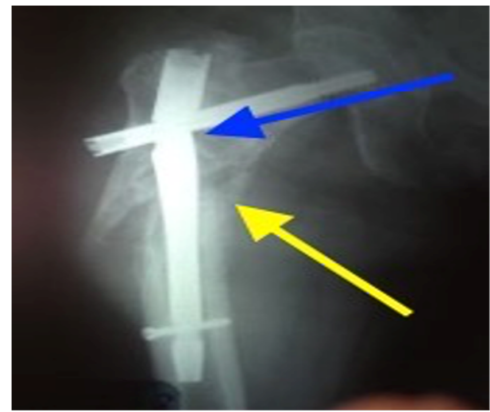
Six months after the surgery, the patient presented with pain and functional limitation of the right hip. An X-ray, which is shown in Figure 3, was performed, which highlighted nonunion at the fracture level and damage to the implant (Figure 3a,b).

Figure 3. (a) Radiographic aspect of the damaged implant (blue arrow) and of the nonunion (yellow arrow). (b) Radiographic aspect of the damaged implant (blue arrow) and of the nonunion (yellow arrow).

After the X-ray, the removal of the implant was decided, and a surgical correction was performed by changing the implant and stabilizing the fracture with a long DCS system.

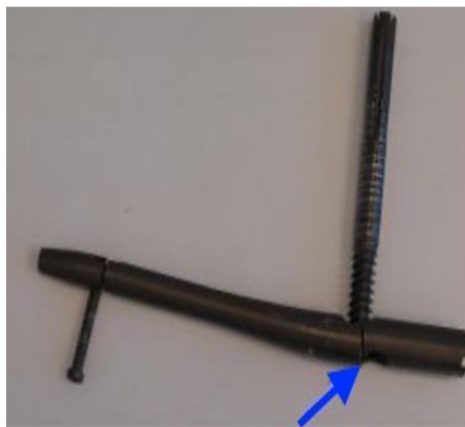
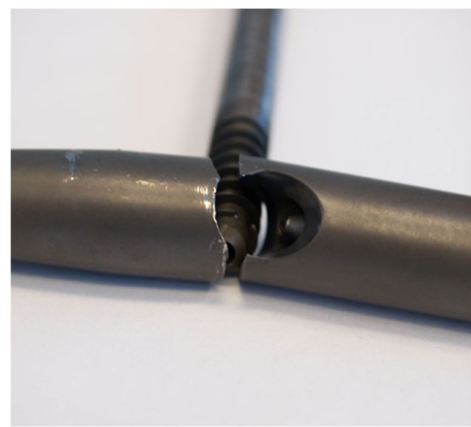
After the removal of the broken Gamma Nail, the implant was subjected to some experimental analyses. The broken implant is highlighted in (Figure 4).

Figure 4. The removed implant: the blue arrow indicates the failure point (a). Macroscopic examination after removal (b), showing a close-up of the failure point.

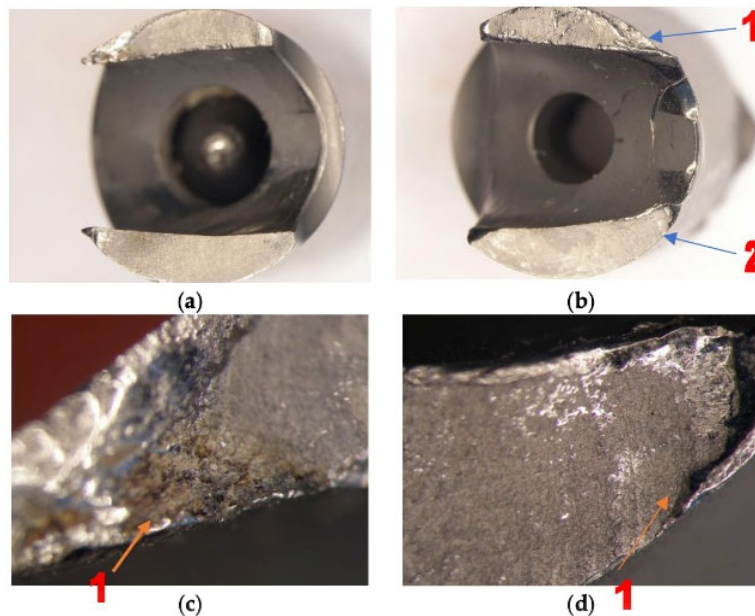
Figure 6. (a–d) Images obtained by stereomicroscopy of the failure area.

After the stereomicroscopic analysis of the failure surface of the implant, it was observed that there were broken areas, as shown in Figure 6. The component shows gradual breaking due to low and constant energy, with the presence of propagation lines, and then a final, sudden break. The intergranular rupture has a matte aspect and forms three zones: initial, of propagation, and a sudden, final rupture which took place in a short period of time (Figure 6a). It can also be observed that the rupture with intergranular aspects was covered by a thin layer of oxides in Figure 6c(1). In Figure 6b, the fatigue break characteristics, which took place in a short period of time, are highlighted. The failure is mixed: both ductile (1) and brittle (2). The detailed image of the area highlights the cup–cone break type (Figure 6d(1)).

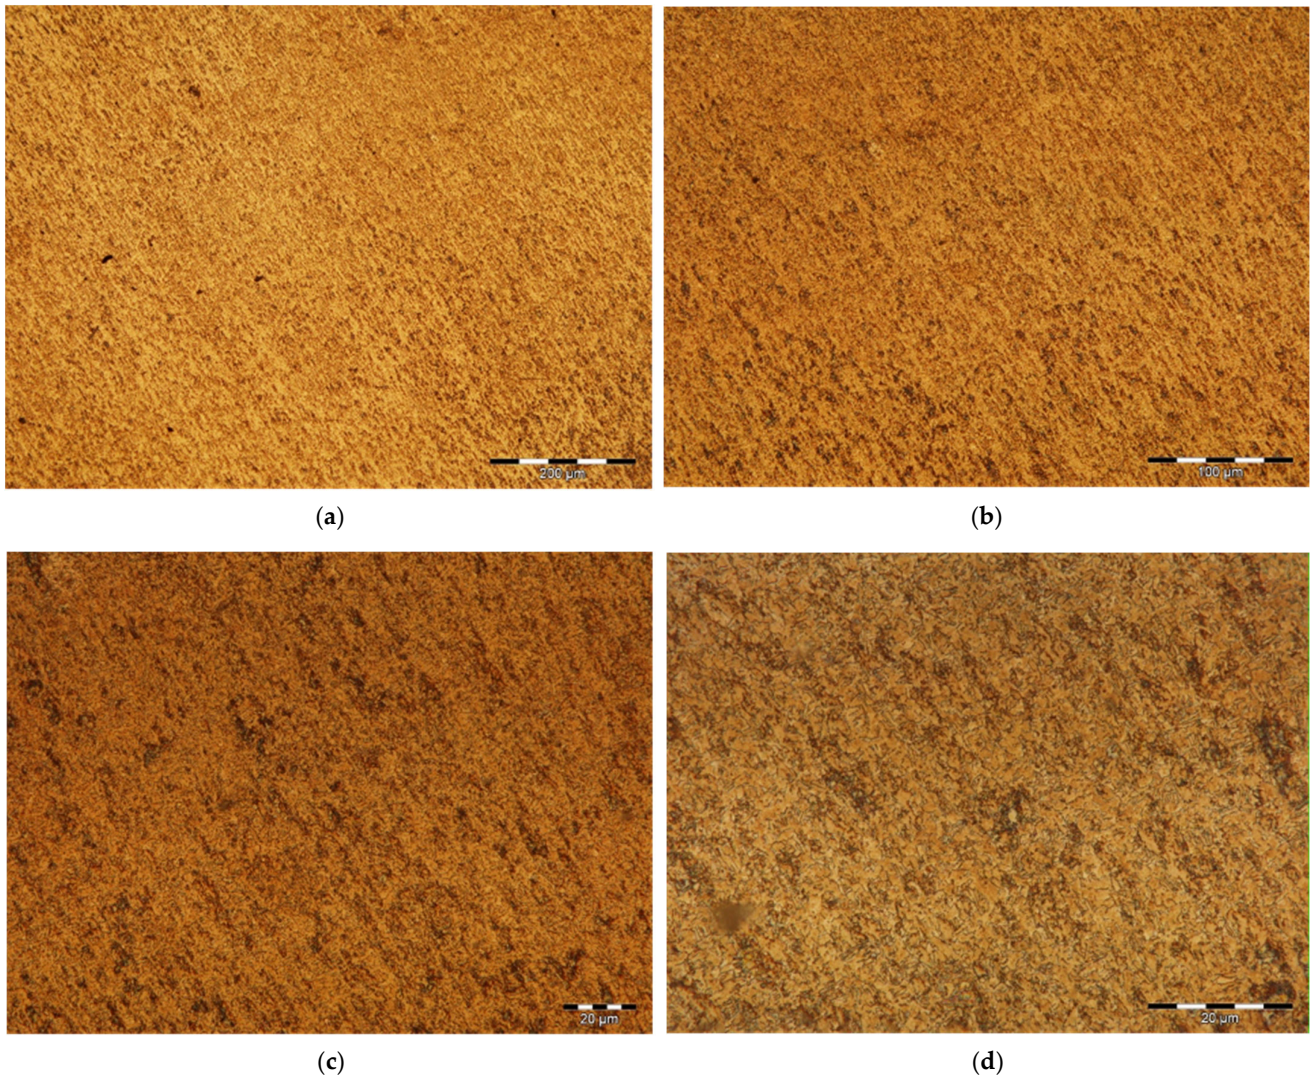
The images provided by the optical microscope, presented in (Figure 7), highlight a classic biphasic $\alpha + \beta$ structure, obtained most probably after a heat treatment for tempering. The elongated appearance of the grains is due to the plastic deformation operations to which the material was subjected (Figure 7a,d).

Figure 7. Optical microscopy images related to the microstructural features of the metallic implant material, Ti6Al4V alloy: (a) enhancement 100 \times ; (b) enhancement 200 \times ; (c) enhancement 500 \times ; and (d) enhancement 1000 \times .

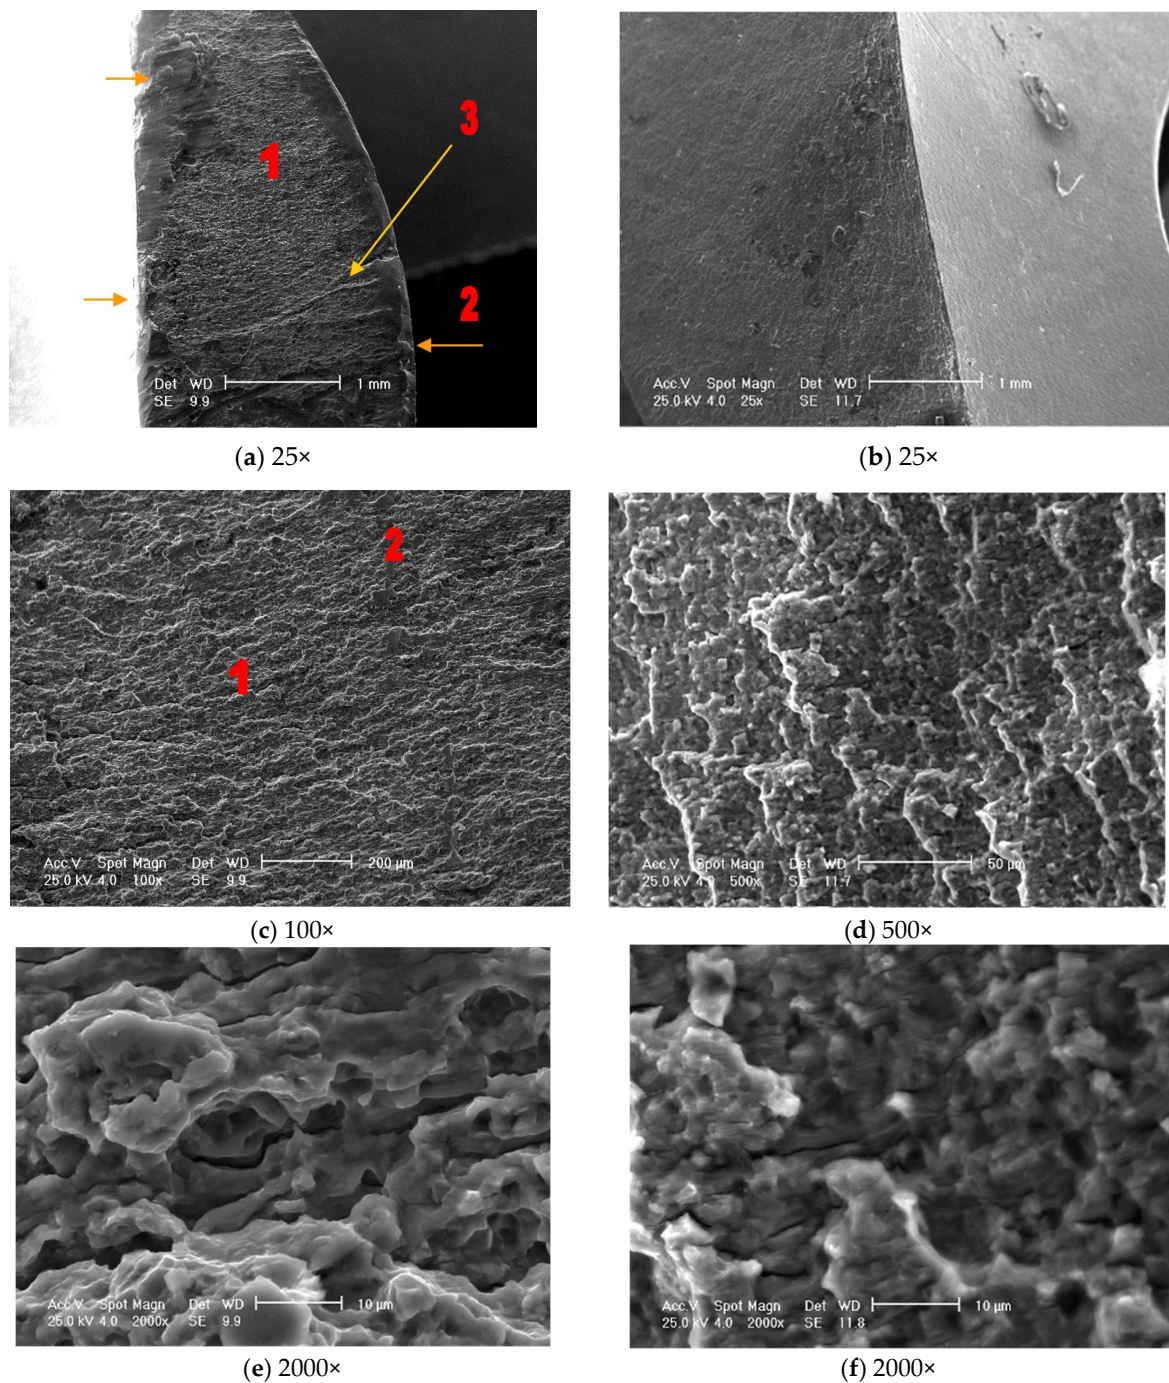
Figure 8a shows the intergranular break area, with a matte aspect, covered by a thin layer of oxides (1), which highlight the cup–cone appearance of the rupture (2) as well as the propagation lines of the rupture (3). In image b, the intergranular rupture areas with the presence of small voids in the oxides-covered surface of the sample can be seen. The mixed character of the rupture at 100 \times magnification can be seen by the presence of brittle (1) and ductile (2) fractures in image c.

Image 8d represents a fracture image magnified by 500 \times , highlighting relatively equal cups (approximately 10 μm of ductile breakage), as well as relatively parallel rupture zones. In image 8e, the ductile rupture, characterized by the presence of cone–cup type elements, is highlighted. In image 8f, the rupture area at 2000 \times magnification highlights relatively

equal cups (ductile rupture) as well as rupture propagation cracks, both parallel to and in the depth of the sample (Figure 8a–f).

Figure 8. Scanning electron microscopy analyses did not highlight structural inhomogeneities in the rupture area.
