Performance of a Ship-Based Cupronickel Alloy in Exposure Conditions of Arabian Seawater—A Comparative Study

Abstract: Cupronickel-based alloys are widely known for their excellent resistance against aqueous corrosion, however, they can be susceptible to corrosion at accelerated rates and premature failure when exposed to a polluted or brackish seawater medium, even for short-term exposure durations. This unfamiliar corrosion behavior may be a result of the formation of an unprotected corrosion film during the early exposure durations. The paper investigates the corrosion phenomenon in cupronickel 90/10 alloy, by exposing the coupons in two different seawater compositions in the Arabian Sea region. Corrosion losses were investigated on the experimental coupons in a submerged position, for a maximum exposure duration of 150 days, using the conventional weight loss method and a new dimensional metrology-based measurement technique. Additionally, in this research the tubes of a marine heat exchanger having similar material that failed prematurely during operation in the Arabian Sea were also investigated for corrosion losses, followed by the characterization of the corrosion deposits

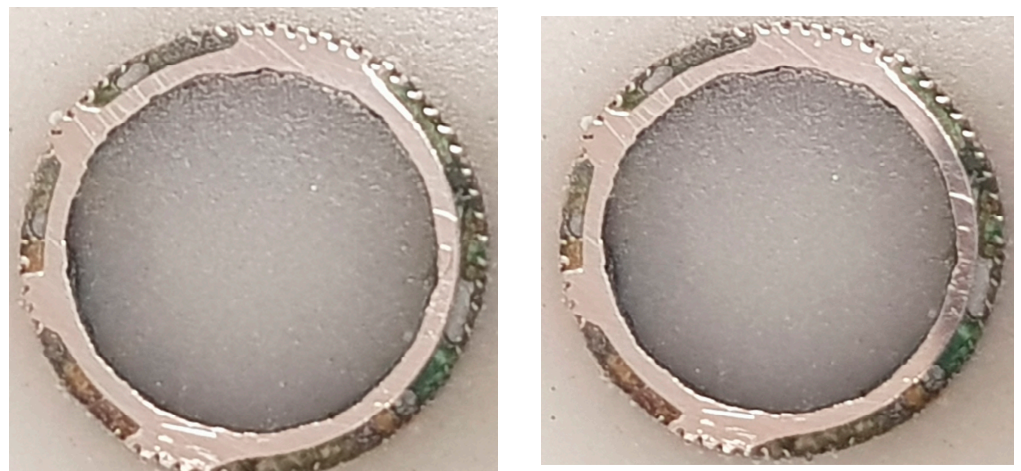
For the heat exchanger tubes, which failed during operation in a ship refrigeration system after 10 years of service life, the cross-sections were prepared from the tubes by cutting them into circular rings, for the evaluation of the corrosion depths, using a specialized optical microscopy/image analyzer arrangement integrated with the DM technique, i.e., the DM–image analyzer approach, as shown in Figure 3. The cross-sections prepared from the heat exchanger tubes and evaluated for thickness loss measurement are shown in Figure 4.

Figure 4. Prepared cross-sections of the tubes of a failed marine heat exchanger exposed mainly in the polluted seawater site in the Arabian Sea.

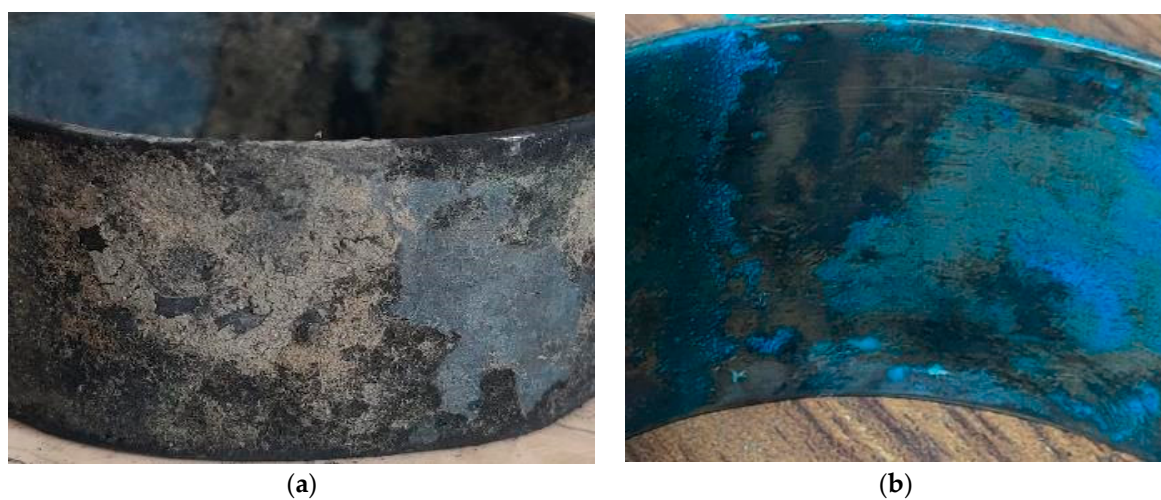
Figures 8 and 9 show the post-corrosion coupons and tubes recovered from both the polluted and natural seawater sites. A blackish corrosion layer was deposited on the coupons placed in the harbor seawater site, whereas bluish deposits appeared on the coupons recovered from the natural seawater-containing tank after 150 days.

Figure 8. Macroscopic view of corroded coupons of Cu-Ni 90/10 material collected from (a) polluted seawater site and (b) natural seawater site.

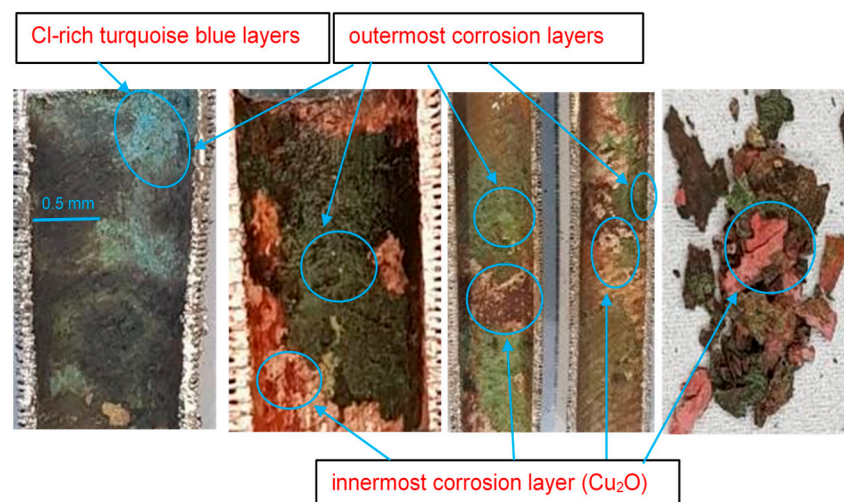
Figure 9. Macroscopic surface morphologies of corrosion layers on Cu-Ni 90/10 alloy tubes operating in seawater conditions of Indian Ocean.

In Figure 9, the outermost corrosion layers (away from the tubes' metal surfaces) present blackish, greenish and turquoise blue colors. The turquoise blue appearance of the external corrosion surface typically indicates the presence of high chloride content [29].

Underneath the top corrosion layers, a highly intact reddish corrosion layer is observed near the alloy surface. This reddish corrosion layer (Figure 9) represents a cuprite film, which normally develops in low-salinity regions. Figure 10 presents the macroscopic images of the external surfaces of the extracted tubes; these are normally exposed to the less corrosive refrigerant gas (R-22 or R-34). It is, however, evident from the photographs that the outer finned surfaces of the tubes are also severely affected by the corrosion. The greenish rust layers (cupric/cuprous oxides) and localized corrosion marks are clearly visible on the exterior surfaces of the tubes, probably indicating the localized corrosion depths or leaked/perforated regions.

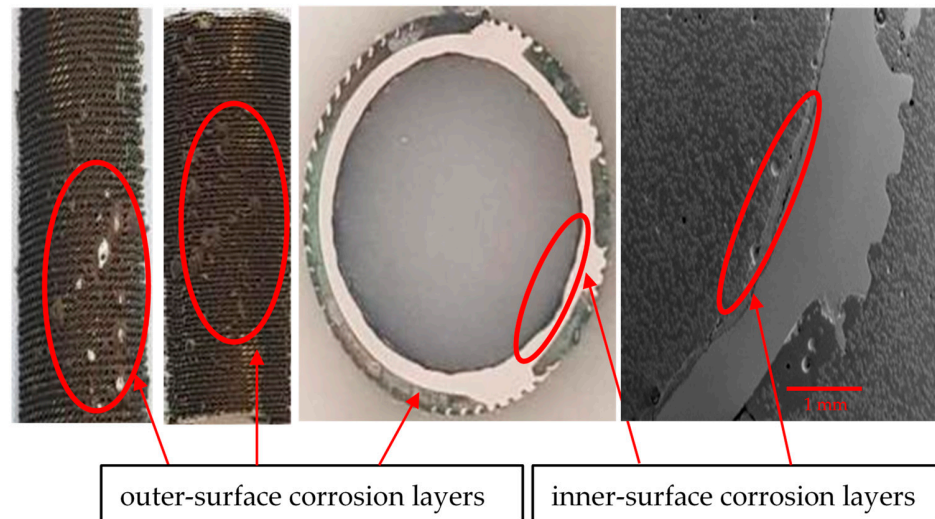
Figure 10. Inner and outer surfaces of heat exchanger tubes with corrosion deposit layers and thickness losses.

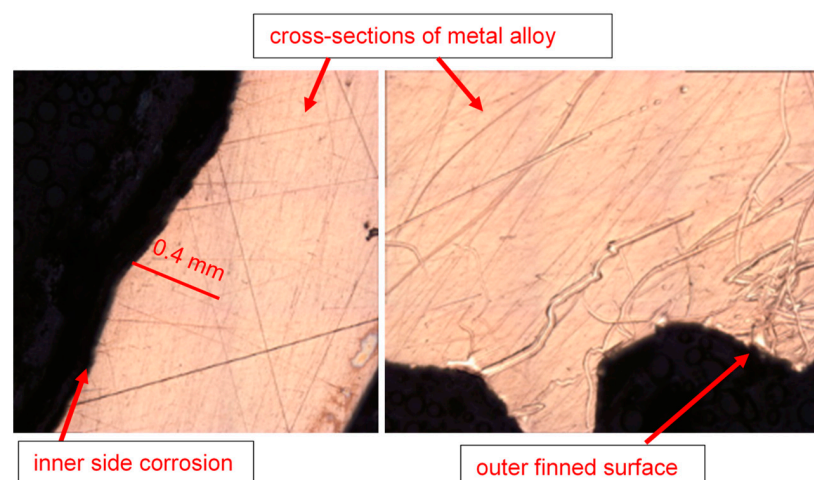
The optical microscopic images of the tube cross-sections (inner and outer sides) are shown in Figure 11. From several corroded tubes, only five cross-sections were prepared for inspection, as random samples out of the total population of the failed tubes. After the failure of the tubes, it was assessed (based on engineering experience) that the maximum metal loss and subsequent tube perforation occurred mainly due to seawater corrosion, which affected the tubes at a pressure of around 30–35 psi.

Figure 11. Inner and outer topologies of a corroded tube cross-section viewed under an optical microscope (using 20X lens). The gear-shaped metallic structures are the finned structures on the outer surfaces of the tube.

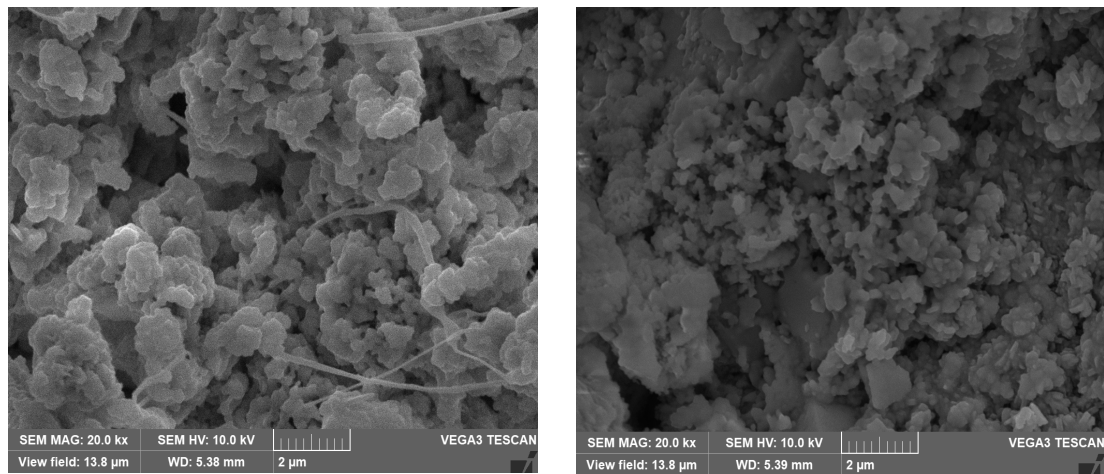
The SEM micrographs of the corrosion products/deposits collected from the seawater side (inner side) of the tubes are shown in Figures 12 and 13. In some cases, different crystalline structures developed within the cracked corrosion surfaces and pores.

Figure 12. SEM micrographs of the outermost corrosion products/deposits on the heat exchanger tubes at magnification of 20k.

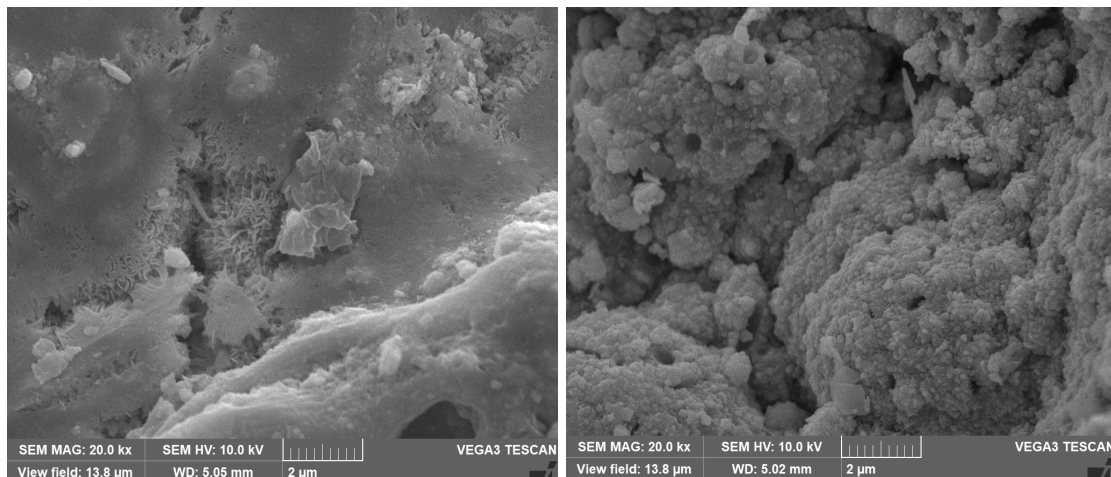
Figure 13. SEM micrographs of the corrosion deposits (on Cu-Ni 90/10 alloy tubes) on the innermost corrosion layers (reddish layers), at magnification of 10 kx and 20 kx.

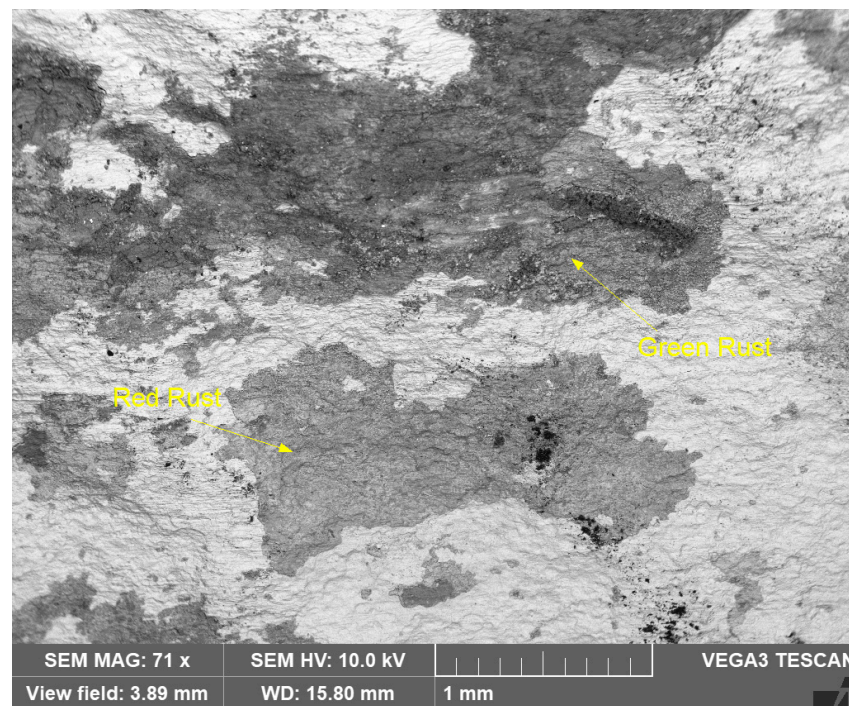
Similarly, Figure 14 shows an SEM image of the reddish and greenish corrosion patches (shown in Figure 9), at lower magnification (71X).

Figure 14. SEM micrograph of greenish and reddish corrosion patches (shown in Figure 9) on seawater side of Cu-Ni 90/10 alloy tube (BSE view).

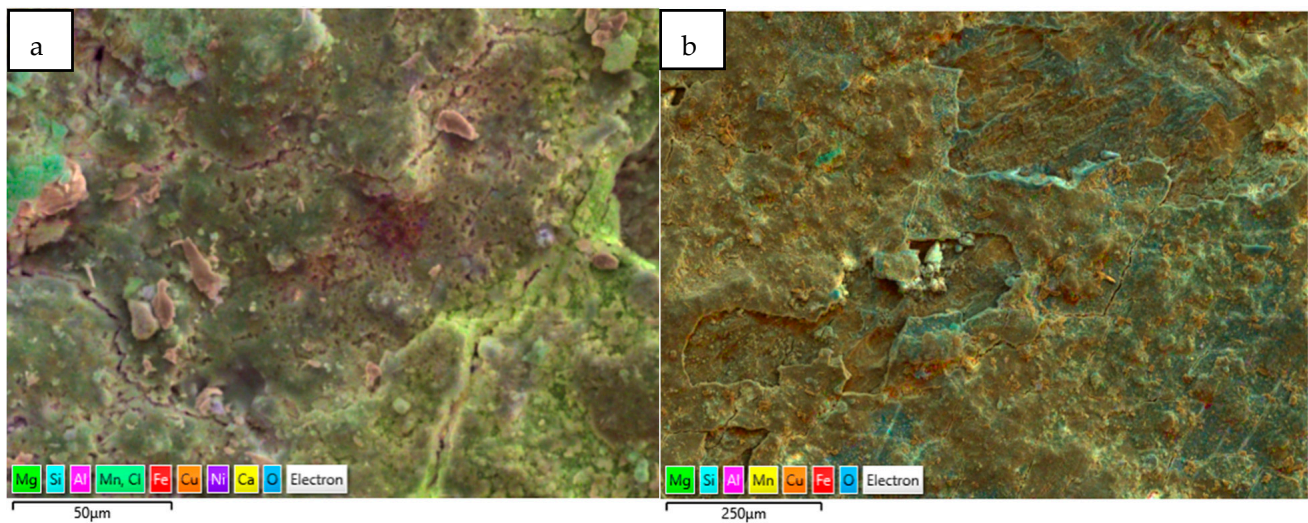
Another form of elemental distribution in the corrosion products on the seawater side of the tube (inner) is shown in Figure 15, obtained using SEM-EDS layered images and analyses. In this technique, the most significant (wt. %) elements in the corrosion product have been highlighted with different colour shades, without changing their actual positions, so that the positioning of various elements in the corrosion product can be evaluated with respect to the metallic surfaces.

Figure 15. (a,b) Elemental map (EDS mapping) of the corrosion products (next to metal surfaces) collected from marine heat exchanger tubes.

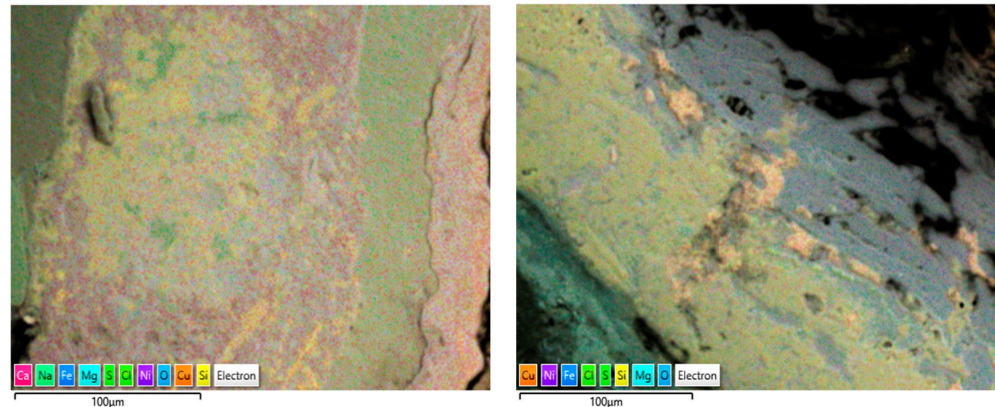
(wt. %), EDS mapping also enables the visualization of the positions of the accumulated elements in the corrosion products, which may reflect the exposure conditions (i.e., seawater constituents). Figure 17 shows some of the EDS maps illustrating the distribution of the elements in the corrosion product accumulated on the seawater side of the condenser tubes (Cu-Ni 90/10) operated in the polluted seawater region in the Arabian Sea. As well as other elements, the substantial presence of sulfur and chlorides is visible in both images; these were also visible in the typical EDS (wt. %) results.

Figure 17. EDS elemental maps of the corrosion deposits accumulated on the seawater side of the heat exchanger tubes exposed mainly to the polluted seawater site (both images show corrosion on tubes exposed to the same polluted seawater sites).
