Fractographic ceramic failure analysis using the replica technique

Susanne S. Scherrer^a, Janet B. Quinn^b, George D. Quinn^c, and H. W. Anselm Wiskott^a

Objectives—To demonstrate the effectiveness of in vivo replicas of fractured ceramic surfaces for descriptive fractography as applied to the analysis of clinical failures.

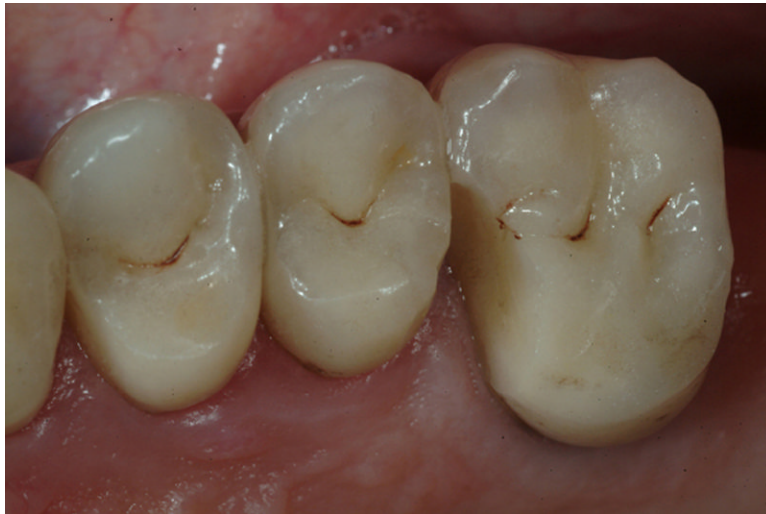
Two sites were identified for study: 1) A failure of the veneering ceramic of a Procera AllCeram restoration (Nobel Biocare, Gothenburg, Sweden) located on a first upper molar. This restoration has been in function for 4.2 years. 2) A fracture of the veneering ceramic (Allux, Wieland Dental, Pforzheim, Germany) sintered onto an In-Ceram Zirconia core (Vita Zahnfabrik, Bad Säckingen, Germany). This restoration was screw-fastened onto an implant replacing a first upper premolar and failed after 2 months of function.

Fig. 1. Fracture of the veneering porcelain (AllCeram) of an upper left Procera alumina molar after 4.2 years of intra-oral function

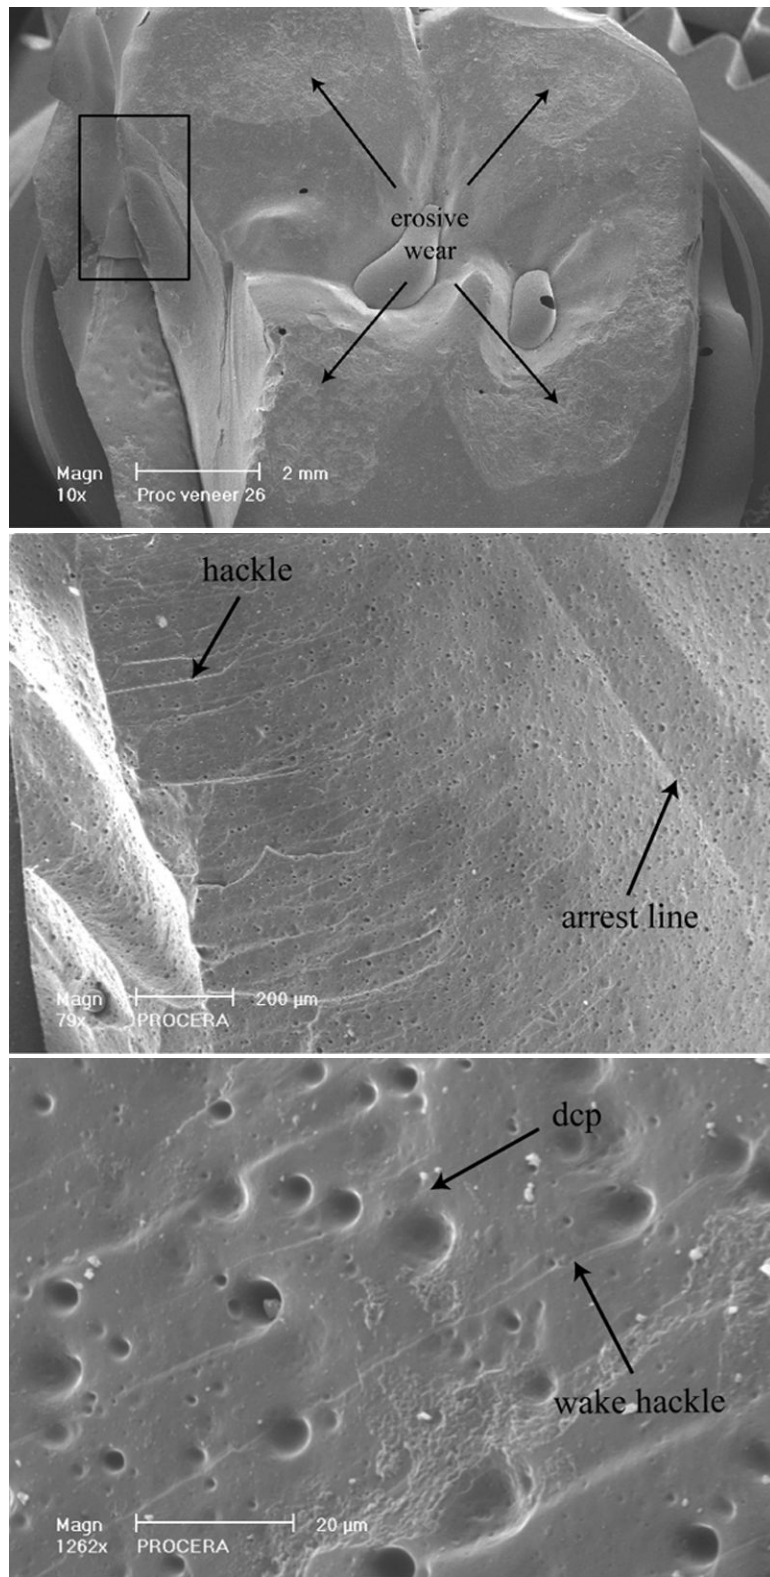
Fig. 5.

The resin replica (Fig.4) of the failed Procera AllCeram crown was sputter-coated with gold and inspected under SEM magnification. Figure 5a shows the crown from an occlusal view at low power (10x). Major erosive wear is apparent on all four cusps, usually a sign of abnormal parafunction habits (bruxism). The zone delineated by the frame looks similar to the compression curl often seen in bend bars. Such curved surfaces generally arise from mixed mode loading (tension, shear, torsion), and are found to be typical of final crack break-through in dental crowns. Higher magnifications within the frame (Figs.5b,c) near the interproximal mesial margin show hackle and wake hackle indicating the direction of crack propagation towards the margin.

a: Occlusal view (at 10x) of the Procera AllCeram crown showing the veneer failure on the palatal-mesial cusp. Major wear is visible on all four cusps. The frame near the mesial gingival margin is magnified in Fig.5b and Fig.5c

b and c: Higher magnifications within the frame (Fig.5a) near the interproximal mesial margin show hackle and wake hackle indicating the direction of crack propagation towards the margin.

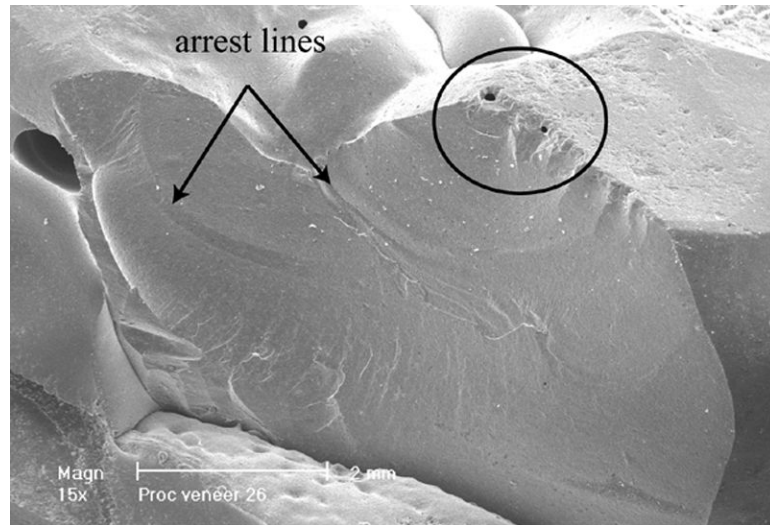
On the fractured surface viewed at 15x magnification (Fig.6) several major *arrest lines* are observable. The occlusal edge of the palatal cusp (circle) is shown under higher magnification in Figs.7 and 8. On the edge of the fractured surface (large frame in Fig.7) an area of erosive wear spanning about one millimeter is delimited by concave *arrest lines*. At 127x magnification (Fig.8), this area comprises two deeper damage zones shaped as indents (craters) about 300 μm in diameter followed by *arrest lines* further downwards. These craters are identified as the origins of the fracture process.

Fig. 6. Side view of the Procera AllCeram crown (at 15x). Major arrest lines are recognizable as well as hackle lines. The circled occlusal broken edge shows some surface damage.

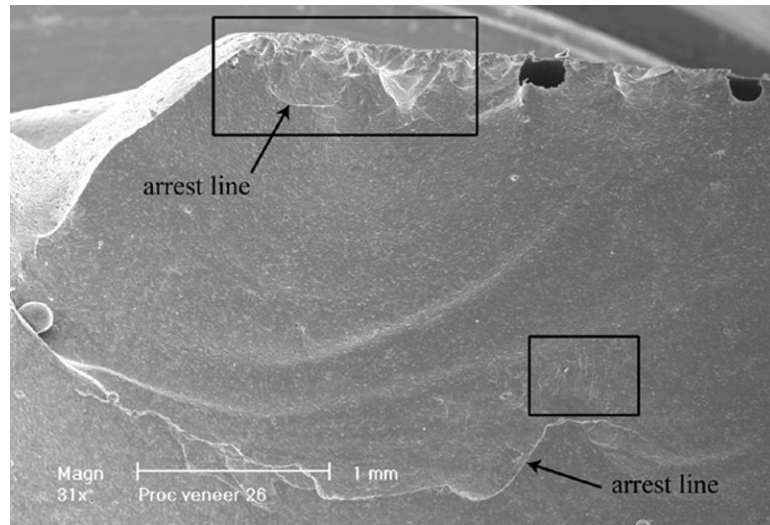
Fig. 7. Higher magnification (31x) of the circled area in Fig.6. Several arrest lines are visible (concave well delimited lines). Areas of interest (frames) are scrutinized at higher magnifications in the following figures.

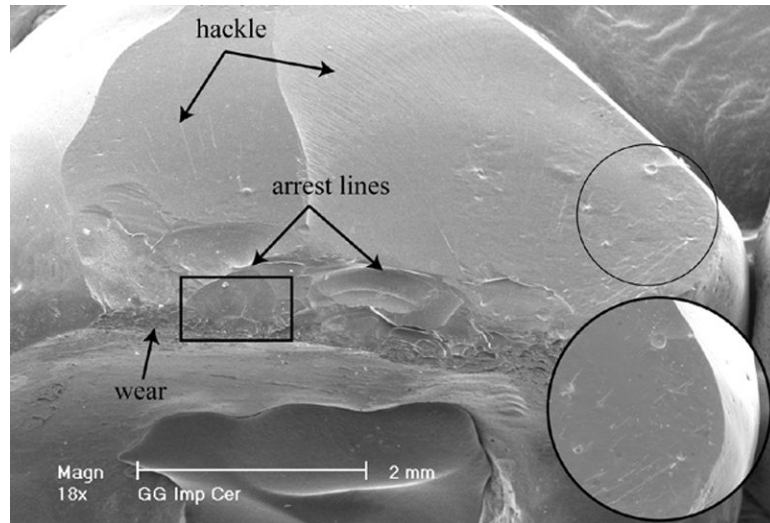
Fig. 14. The SEM view at 18x shows evidence of ceramic wear near the fractured edge, arrest lines, hackle and wake hackle (zoom within the image). The frame area is analyzed in Fig. 15.

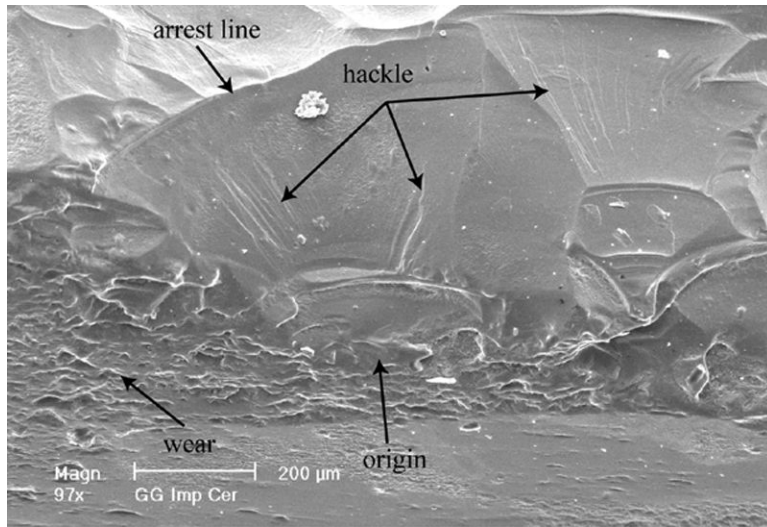
Visual observation of the gold-coated replica (Fig. 13) of the fractured In-Ceram Zirconia upper premolar crown indicates a major chip of the veneering ceramic on the buccal side. Numerous hackle lines curling off towards the gingival margins as well as several smaller ceramic chips on the cusp tip are observable. Fig. 14 (18x) shows a worn cusp tip with several small ceramic chips delimited by concave *arrest lines* on the buccal surface. The higher magnification on the right of the picture shows several *wake hackle* emanating from existing pores. Figure 15 is a close up view of the frame in Fig.14 showing a 97x magnification of the worn and damaged

cuspid tip with *arrest-* and *hackle lines*. A comprehensive view of the direction of crack propagation and multiple origins (arrows on cuspid tip) is given in Fig. 16.

Fig. 15. Higher magnification (97x) of the frame delimited occlusal edge area in Fig. 14 showing many arrest lines, hackle, wear and one of several origins on that edge.

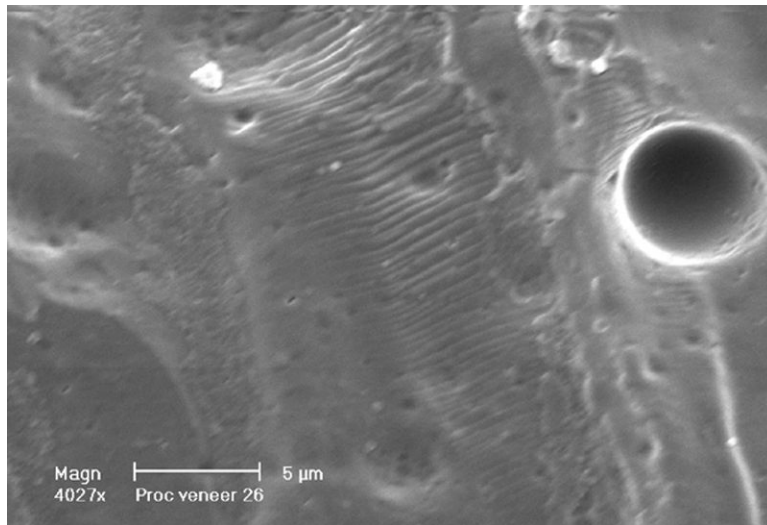
hackle. These ripples have been identified as secondary *twist hackle* from lateral link up of overlapping crack segments [9]. These may occur when multiple crack planes are present.

Fig. 17. The clear details obtained from replicas viewed here at 4027x. Twist hackle looking like ripples are visible perpendicular to a wake hackle (detailed view of Fig. 10). The twist hackle are obtained from final lateral link up of overlapping crack segments.
