J Biomed Mater Res B Appl Biomater. 2009 January ; 88(1): 206–219. doi:10.1002/jbm.b.31171.

IN VIVO SEVERE CORROSION AND HYDROGEN EMBRITTLEMENT OF RETRIEVED MODULAR BODY TITANIUM ALLOY HIP-IMPLANTS

Danieli C. Rodrigues^{1,*}, Robert M. Urban², Joshua J. Jacobs², and Jeremy L. Gilbert¹

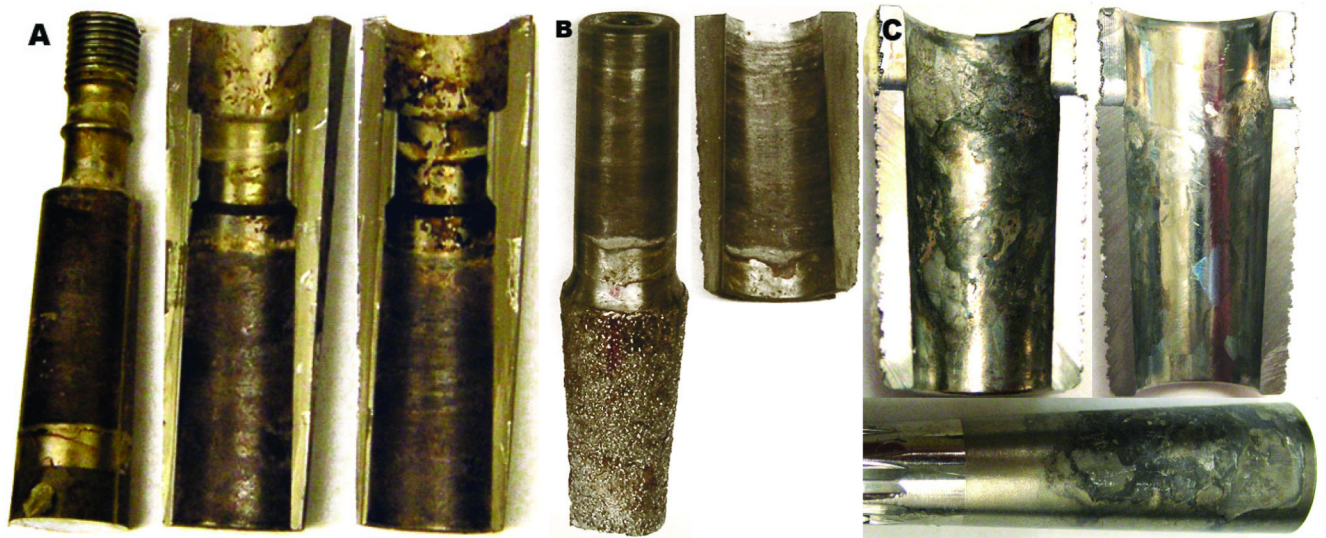
The extent and nature of the damage was similar for the mating interfaces for each design in the study (see Fig. 1). The taper interfaces in the stem region introduce a larger crevice area, which is subjected to micromotion and fretting. Fretting corrosion of modular tapers has been observed with *in vitro*^{26,27} studies with titanium alloys; however these studies have not documented the extent of the corrosion effects observed in this retrieval study. Fretting scars and corrosion damage at the taper interfaces were observed over most of the taper areas in all three devices analyzed. In many regions, signs of fretting produced by the micromotion between the contacting interfaces were obliterated indicating increased metallic dissolution (data not shown).

Fig. 1. Digital images of retrieved samples. (a) Z hip system showing the male taper and proximal female tapers (lateral and medial half-sleeve, respectively). (b) M system showing the male taper and proximal female, portions, respectively, of the femoral stem. (c) S component showing the proximal female and male tapers, respectively.

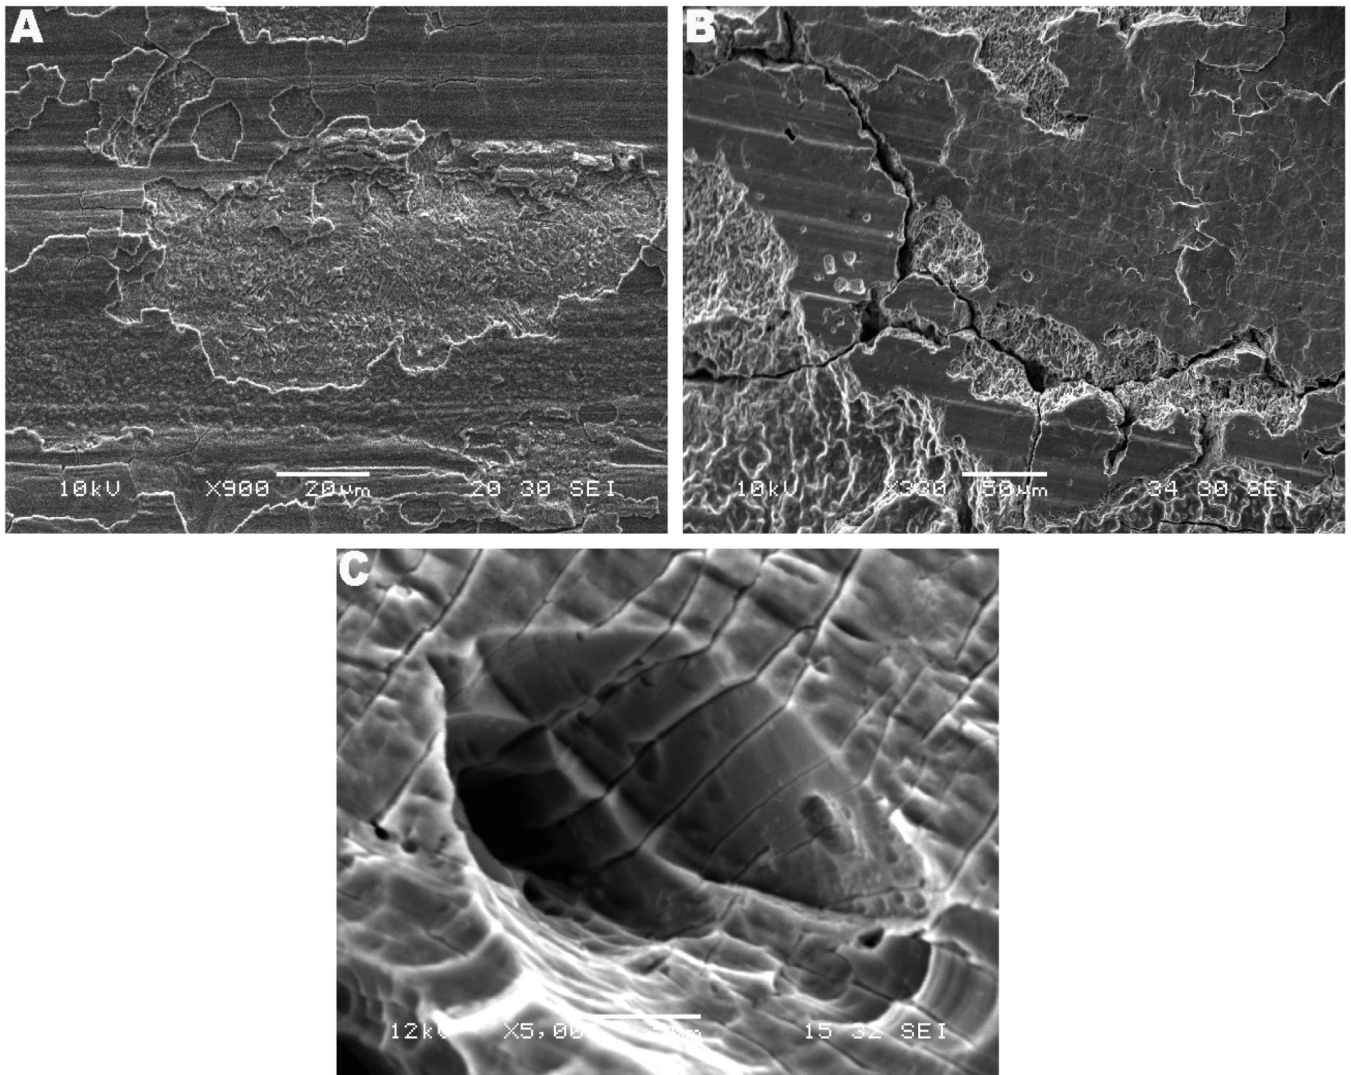
Corrosion-induced cracking on the taper interfaces was another major feature typically present on the corroded surfaces of the stem/sleeve interfaces. Fretting-corrosion fatigue cracking is likely to occur as a result of cyclic loading and fretting motion interacting with the crevice corrosion reactions. However, the cracking morphology did not appear to have been initiated by a corrosion fatigue process. Figure 3 shows the cracking patterns observed on the sleeve interfaces of the three implants. The M component presented cracking of the most superficial layers, shown in Fig. 3a, while the S sample interfaces presented interpenetrating cracks on the corroded sleeve (lateral proximal female taper) following the Widmanstätten microstructure, as illustrated in Fig. 3c. Particularly, the cracking on the Z interfaces, both on the stem and sleeve, presented microstructural and interpenetrating morphology revealing cleavage of the bare material and brittle failure, as shown in Figs. 3b and 3c. The patterns shown in Fig. 3 include needle-like precipitates (Fig. 3a) and interpenetrating cracks (Figs. 3b, c and d) and are morphological evidence of precipitation of brittle phases in the material (hydride formation), which can lead to HIC. This propagation mode and cleavage are likely a result of residual stresses development caused by lattice expansion during the hydrogen embrittlement process and/or cleavage of brittle phases precipitated in the material

Fig. 3. SEM micrographs of cracking morphology. (a) M component (anterior medial proximal female taper, 900 \times). Notice the cracking of the top surface layer and region with microstructure exposure by crack propagation. (b) Z component (lateral proximal female taper, 500 and 330 \times , respectively). Interpenetrating cracks were observed in several regions of the stem/sleeve taper samples. (c) S component (lateral proximal female taper, 5,000 \times). High magnification showing cracks following the microstructure in which the cracks were penetrating into the microstructure, also propagating out from the pit.

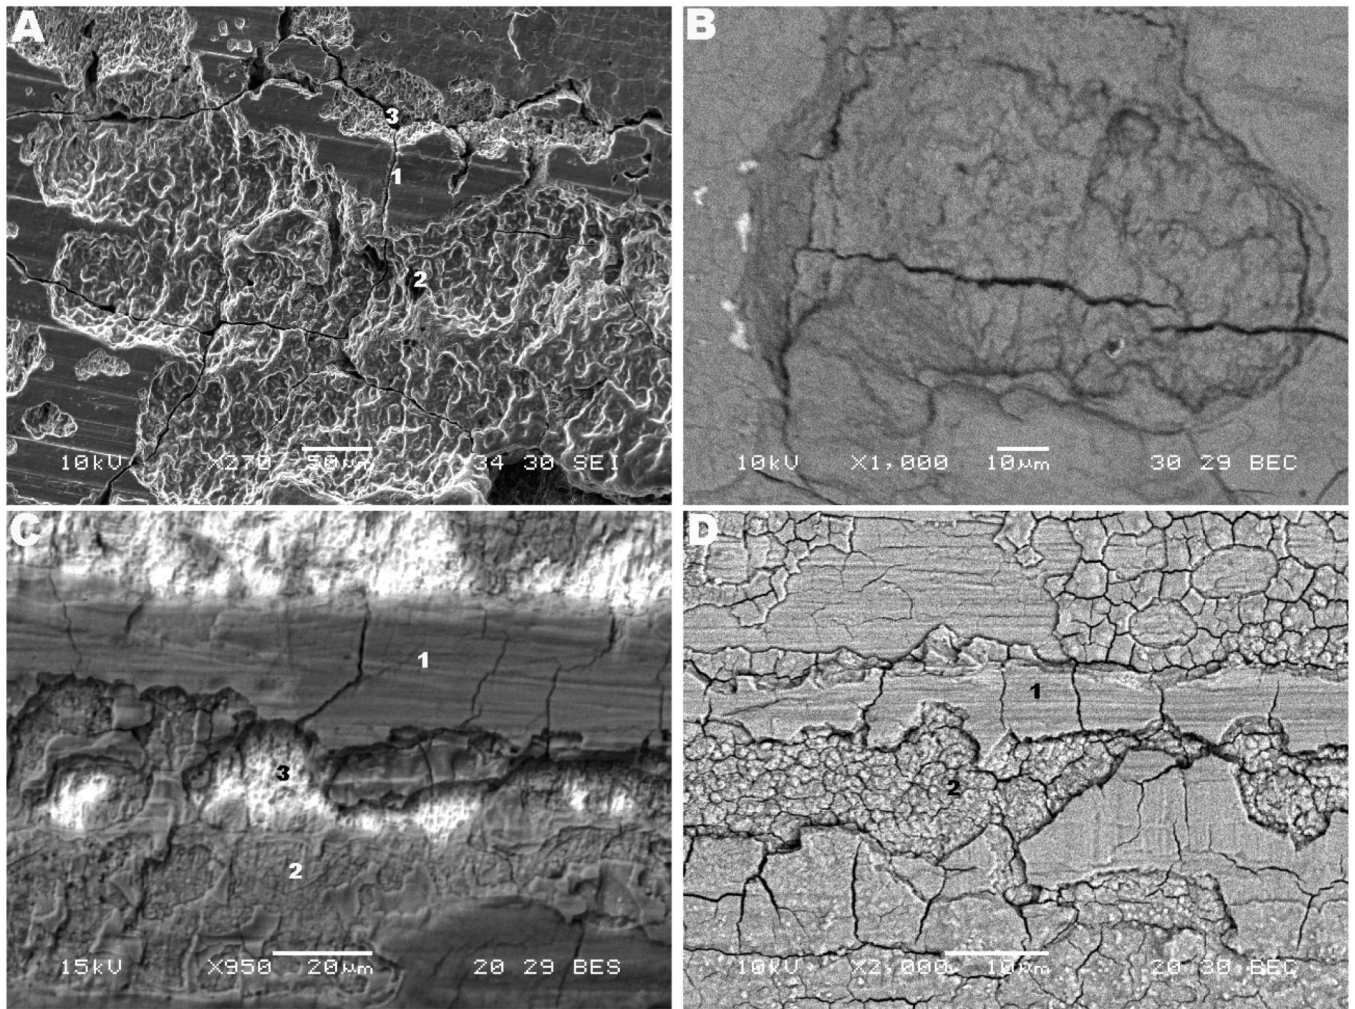
The presence of hydrogen embrittlement occurring in the modular tapers was first hypothesized by the observation of regions with brittle appearance and with particular crack propagation mode, as previously shown in Figs. 3a and 3b. Figure 4 shows regions with delamination, cracking in different layers and corrosion patterns observed in the three implants. Figure 4a shows a high magnification SEM image where cracking in three different layers exposed the microstructure. Several regions in the tapers of the Z component, including the femoral stem, presented cracking of the top layer (indicated by number 1 in Fig. 4a), intermediate layer (number 2) and microstructure (number 3). It is interesting to note the unbranched morphology of the cleaved regions (see Fig. 4a). Figure 4c shows a backscattered SEM image of an example of delamination in three layers observed for the M component. The regions with the three layered structure presented cracking of the top and intermediate layers (grooved portions), while the underlying microstructure (bright region) remained intact in most of the cases observed. This morphology was frequently observed with other taper samples from the M component showing delamination of the surface with the following structure: 1. top layer (debris, oxide layer and biological material); 2. intermediate layer (granular layer – spherical particles present); 3. alloy substrate (presenting pitting attack within the microstructure – bright region). Figures 4b and 4d show high magnification backscattered mode SEM micrographs of the cracked structure of the Z and M components, respectively. The former case shows deep interpenetrating cracking, while the latter presents cracking of the most superficial layers. Similar to Fig. 4c, the three-layered structure was observed for the stem of the S component (cracking of the top and intermediate layers); however this component did not present the three-layered delamination in the sleeve (female taper) interface.

Fig. 4. SEM micrographs of cracking patterns in the three designs and structure of delamination. (a) and (b) Z lateral proximal female taper (270 \times) and medial proximal female taper (1,000 \times), respectively. (c) and (d) M posterior medial proximal female taper (950 \times) and anterior medial proximal female taper (2,000 \times), respectively. In the Figures, the features numbered as 1, 2, 3 represent top layer (metal surface), intermediate layer and microstructure, respectively.

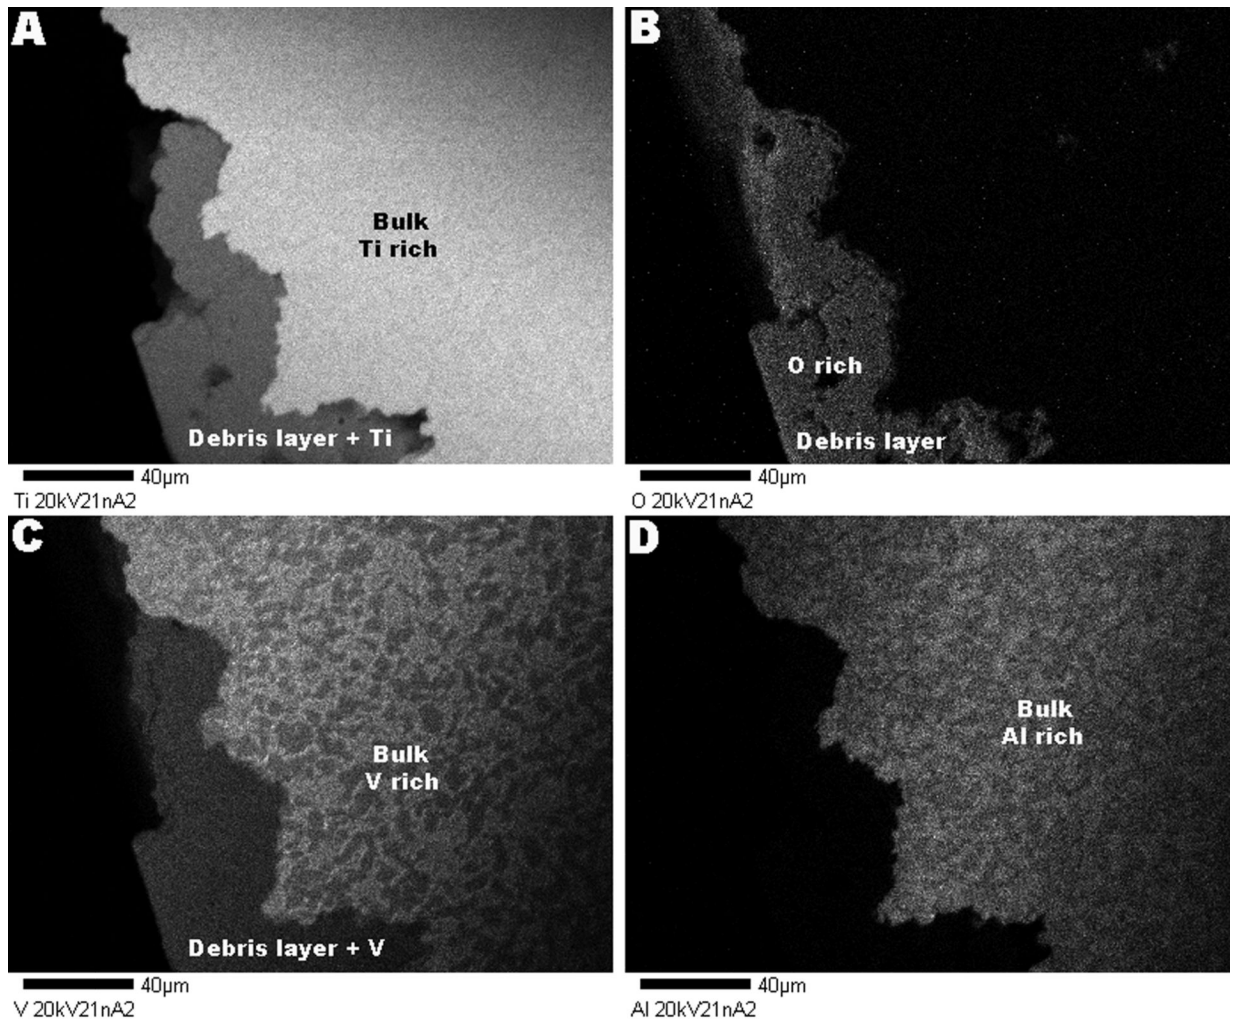
Fig. 9. Topographical WDS micrographs. (a) Observation for Ti: Enhanced concentration in the bulk alloy (bright) and presence of the element in the debris layer (gray). (b) Oxygen: presence in the debris area and depletion in the bulk alloy (black). (c) Vanadium: presence of the element in the debris layer and in the bulk (regions of high and low concentration). (d) Aluminum: depletion in the debris layer (black) and presence in the bulk alloy. The debris layer is primarily composed by titanium, vanadium and debris. Aluminum is not reacting to form this layer.
