Fracture of a Modular Femoral Neck After Total Hip Arthroplasty

A Case Report

By Commander Geoffrey Wright, MD, Scott Sporer, MD, MS, Robert Urban, PhD, and Joshua Jacobs, MD

Investigation performed at the Department of Orthopedics, Rush University Medical Center, Chicago, Illinois

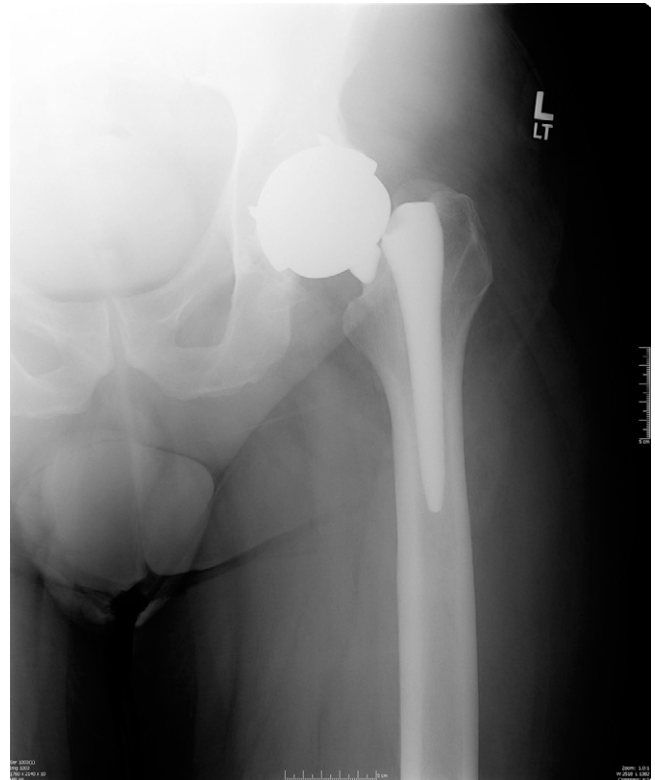
Fig. 1

Anteroposterior radiograph of the left hip made at the time of presentation four years after total hip arthroplasty and two months after a fall. Note that the femoral stem is not in contact with the neck and instead appears to be in contact with the femoral head. The proximal portion of the neck appears to be in contact with the medial calcar.

In January 2009 (four years postoperatively), the patient slipped on ice and fell directly onto the left hip. Following the fall, he reported no pain or discomfort but noticed a new onset of clicking and squeaking coming from the hip. Approximately two months later, three days before presentation to our office, he leaned over to tie his shoes, heard a snap, and was unable to bear weight on the left lower extremity. Radiographs made at that time demonstrated well-fixed acetabular and femoral components with a fracture of the modular neck (Fig. 1). The femoral head remained well fixed to the proximal fragment of the modular neck, while the distal fragment of the modular neck remained seated in the bore of the femoral stem.

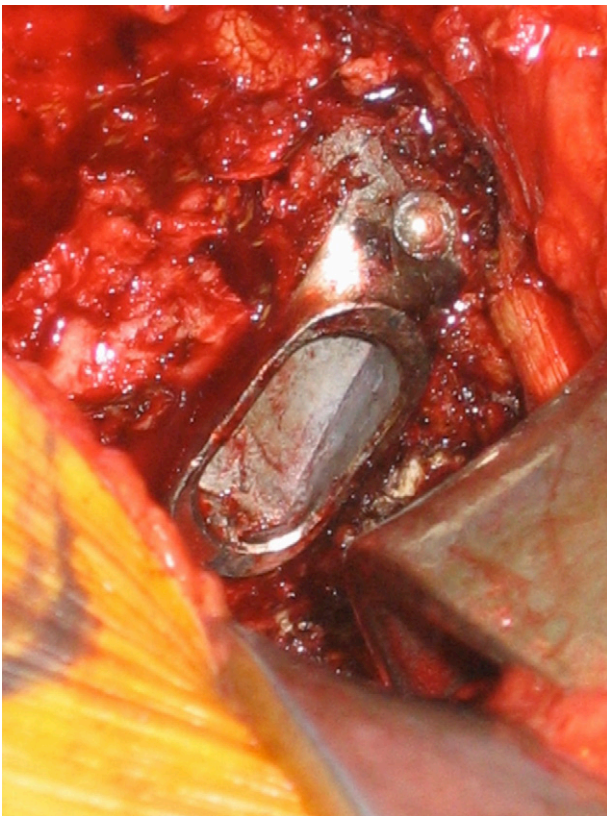
He was referred to our institution, where he underwent a revision total hip arthroplasty. Preoperative laboratory testing was not suggestive of an infection, with an erythrocyte sedimentation rate of 23 mm/hr (normal, 0 to 9 mm/hr) and a C-reactive protein level of 2.3 mg/L (normal, 0 to 1.0 mg/L). No metal ion serum levels were obtained. A posterior approach was used to expose the hip. Intraoperative cell count and frozen-section results showed no signs of infection. The modular neck was confirmed to be fractured near the neck-stem junction. The head and proximal aspect of the neck were removed from the wound. It was not possible to independently remove the distal aspect of the femoral neck from the stem; therefore, the stem extractor could not be used (Fig. 2). An extended tro-

Fig. 2
Intraoperative photograph of the femoral stem and the distal aspect of the neck embedded in the femoral canal.

chanteric osteotomy was performed, and the femoral stem and fractured distal fragment of the modular neck were removed en bloc. The acetabular cup was removed with the explant device because of incompatibility between the acetabular component and the new femoral head. The hip was reconstructed with a 66-mm modular trabecular metal cup (Zimmer, Warsaw, Indiana) and 6-in (15.2-cm) VerSys FullCoat stem (Zimmer) with a 40-mm head. The extended trochanteric osteotomy was repaired with cables. Cultures at the time of surgery showed no growth.

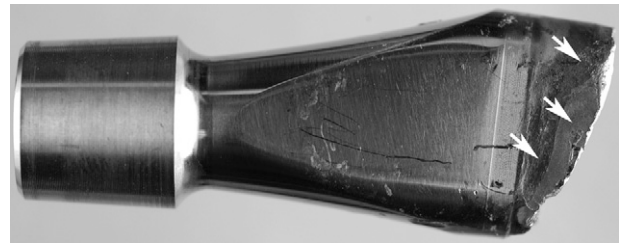
Fig. 3
The retrieved modular neck demonstrates fretting and corrosion damage (arrows) on the surface that had mated with the femoral stem.

Examination of the distal fragment of the modular neck with use of light microscopy showed marked fretting and corrosion damage and black fretting with corrosion debris (Fig. 3). The damage was concentrated on the lateral and anterior surfaces where they had mated with the stem. Scanning electron microscopy revealed severe corrosion, consisting of scalloping and pitting of the mating surfaces (Fig. 4). The fracture surface demonstrated a clear clamshell pattern characteristic of a fatigue fracture radiating from the corroded area on the anterolateral surface of the modular neck. Neither fretting nor corrosion damage was evident at the modular head-neck junction.

This implant had a long varus modular neck. The lever arm, combined with the height and weight of the patient, probably resulted in increased stresses at the neck-stem modular junction. While it is impossible to be certain, we believe that the body habitus of the patient along with the long varus neck contributed to the finding of substantial fretting and corrosion, and subsequent neck fracture. ■

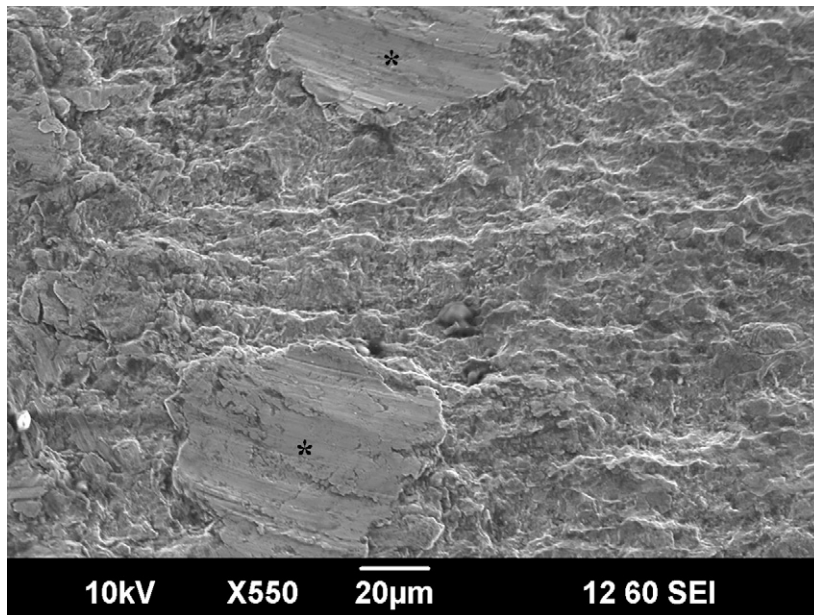
Fig. 4

Scanning electron microscopy of the lateral aspect of the mating surface reveals severe corrosion, consisting of scalloping and pitting. The asterisks indicate the original implant surface.
