*J Arthroplasty*. 2011 August ; 26(5): 796–801. doi:10.1016/j.arth.2010.07.016.

## CRACK INITIATION IN RETRIEVED CROSS-LINKED UHMWPE ACETABULAR LINERS:

### An Investigation of Nine Cases

Jevan Furmanski, PhD<sup>1</sup>, Matthew J. Kraay, MD<sup>2</sup>, and Clare M. Rimnac, PhD<sup>1,3</sup>

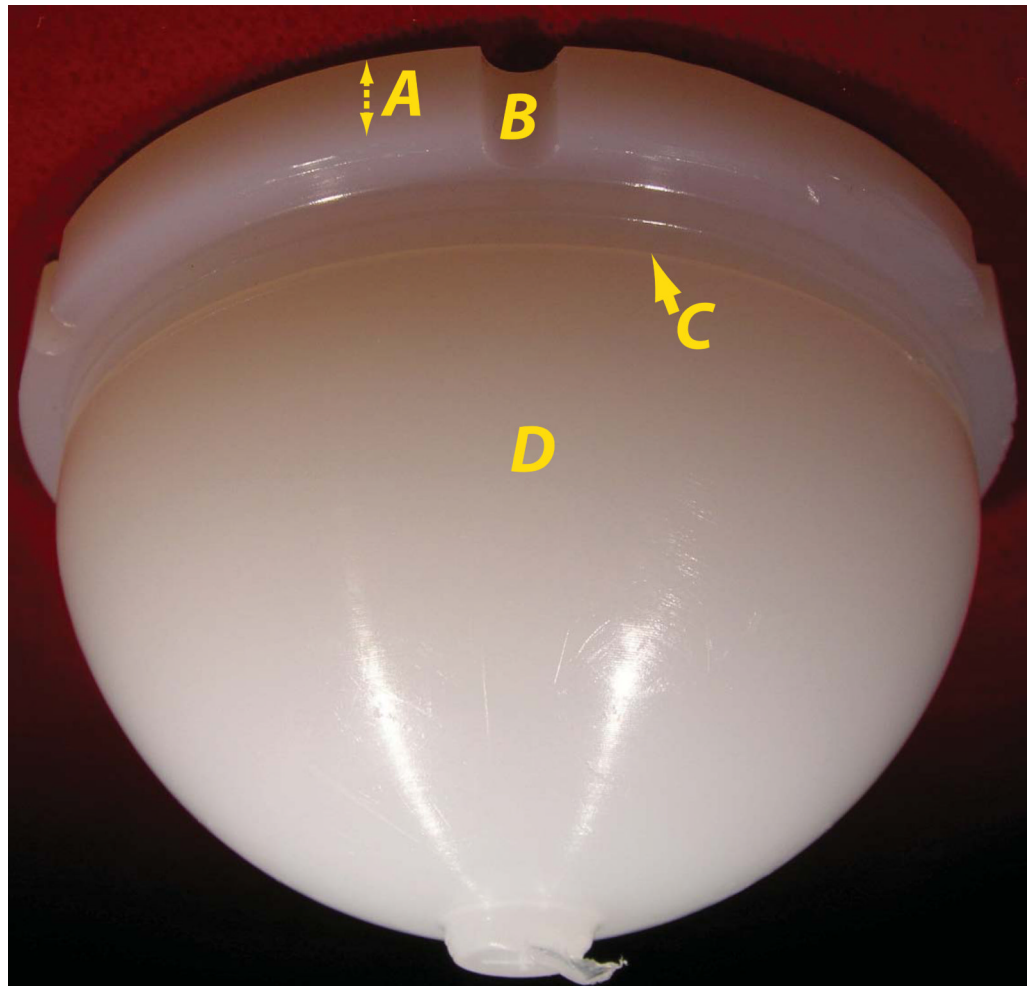
Six of the nine UHMWPE acetabular liners in this series exhibited shallow cracks (cases A-F, Table 1), all of which were identified at the root of a notch machined in the unsupported rim of the component (Figure 1). One liner had sustained a partial fracture secondary to a failure of a metallic acetabular augment (case D) and the rest were intact and fully functional at the time of revision surgery. Four liners exhibited multiple cracks, with as many as five cracks in case F. Each crack was found in a separate notch, and the reported shallow crack identified in case D occurred in a different notch than the fracture.

**Fig 1.** External view of case E liner. The elevated rim (A) is unsupported by the metal shell. Six notches (B) are cut into the exterior of rim. A locking groove (C) accepts an external clip to prevent dissociation from the metal backing. The external liner surface below the rim (D) contacts the metal shell.

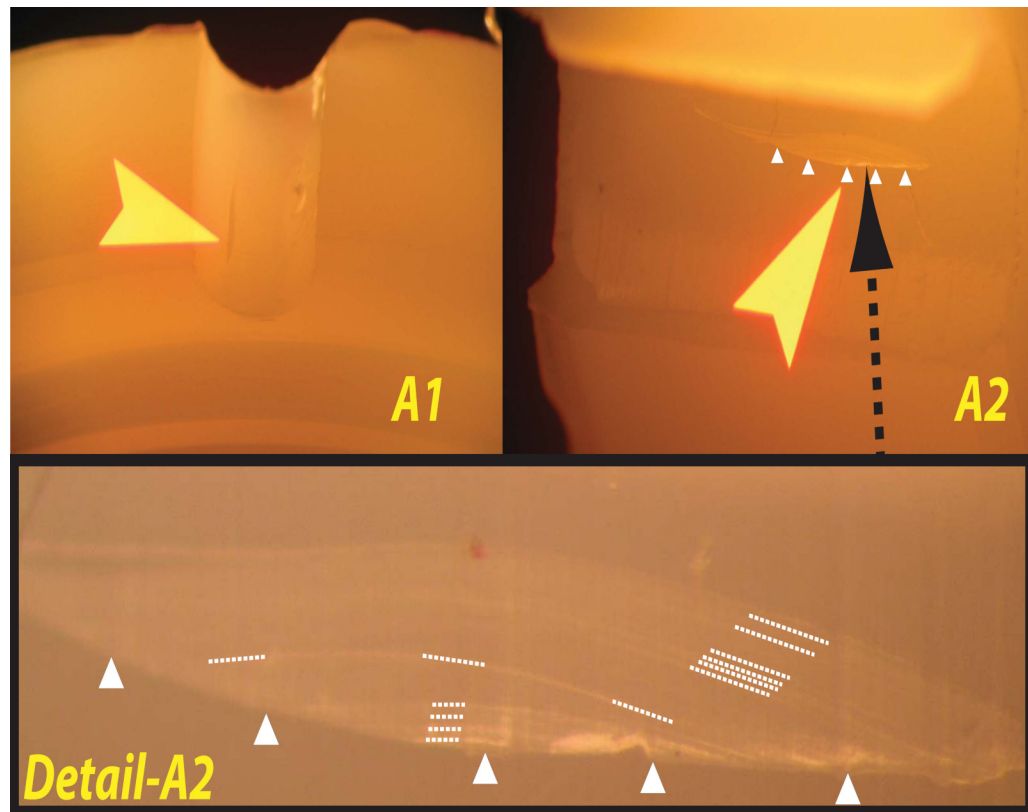
The initiated cracks were all approximately 1-3 mm long and 0.1 mm deep, extending from the surface of the notch in a radial direction (Figure 2). Additionally, many of the initiated crack surfaces exhibited clearly identifiable clam shell markings (Figures 2b-3), which are characteristic of fatigue crack initiation and intermittent growth and have been observed at

**Fig 2.** Representative optical microscopy images from case A showing two initiated cracks in two separate rim notches (denoted A1 and A2). A1 shows a crack that is in dark contrast with the liner, and clam shell markings were difficult to resolve for this crack. A2 shows a crack in light contrast with the background, where the crack surface is nearly in the plane of the image. Detail-A2 shows the thumb nail shaped crack at the root of the notch, with the crack opening at the implant surface indicated by triangular markers. Clam shell markings indicative of intermittent crack growth are visible, and those that are most clear are marked by dashed lines.

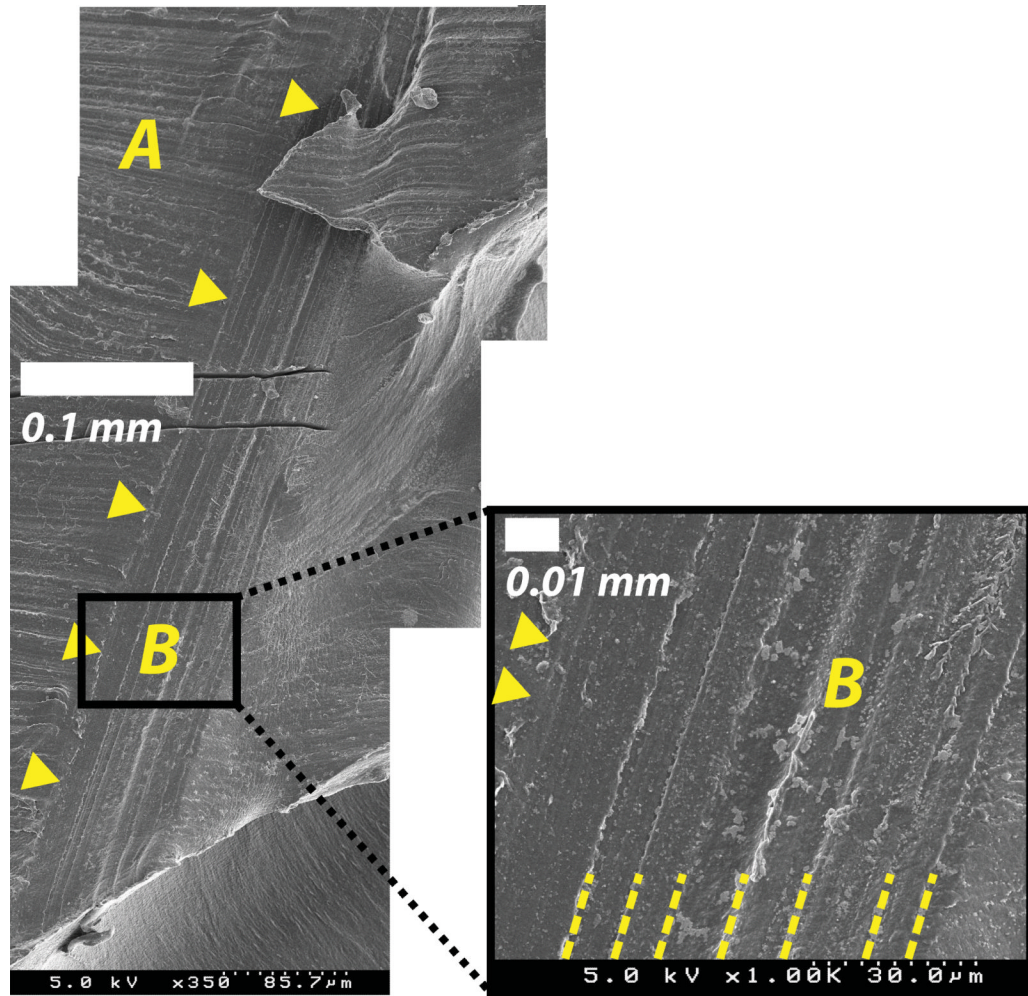
the initiation sites of previously documented catastrophic liner fractures[8]. SEM observation of an exposed crack surface in case E (Figure 3) verified the existence of clam shell markings, in agreement with the optical inspection findings (Figure 2).

**Fig 3.** Scanning electron micrographs of the exposed surface of an initiated crack from case E, oriented approximately vertically as in Fig 1. The external surface of the liner notch (A) features horizontal machining lines. The intersection of the crack with the surface is delineated with triangular markers. The surface of the crack (B) exhibits distinct vertically oriented and parallel clam shell markings (highlighted with dashed lines), verifying the observations made with visible microscopy. The parallel cuts in upper left are artificial marks for locating the fracture surface.
