Fractographic Analysis of a Dental Zirconia Framework: a Case Study on Design Issues

Ulrich Lohbauer¹, Gudrun Amberger¹, George D. Quinn², and Susanne S. Scherrer³

Fractographic analysis of clinically failed dental ceramics can provide insights as to the failure origin and related mechanisms. One anterior 6-unit all-ceramic zirconia fixed partial denture (FPD) (Cercon®) has been clinically recovered and examined using qualitative fractography. The purpose was to identify the fracture origin and to state the reasons for failure. The recovered parts of the zirconia FPD were microscopically examined to identify classic fractographic patterns such as arrest lines, hackle, twist hackle and wake hackle. The direction of crack propagation was mapped and interpreted back to the origin of failure at the interface of the occlusalpalatal tip of the core and the veneering ceramic. An inappropriate core drop design favoring localized stress concentration combined with a pore cluster in the veneering ceramic at the core tip interface were the reasons for this premature through-the-core thickness failure.

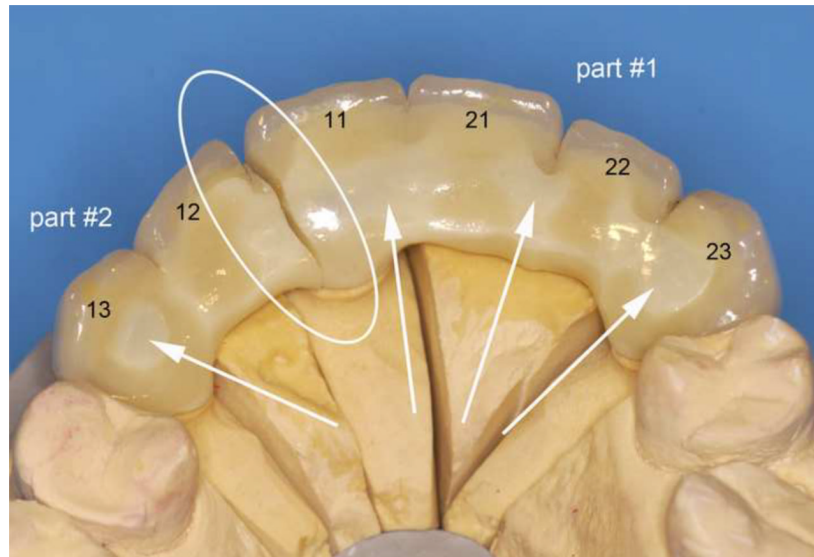
Figure 1 shows the global palatal overview of the Cercon® six-unit anterior zirconia bridge repositioned on the working stone model. The fracture is located at the connector level (white circle) between the central right incisor (tooth #11) and the pontic tooth #12. The two fractured parts analyzed have been labeled part #1 for the fractured surface view towards tooth #11 and part #2 for the fractured surface view towards tooth #12. From the palatal direction, regions of exposed zirconia core structure can be seen as indicated by the arrows. The actual fracture planes of the fractured parts #1 and #2 are shown in Fig 2. The zirconia core has a non-suitable drop-shape connector design (outlined in red), whereas the veneering porcelain shows a high volume on the buccal side but is almost absent from the occlusalpalatal surface. The green line indicates what would have been a more clinically appropriate shape and positioning of the framework connector. Fig. 3 provides a SEM close-up view of part # 2. On this image, the actual connector area was measured to be only 8.4 mm² using image analysis software (KL ACI Focus, Klughammer, Markt Indersdorf, Germany) which does not match the minimal requirement by the manufacturer of 9 mm².

Figure 1. Cercon® veneered six-unit anterior zirconia bridge, fractured between the upper teeth 11 and 12 in the maxillary arch (FDI numbers for each relevant tooth are labelled). The fracture surface distal of tooth #11 is labelled part #1, the fracture surface mesial of tooth #12 is labelled part #2. The region of fracture and exposed zirconia core structure are indicated by the arrows and the loading direction is indicated in red.

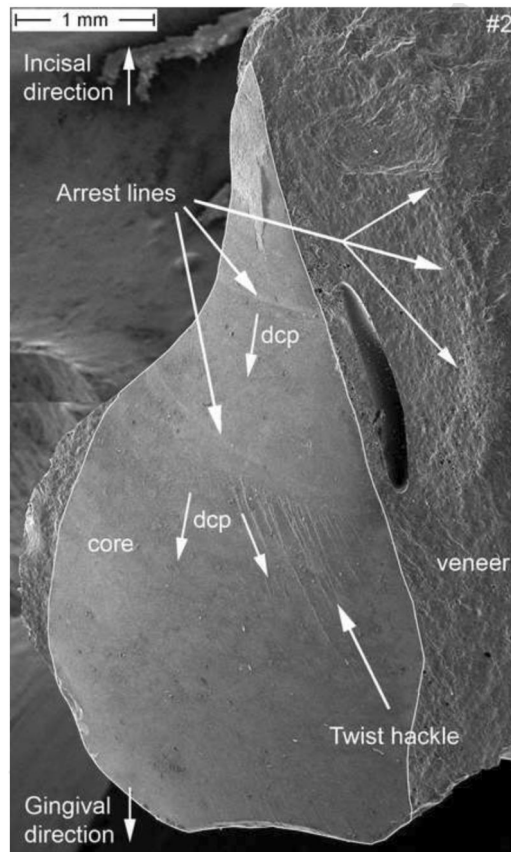
At low magnifications, two clear arrest lines and twist hackle are visible on the zirconia core as indicated by the arrows in Figure 3. These two easily seen features provide already a clear indication as to the dcp which is running from top (incisal) to bottom (gingival). Indeed, the arrest lines are perpendicular to the crack propagation and the origin of the crack is located on the concave side of the first arrest line, which means further up, near the incisal tip of the core. Next to these two arrest lines, and within the veneering ceramic is a major pore. An arrest line is in continuation with this pore but can be better seen in the matching half (part #1) in Fig. 5. This veneer arrest line represents a slowing down of the crack front soon after encountering the pore. The second feature visible in Fig. 3 and serving as an indicator of dcp are twist hackle. These are seen at higher magnification in Fig. 4 emanating from a core arrest line. They are hackle with a rotation due to a new stress direction giving them the appearance of lances as the small hackle lines merge into coarser needle like hackle lines. The dcp (arrow) is moving from incisal (top) to gingival (bottom). The second recovered broken part (Fig. 5) shows a better overall image. Three arrest lines are clearly visible on the zirconia core surface, and so is a big pore and an arrest line in the veneering ceramic. In addition, a small edge chip and a grinding damage zone on the palatal exposed zirconia frame are marked and are discussed in more detail further in the text under Fig. 7. A close-up image of the incisal tip of the zirconia frame (Fig. 6), shows the fracture origin at the tip of the zirconia core frame in form of a pore cluster within the veneering ceramic at the interface core-veneer (small arrows). Wetting of such a thin (< 200 µm) zirconia frame tip is a difficult task for the lab technician and may result in trapped air bubbles. Such a flawed core-veneer interface was seen with the pore cluster in Fig. 6. Classic fractographic features

Figure 3. SEM image of the zirconia core section of part #2. A connector area of 8.4 mm² was measured. Fractographic features like arrest lines and twist hackle are indicated. The direction of crack propagation (dcp) is indicated. A major processing pore is seen in the veneering ceramic.

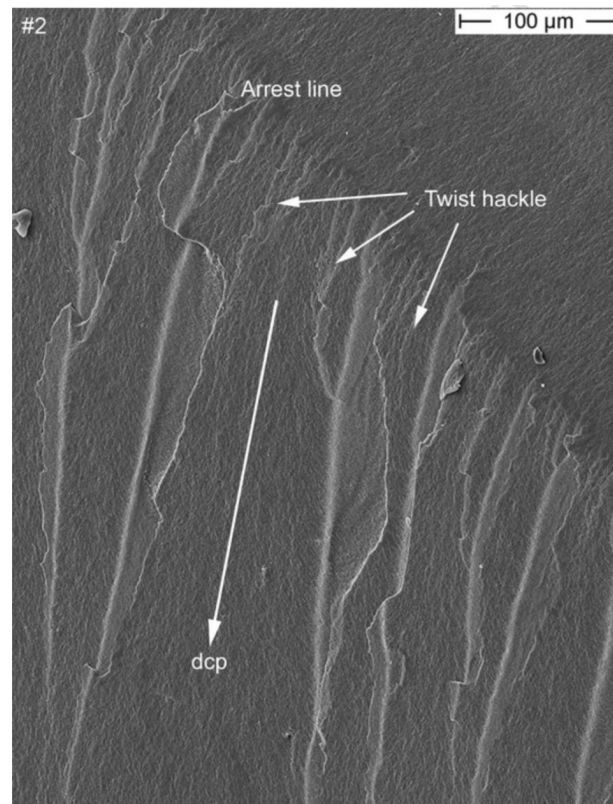
Figure 4. SEM image of a detailed view of the twist hackle region, indicated in Fig 3. The direction of crack propagation (dcp) is indicated by the arrow (moving downwards towards the gingival side)

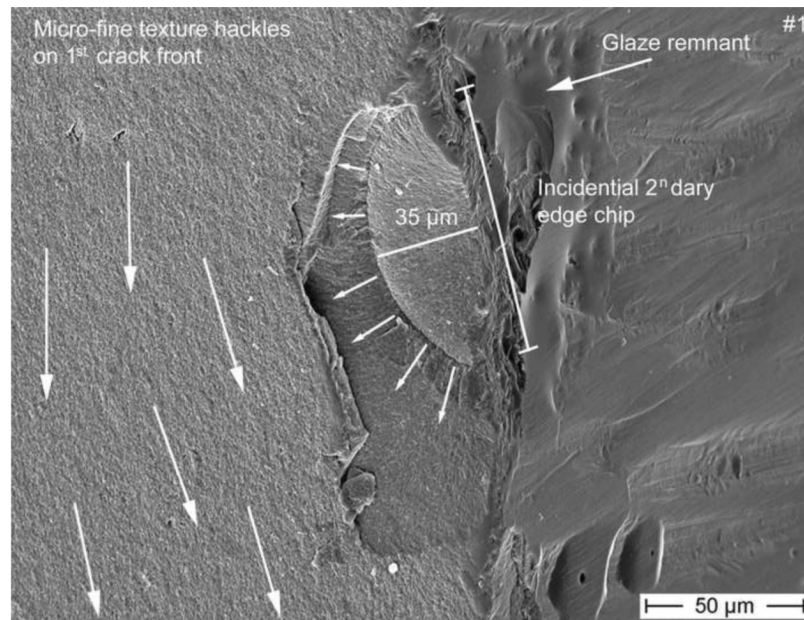
Fig. 7 shows a higher magnification of Fig. 5 of the edge chip which started on the palatal exposed zirconia frame next to some grinding damage and next to some glaze remnants. The initial flaw size of the chip is of 35 μm and delineated by an arrest line. This edge chip crack is however stopped soon after as seen by the absence of hackle penetrating into the core beyond the chip, indicating that this is a secondary event. Indeed, many micro-fine texture hackle in the core material are propagating downwards to the gingival margin and are perpendicular to the edge chip. Those fine hackle together with the major arrest lines (Fig. 3 and 5) are clear indicators of the prime crack front (big white arrows) moving downwards towards the gum. There also is no indication whatsoever of this edge chip on the matching fracture half on part 2 shown in Figure 3, which confirms the edge chip is a secondary fracture that only occurred in part 1.

Figure 7. SEM magnification of the secondary edge chip from Fig 5 starting on the exposed zirconia frame on the palatal surface next to some glaze remnant. The initial flaw size of the chip is of 35 μm and delimited by an arrest line. This edge chip crack is however stopped soon after as seen by the absence of hackle penetrating into the core beyond the chip size, indicating that this is a secondary event. Many micro-fine texture hackle visible in the core material are propagating downwards to the gingival margin, perpendicular to the edge chip (big white arrows).

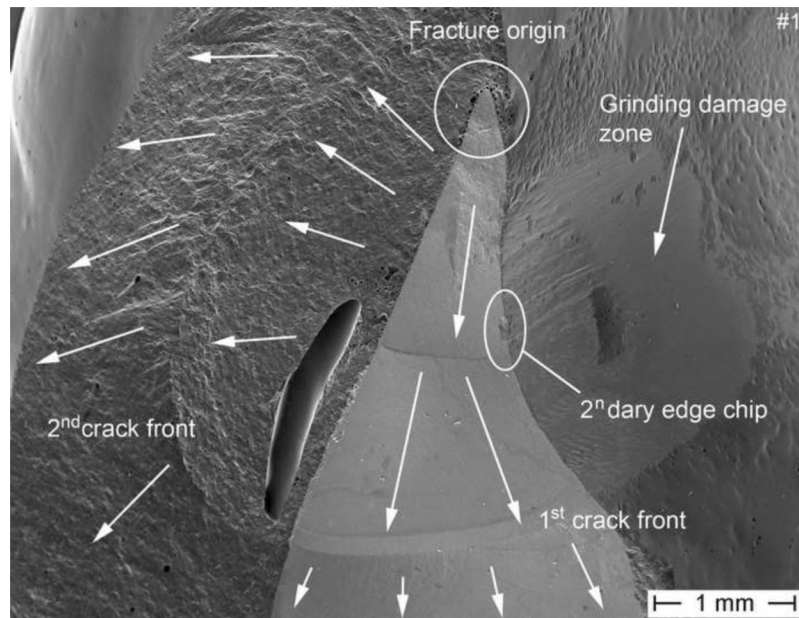
Fig. 8 provides a close-up view of the big pore in the veneering ceramic. This enormous pore is approximately 1.3 mm in length. Wake hackle emanate from tiny pores in the veneering ceramic which allow us to follow the direction of the crack front. It moved through and around the big pore in a counter clock rotation and finished parallel to the zirconia core crack front moving downwards in a gingival direction. All the above evidence show that this large pore was not the origin of fracture.

Figure 8. This SEM photomontage shows the region of the big pore as seen in part #1. Hackle and wake hackle within the veneering ceramic indicate the direction of the crack front, contouring the big pore in a counterclock rotation. The dcp is marked with the white arrows.
