Polyethylene Wear in Retrieved Reverse Total Shoulder Components

Judd S Day, PhD^{1,2}, Daniel W MacDonald, MS¹, Madeline Olsen¹, Charles Getz, MD³, Gerald R Williams, MD³, and Steven M Kurtz, PhD.^{1,2}

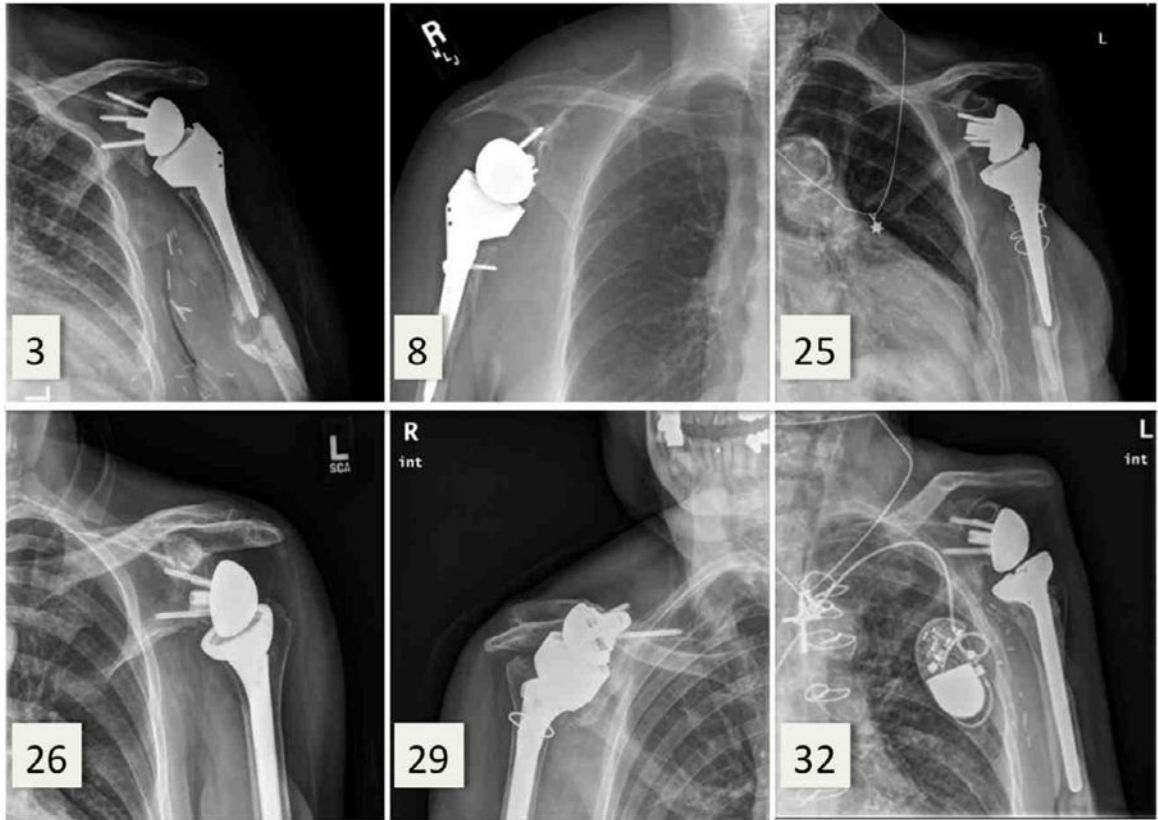
The position of the glenoid baseplate on the glenoid was appropriately low in the five patients with available films (Figure 1). Two patients (2/5) had a slight inferior tilt to the glenoid component and three (3/5) had no tilt.

Figure 1. Preoperative revision radiographs. Note the catastrophic glenoid failure in Patient 29. Radiographs from Patient 23 are omitted due to poor radiographic quality.

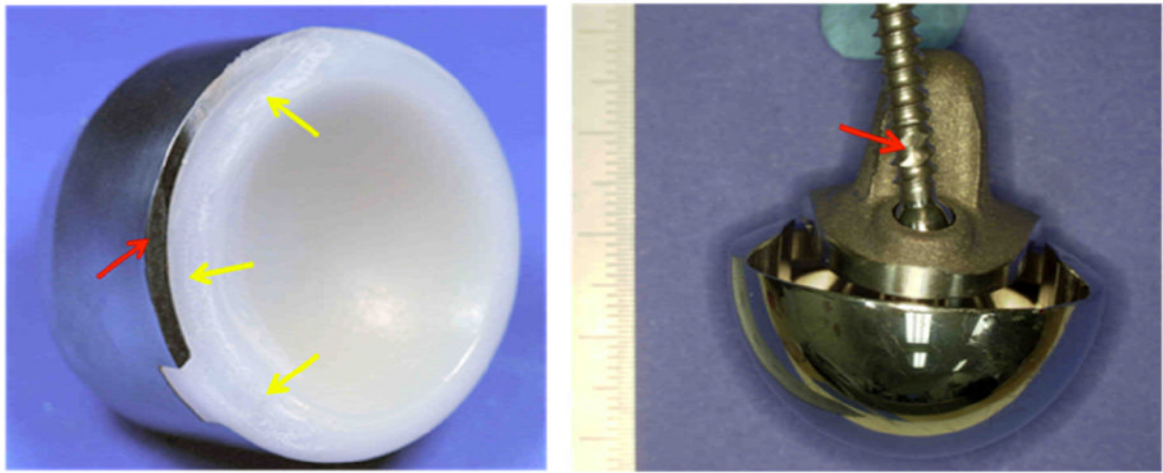
As mentioned, two cases of extreme rim wear were observed. Both implants exhibited wear depths exceeding 4 mm and there was evidence of contact with the inferior screw. In the first case, the polyethylene rim wore all the way through to the metal baseplate. Grooves within the remaining polyethylene suggest that the rim was worn away by a combination of the scapula and subsequently the inferior screw. Inspection of the humeral metallic cup and inferior screw revealed metal on metal wear at this surface (Figure 3). In the second case, the rim appeared to be worn by the scapula and inferior screw, as in the first case. However, the inferior screw fractured (Figure 4) and the broken screw then became a new wear surface that created abrasive wear on intended bearing surface (Figure 4).

In addition to undesired metal on metal wear, the contact of the of the humeral component on the inferior locking screw may induce a moment on the glenoid component leading to distraction of the component at the superior glenoid as most inferior screws are locked to the baseplate. Assuming that the locking mechanism with the baseplate does not fail, contact between the inferior screw and the humerus could lead to premature mechanical loosening of the glenoid baseplate from a rocking mechanism or to a fatigue fracture of the inferior locking screw. The latter mechanism was observed in only one retrieval in our collection. The broken screw in this case subsequently created abrasive wear on the articulating surface of the humeral inlay (Figure 3).

Figure 3. Retrieved reverse total shoulder implant that was implanted for 2.7 years. Note the extreme polyethylene wear at the rim (yellow arrows) as well as metal-on-metal contact (red arrows) (A). Note the metal wear on the inferior screw (B).

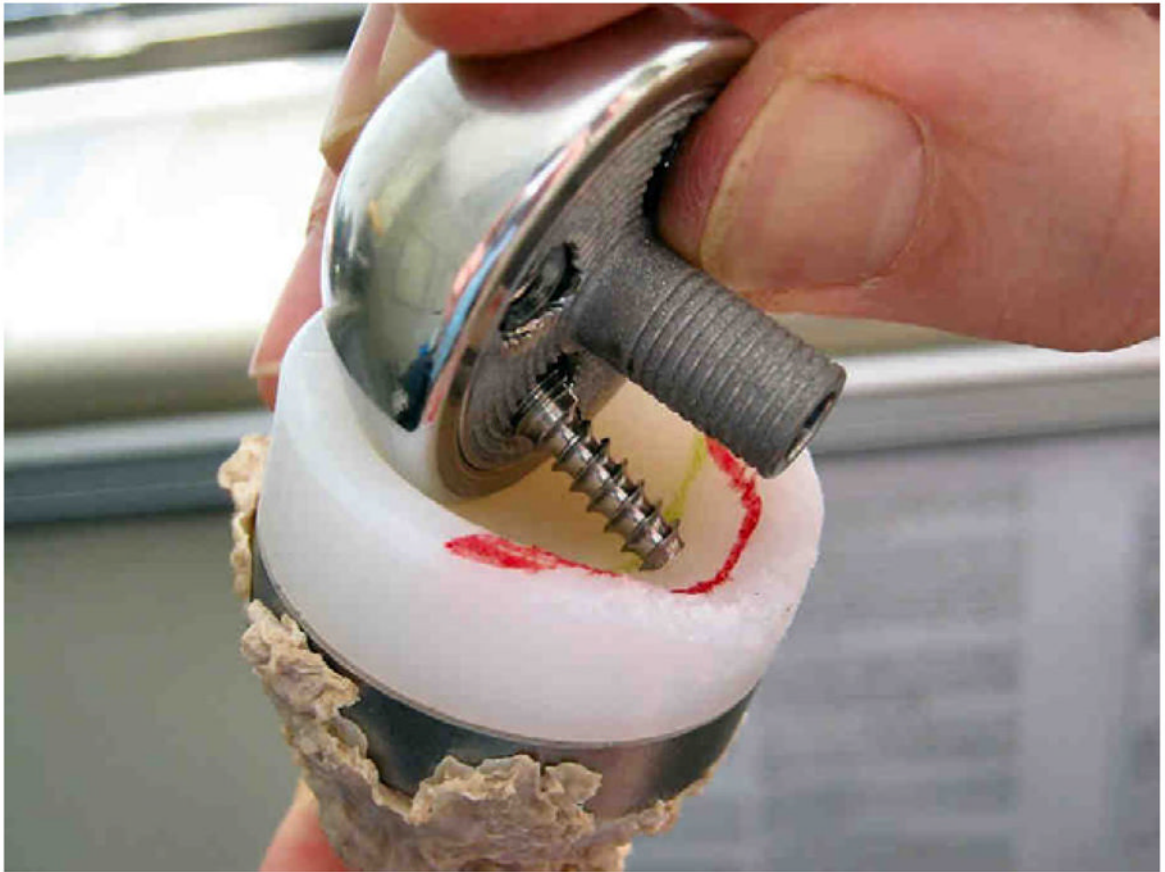
Figure 4. Retrieved reverse total shoulder implant that was implanted for 3.3 years with evidence of wear on the rim from the screw as well as abrasive wear on the intended bearing surface from the broken screw.
