COMPARISON OF REAL WORLD SIDE IMPACT / ROLLOVER
COLLISIONS WITH AND WITHOUT THORAX AIRBAG / HEAD
PROTECTION SYSTEM:
A FIRST FIELD EXPERIENCE STUDY

Peter Baur
Department of Engineering
BMW of North America, Inc.
Montvale, New Jersey

Wolfgang Lange
Georg Messner
Stefan Rauscher
Department of Vehicle Safety, Regulations and Certifications
BMW Group
Munich, Germany

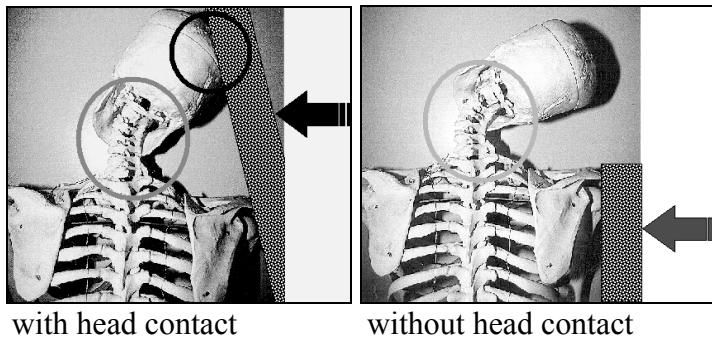
INJURY MECHANISM – Our own data of crash tests and real world crashes provides results regarding the injury mechanism similar to results already published by other researchers [Morris, Hassan, Mackay, 1993]. Principally, there are two injury mechanisms in side collisions (Fig. 3). The left photograph shows the direct contact of the head (black circle) with an object (e.g. side window, B-pillar, tree or light pole) in combination with a lateral flexion and shear, possibly in combination with an axial compression (flexion compression) of the cervical spine (gray circle) (see also Fig. 5 and 6). The right photograph shows a lateral hyper flexion of the cervical spine (gray circle) without head contact, e.g. in cases of side collisions with a broken side window and a lateral motion of the head through the plane of the side window.

Fig. 3 – Injury mechanism in side collisions

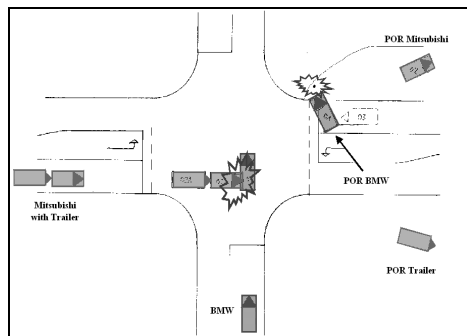
Collision without HPS/TA - A BMW 316i Compact drove into an intersection with a green light. A Mitsubishi Pajero (midsize utility vehicle) coming from the left ran a red light and frontally collided with the left side of the BMW (impact speeds: BMW app. 43 km/h, Pajero app. 77 km/h). The Compact was struck (Δv_y app. 30 km/h) at a 9 o'clock position (Fig. 7). The trailer of the Pajero uncoupled during the collision. The Compact was hit behind its center of gravity and rotated counter-clockwise. In addition, the vehicle collided frontally with a traffic light pole and the driver front airbag deployed.

Fig. 7 – Collision scene

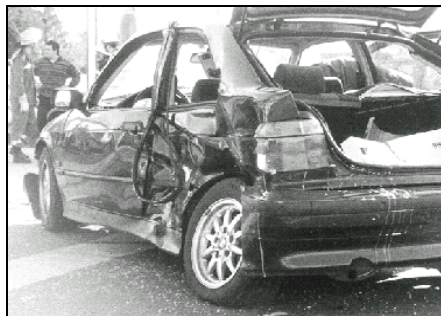
The BMW was damaged from the driver door to the rear; the deepest intrusion, app. 20 cm, was in the region of the rear axle. The lower region of the B-pillar intruded 10 cm into the passenger compartment (Fig. 8). The damage corresponds to an energy equivalent speed (EES) of app. 25 km/h.

Fig. 8 – Damage to the BMW 316i Compact

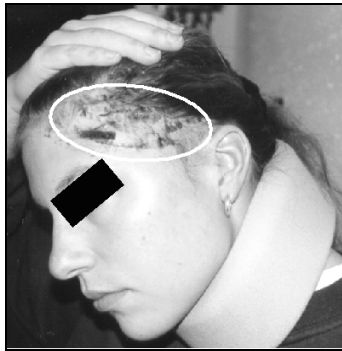
The driver was belted. She suffered an extensive head laceration app. 10 cm long, with a large surface skin abrasion on her left temple (resulting in a permanent scar) (AIS 1) (Fig. 9) and a cerebral concussion caused by contact with the breaking side window. Furthermore, she obtained a cervical spine distortion (AIS 1) caused by a lateral bending and two fractured ribs on the left side (AIS 2) caused by the interior side structure of the door panel.

Fig. 9 – Head and neck injury

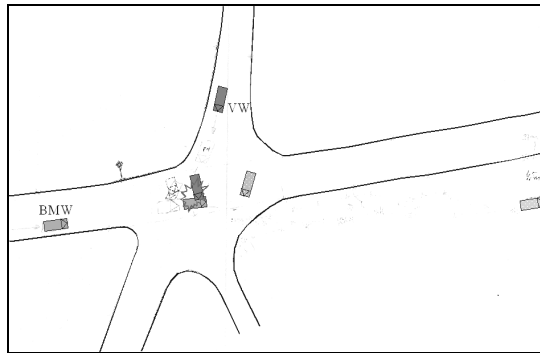
Collision with HPS/TA - A VW Golf crossed a highway and frontally collided with the left side of a 3-series BMW (impact speeds: BMW app. 85 km/h, Golf app. 35 km/h). The impact (Δv_y app. 25 km/h) to the BMW 318i came from the 10 o'clock direction to the vehicle (Fig. 10). Both vehicles rotated counter-clockwise. The positions of rest of the vehicles were app. 50 m from one another.

Fig. 10 – Collision scene

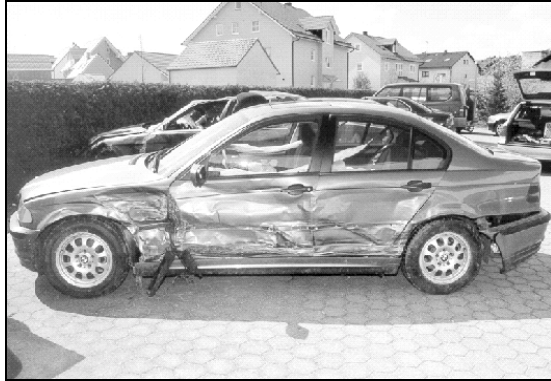
The primary damage to the 318i occurred in the area of the A-pillar and the driver door. The deepest intrusions were in the

region of the A-pillar, app. 6 cm and in the region of the B-pillar, app. 5 cm. The EES was estimated at app. 23 km/h (Fig. 11).

Fig. 11 – Damage to the BMW 318i

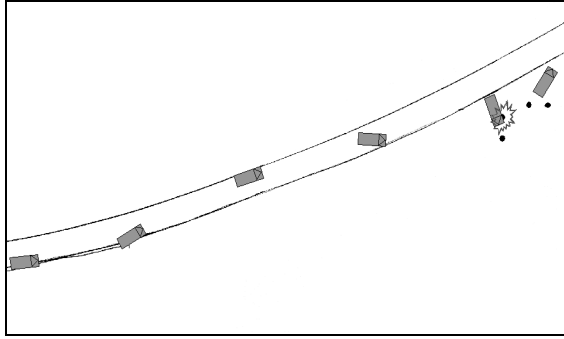
Collision without HPS/TA - A BMW 525i lost control on a gentle left curve, spun clockwise and collided with the left side into trees (Fig. 12).

Fig. 12 – Collision scene

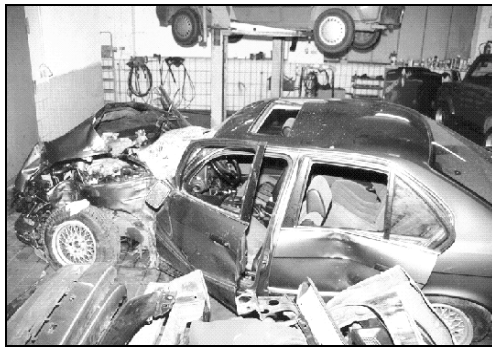
One of the trees intruded at a 9 o'clock position app. 45 cm into the vehicle in the region of the A-pillar (impact speed app. 47 km/h, Δv_y app. 27 km/h). The EES was app. 35 km/h (Fig. 13).

Fig. 13 – Damage to the BMW 525i

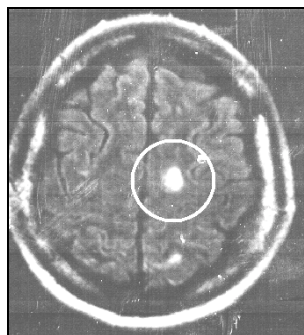
The belted driver was seriously injured in this collision. A direct impact trauma of the head with the interior roof frame led to intracerebral bleeding (white circle, Fig. 14) (AIS 4). There were numerous contusions to the thorax (AIS 1) - no definite causation detectable - in addition to superficial lacerations to both ankles (AIS 1) caused by the side panel in the foot well.

Fig. 14 – Head Injury

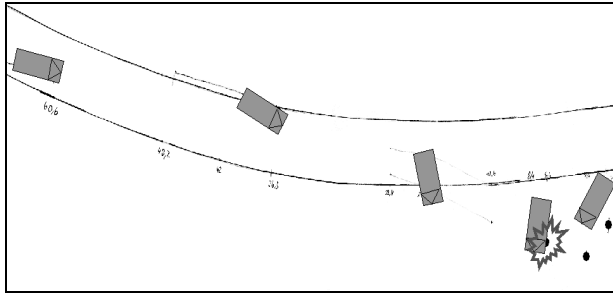
Collision with HPS/TA – A 730d went out of control in a left curve, spun clockwise off the road and collided into a tree on the driver's side (impact speed app. 52 km/h, Δv_y app. 30 km/h) (Fig. 15).

Fig. 15 – Collision scene

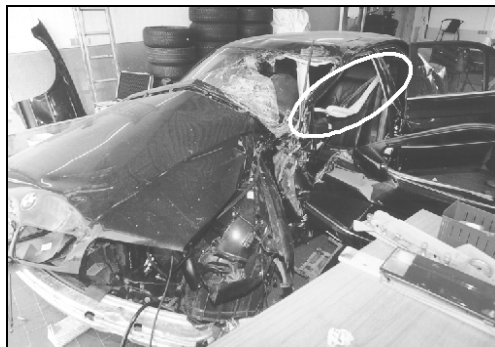
The tree penetrated the A-pillar region app. 42 cm into the vehicle from a 9 o'clock direction. The EES was estimated to be 35 km/h. The TA and the HPS (white circle) deployed (Fig. 16).

Fig. 16 – Damage to the BMW 730d

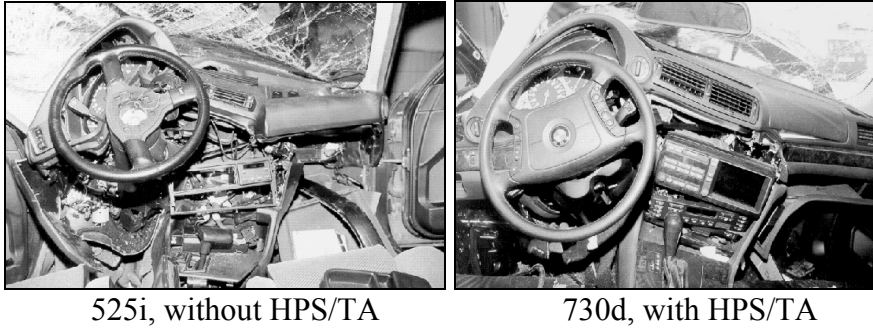
Comparison of the damage – Looking at the interiors of both vehicles (Fig. 17), it can be observed that the damage to both vehicles is quite the same. The intrusion, as well as, the impact directions are almost identical, inviting the comparison.

Fig. 17 – Interior comparison
