The absence of a metal-on-metal bearing does not preclude the formation of a destructive pseudotumor in the hip—a case report

Pepijn Bisseling¹, Timothy Tan², Zhen Lu², Pat A Campbell², and Job L C Susante¹

¹Department of Orthopaedics, Rijnstate Hospital, Arnhem, the Netherlands; ²Los Angeles Orthopaedic Hospital, Los Angeles, CA, USA.

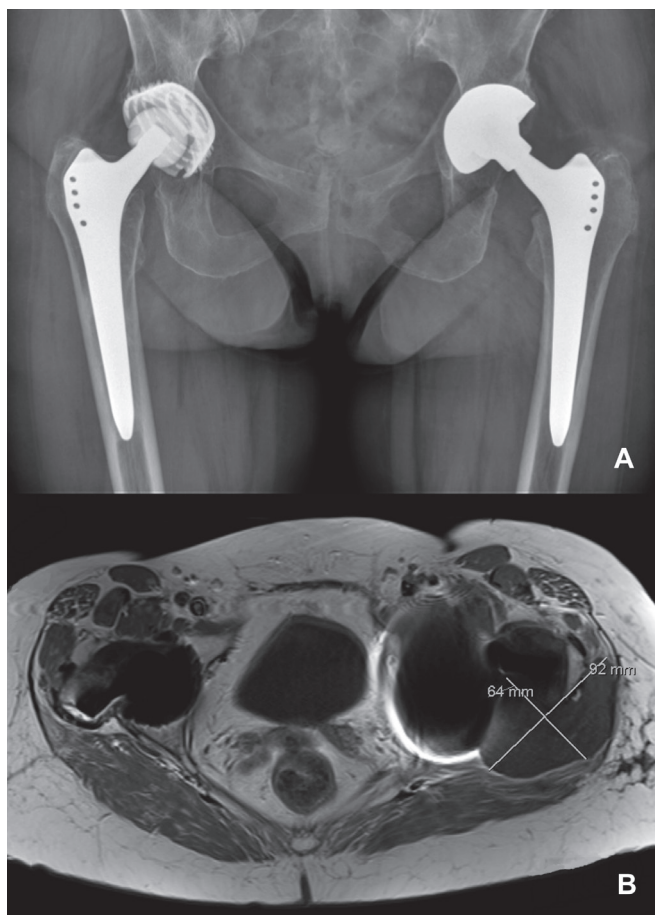
2 years after implantation, the patient was referred to our center by her rheumatologist, since a soft tissue mass adjacent to the left THA had been diagnosed by ultrasound. A standard AP pelvic radiograph revealed adequate positioning of both hip implants without any signs of wear or osteolysis. Subsequent MARS-MRI scanning confirmed the presence of a 6 × 9 cm soft tissue mass at the posterolateral aspect of the left greater trochanter (Figure 1). There were no signs of any soft tissue reaction around the contralateral THA.

Figure 1. Standard AP radiograph (panel A) and MARS-MRI scan (panel B) 2 years after implantation of the left THA with a double-mobility acetabular component. Note the adequate implant positioning and fixation (A) and a 6 × 9 cm soft tissue mass (B) at the posterolateral side of the left femoral component. On the right, there were no signs of periprosthetic soft tissue reaction.

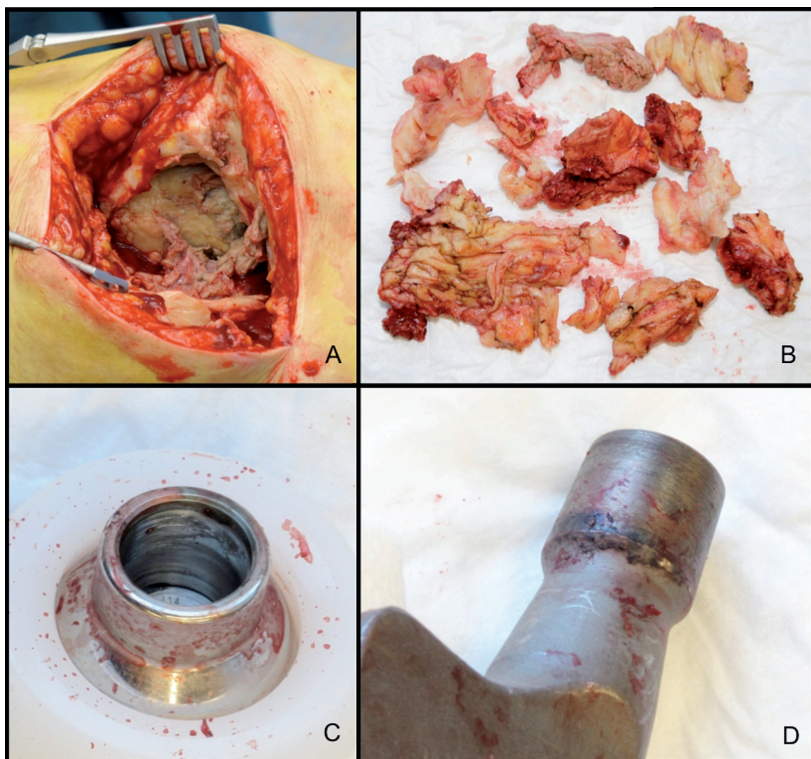
Perioperatively, extensive tissue necrosis and partial destruction of the abductor mechanism were found in the absence of any macroscopic signs of infection. The acetabular compo-

nent was well fixed. Both the femoral trunnion and bore of the head showed signs of black debris (Figure 2). The femoral component was revised to a cemented polished straight stem (Exeter; Stryker, Allendale, NJ) with a ceramic 28-mm head (also Stryker) and a new double-mobility liner (Avantage Double-Mobility Acetabular System; Biomet). At the revision operation, 6 tissue samples were taken for bacterial culture according to our protocol. All 6 samples were negative for bacterial growth.

Figure 2. A. Extensive necrosis at the greater trochanter area and destruction of the abductor mechanism. B. Debulking of large amounts of necrotic and fibrotic tissue from the periprosthetic region. C and D. Macroscopic signs of corrosion products at the bore of the Co-Cr head (panel C) and at the trunion of the femoral component (panel D).

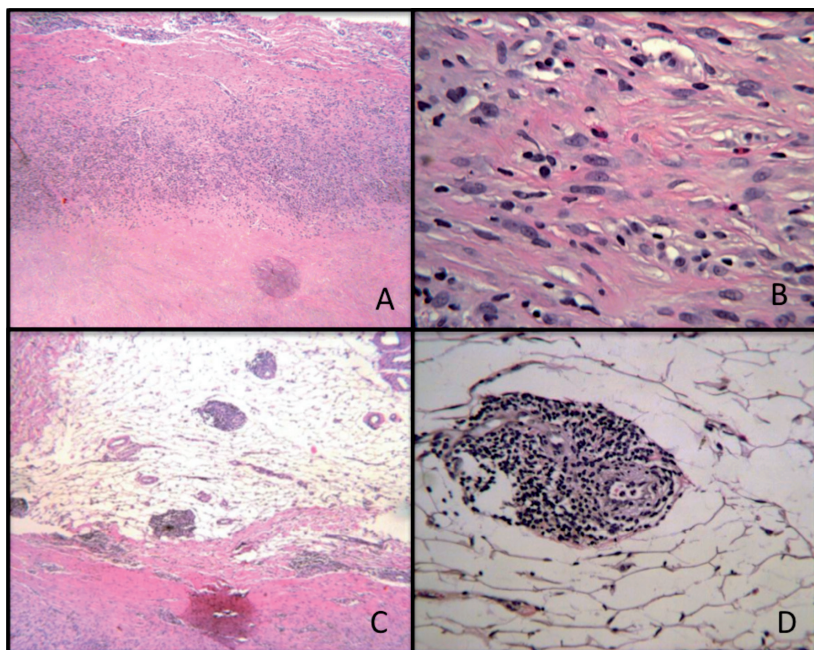
Figure 3. A. Histological view of the soft tissue mass at the interface between the necrotic material (on the joint side) and inflammatory cells. Hematoxylin and eosin (HE), 40 \times . B. Enlargement of A with inflammatory cells consisting mainly of macrophages and lymphocytes along with plasma cells and eosinophils. HE, 200 \times . Several lymphocytic aggregates were observed at low magnification (panel C; HE, 40 \times) and at high magnification (panel D; HE, 200 \times).

The components were sent for retrieval analysis. Multiple samples of the periprosthetic tissues were processed in paraffin for routine histology. The histopathology of tissue samples revealed extensively necrotic material with only a focal cellular area of inflammatory cells containing macrophages, plasma cells, occasional foci of eosinophils, and several small perivascular lymphocytic aggregates (Figure 3). No polarizable materials or metallic debris were present in several tissue samples. The ALVAL score (Campbell et al. 2010) was $3 + 3 + 2 (= 8/10)$, moderate. Overall, the histological profile was consistent with an adverse immunological reaction in the absence of visible wear debris.

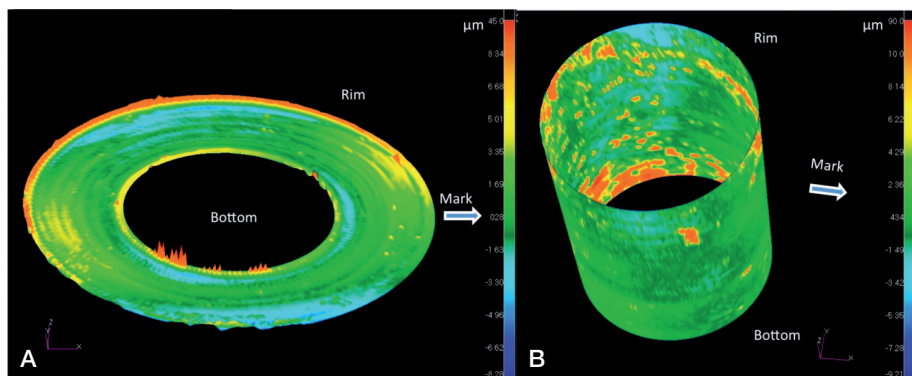
The profile of the ball taper was measured using a coordinate measuring machine (Lexg 322; Mitotoyo, Aurora, IL). The dimensions of a perfect taper based on 6726 CMM points with a point spacing of 0.3 mm were determined using a least-squares method. The taper had an angle of 5 degrees, 47 min, and 34 s. A contour map was generated using the deviations of the CMM points from the fitting taper (Figure 4). The CMM results indicated uneven areas of contact, but the amount of material that had been removed through wear or corrosion could not be determined without knowing the initial form of the parts. However, in combination with the microanalysis described below, it appears that the small degree of texture and color changes was consistent with mild corrosion.

Figure 4. A. 2-dimensional graphical representation of the same profile. The outer diameter of the CMM map is the portion of the taper closest to the stem (labeled Rim) and the inner diameter of the CMM image corresponds to the inner surface (labeled Bottom). Areas with differences in color intensity may be related to wear or corrosion from the original dimensions. B. 3-dimensional map with the portion closest to the stem labeled Rim and the deepest portion of the taper closest to the bearing surface labeled Bottom. Note the uneven distribution of color, corresponding to differences in contact with the trunnion.

double-mobility system may have led to greater stresses on the taper junction according to the same principle that applies to large-diameter head THAs. A +10.5-mm (XXL) extended head increased the lever arm and applied even greater forces to the taper junction. Although contact stress may account for the contour irregularities observed (Figure 4), corrosion may have occurred without the presence of contact stress, which makes it difficult to definitively attribute the contour irregularities to contact stress alone.

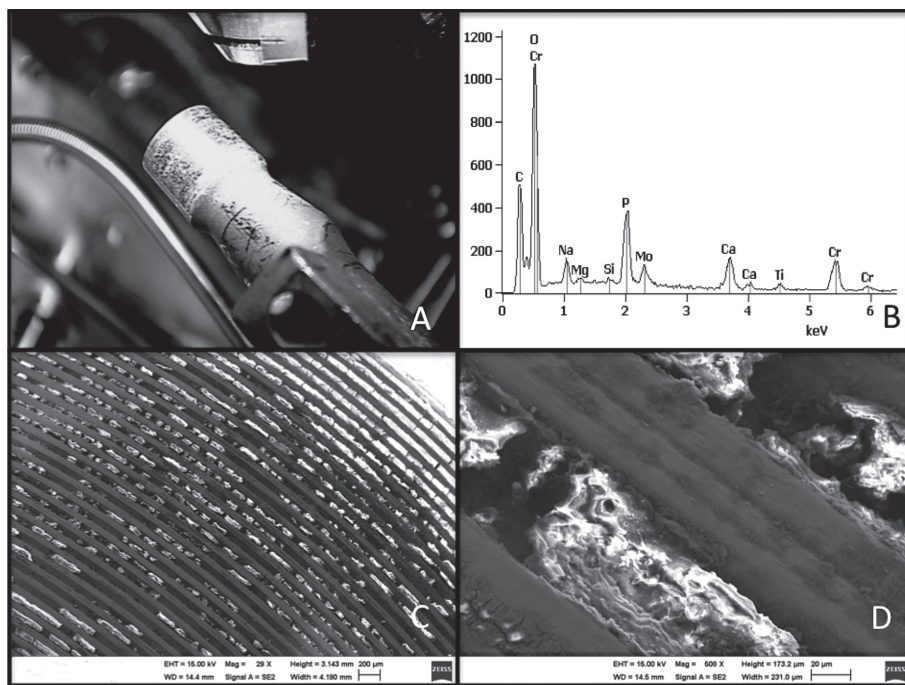
The area of the stem trunion that appeared discolored was examined by scanning electron microscopy (SEM) and energy-dispersive analysis of X-rays (EDAX) to identify the elements present. Organic material containing chromium and/or molybdenum consistent with corrosion products was identified within the machined grooves and in the deposited dark material outside the trunion (Figure 5). Similar analysis performed on deparaffinized soft tissue sections failed to demonstrate any wear or corrosion products.

Figure 5. Material present on the trunnion of the femoral component (panel A) was investigated by EDAX, revealing chromium (Cr), molybdenum (Mo), and oxygen (O) peaks consistent with corrosion products (panel B). The organic material within the grooves containing chromium oxides is shown at approx. 30x (panel C) and 500x magnification (panel D).

Furthermore, the SEM and EDAX analysis showed corrosion products on the trunnion. Corrosion and wear at this modular head-neck junction can occur when a passive protective oxide film on the metallic surfaces is constantly disrupted by fretting and micromotion (Gilbert et al. 1993, Jacobs et al. 1998). The extent of the corrosion process is affected by a number of factors, including the amount and quality of metallic junctions and forces that are projected on the junctions (Brown et al. 1995, Jacobs et al. 1998, Goldberg et al. 2002, Goldberg and Gilbert 2003).
