Identification of a unique cause of ring artifact seen in computed tomography trans-axial images

Ashish Kumar Jha, Nilendu C Purandare, Sneha Shah, Archi Agrawal, Ameya D Puranik, Venkatesh Rangarajan

Department of Nuclear Medicine and Molecular Imaging, Tata Memorial Hospital, Parel, Mumbai, Maharashtra, India

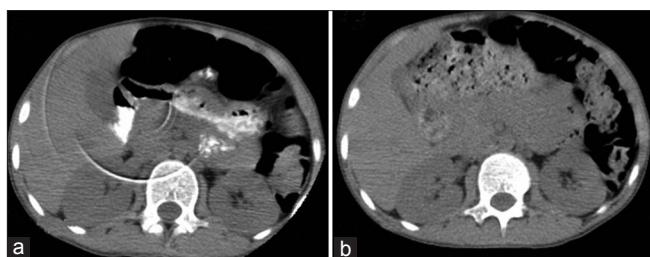
after half of the scheduled patients were successfully scanned, when all of a sudden, there was appearance of a ring artifact on CT trans-axial image [Figure 1a-arrow], in the CT component of PET/CT images acquired on our PET/CT scanner, Discovery ST, GE Medical Systems, USA. We immediately informed this occurrence to service engineer. Service engineer suspected that there might be defective detector element. While recalling the events that had occurred during that day, since we started acquiring scans, it struck to us that a contrast had splashed on CT scanner during acquisition of a scan due to a defective infusion tube during contrast infusion. Such events had occurred in the past and are not unusual in imaging departments. However, appearance of ring artifact, even when the scanner had passed daily CT quality control test in the morning, at the start, raised doubts. We had a strong suspicion that contrast might have trickled down inside the gantry because Mylar window was having a small slit, at its center. Service engineer opened the gantry and we inspected the detector ring and CT tube aperture for any contrast contamination. We found a small droplet of contrast on the CT tube aperture. We cleaned the CT tube aperture. We cleaned the CT tube aperture and repeated the scan. In repeat scan CT trans-axial slices was free of ring artifact [Figure 1b].

Figure 1: Clinical image (a) Trans-axial image showing a ring artifact (arrows), (b) trans-axial image showing no artifact

The ring artifact seen in trans-axial image was caused by contrast contamination of CT tube aperture. Proper fitting of Mylar window and avoidance of contrast leakage can avoid this occurrence. And if ring artifact appears in the CT image this cause needs to be ruled out.
