Semin Arthroplasty. 2013 December 1; 24(4): 246–254. doi:10.1053/j.sart.2014.01.002.

Does Taper Angle Clearance Influence Fretting and Corrosion Damage at the Head-Stem Interface? A Matched Cohort Retrieval Study

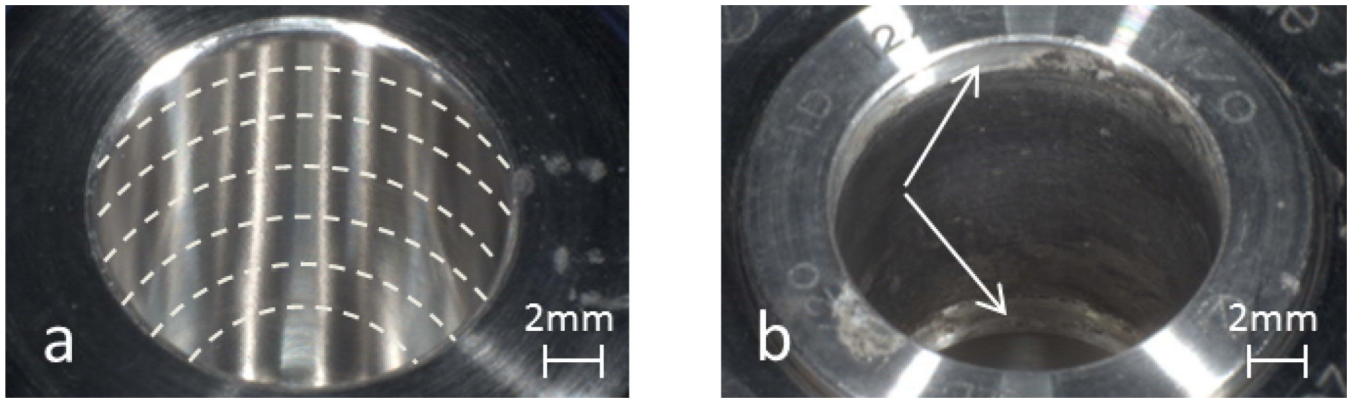
Figure 2.

Figures showing the regions used for measurements in female tapers. a) Taper with visual corrosion score of 1 (Fretting on < 10% surface and no corrosion damage) with profile measured (white dotted lines) evenly spaced throughout taper. b) Taper with corrosion score of 4 (Damage over majority (>50%) of mating surface with severe corrosion attack and abundant corrosion debris) showing identified bands of as manufactured surface remaining at the proximal and distal end of the taper, shown by arrows. The roundness measurements were distributed within these as manufactured surfaces.

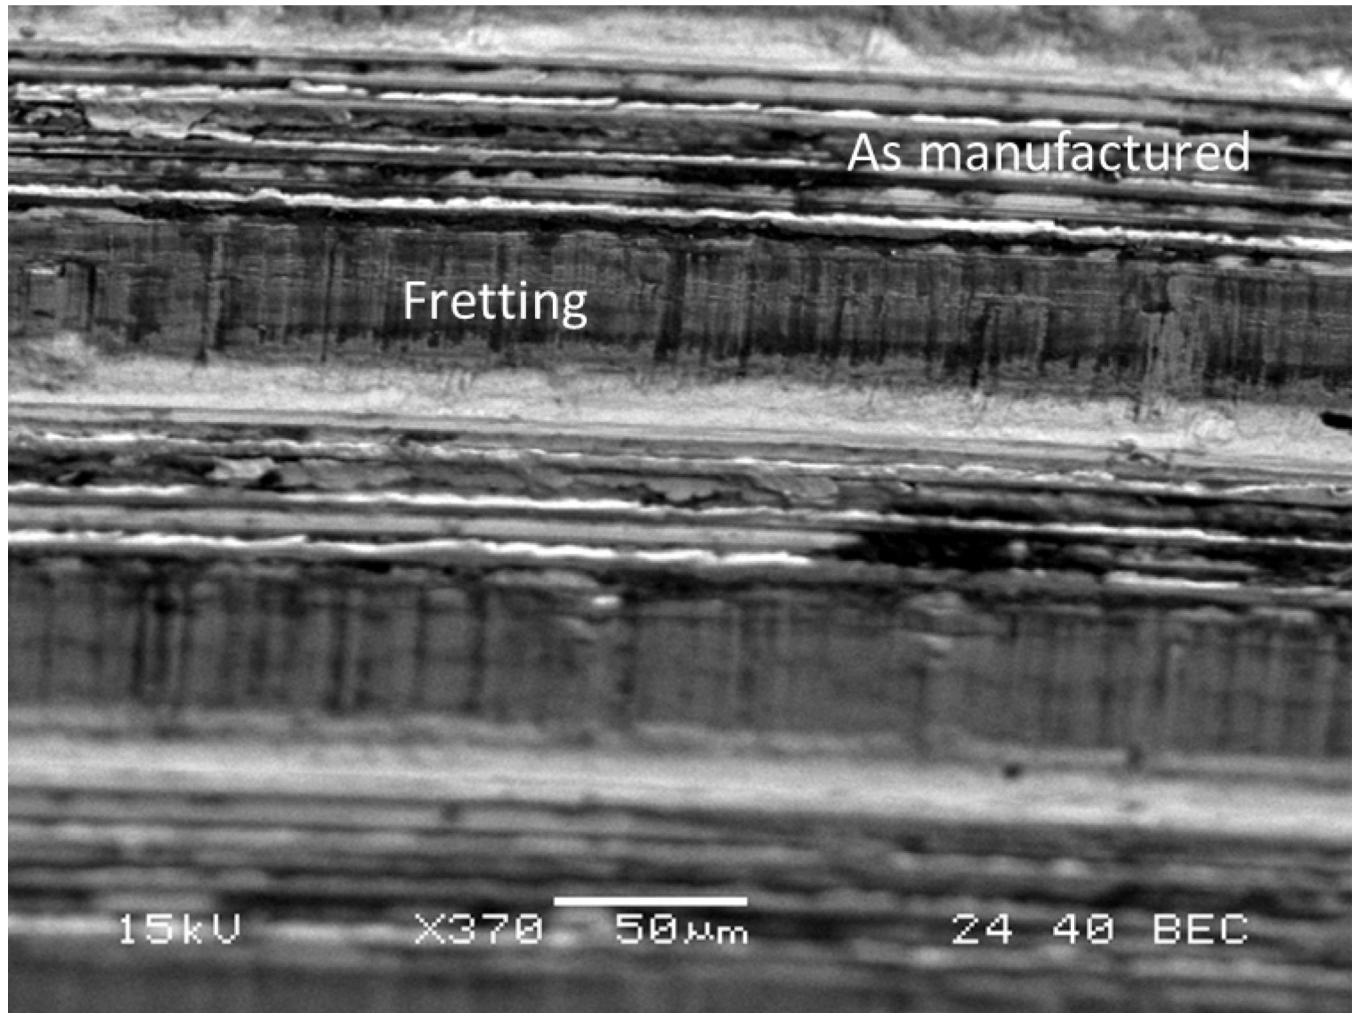
SEM imaging for metal female tapers with evidence of material loss proximally, distally, or both on measured profiles showed features which are consistent with the findings reported in other studies which identified mechanically assisted corrosion (Figures 9–10) [23,24]. SEM also evidenced that electrochemical material loss (pitting) preferentially evolved in regions that showed evidence of fretting (scratches in the scale 5–40 μm) or had larger scratches (50–500 μm) (Figure 10). We hypothesize that these larger scratches may have been caused when the head was impacted onto the trunnion during the primary surgery or during removal. Local changes in the surface topography were observed in heads mated with both “microgrooved” and “smooth” trunnions (Figure 11–12). The measured profiles and SEM

Figure 9. SEM image taken in distal portion of metal head taper showing fretting in regions with horizontal bands of material loss. Bands of material loss most likely corresponded to regions in contact with trunnion as manufactured grooves (370 \times , BEC).

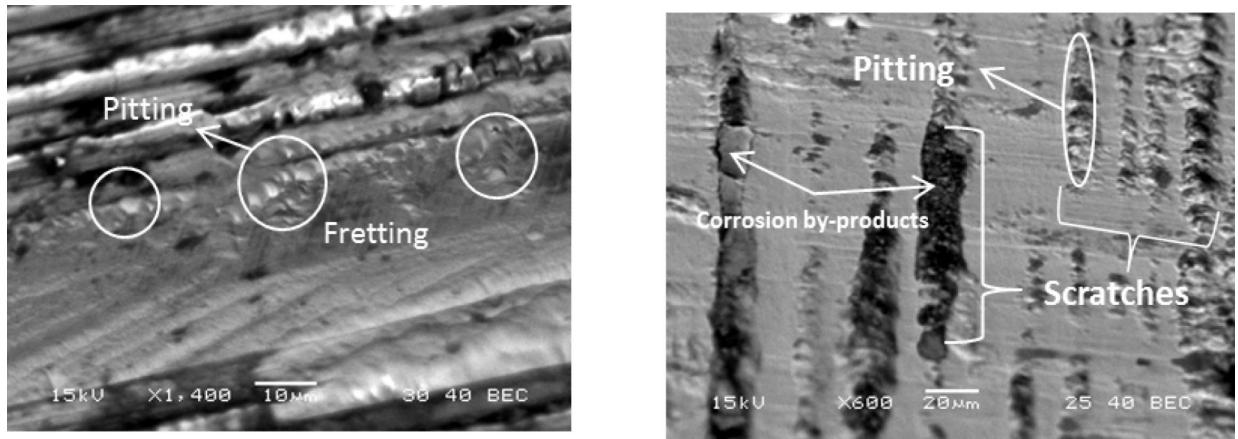
Figure 10.

A component showing pitting corrosion (marked in white circles) initiated preferentially in a crevice formed due to fretting abrasion (5–40µm scratches), imaged midway between proximal and distal ends on the taper (left, BEC, 1400×). A different component showing scratches (50–500µm) throughout head taper, with preferential pitting inside the scratches, imaged midway between proximal and distal ends on the taper (right, BEC, 600×). Corrosion by-products (biological and electrochemical deposits) have accumulated inside the scratches.

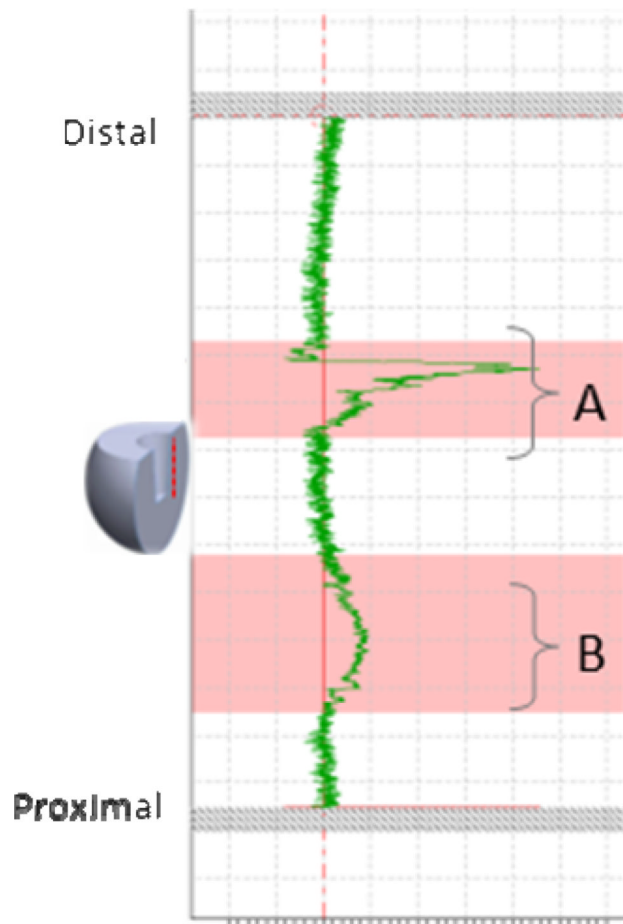
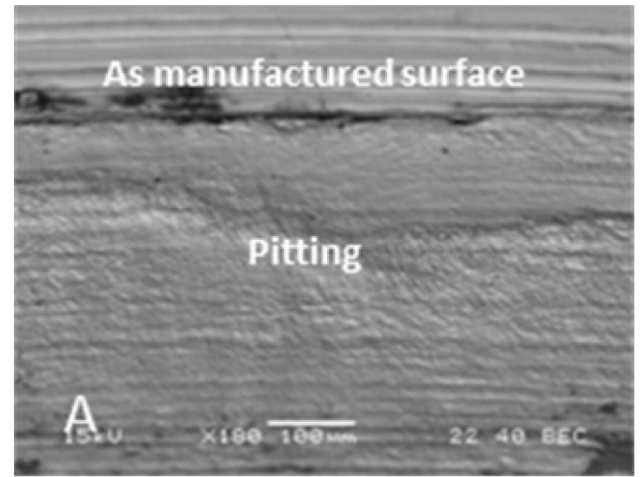
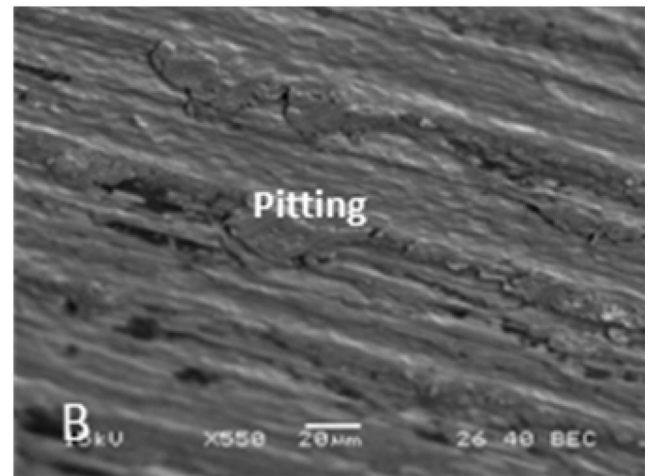
Figure 11. Axial profile of a metal head implanted with a trunnion with a “smooth” finish (left). Regions corresponding to the material loss, marked A and B were imaged using the SEM (right). Both regions of material loss on the Talyrod profile showed evidence of change to the as manufactured surface.

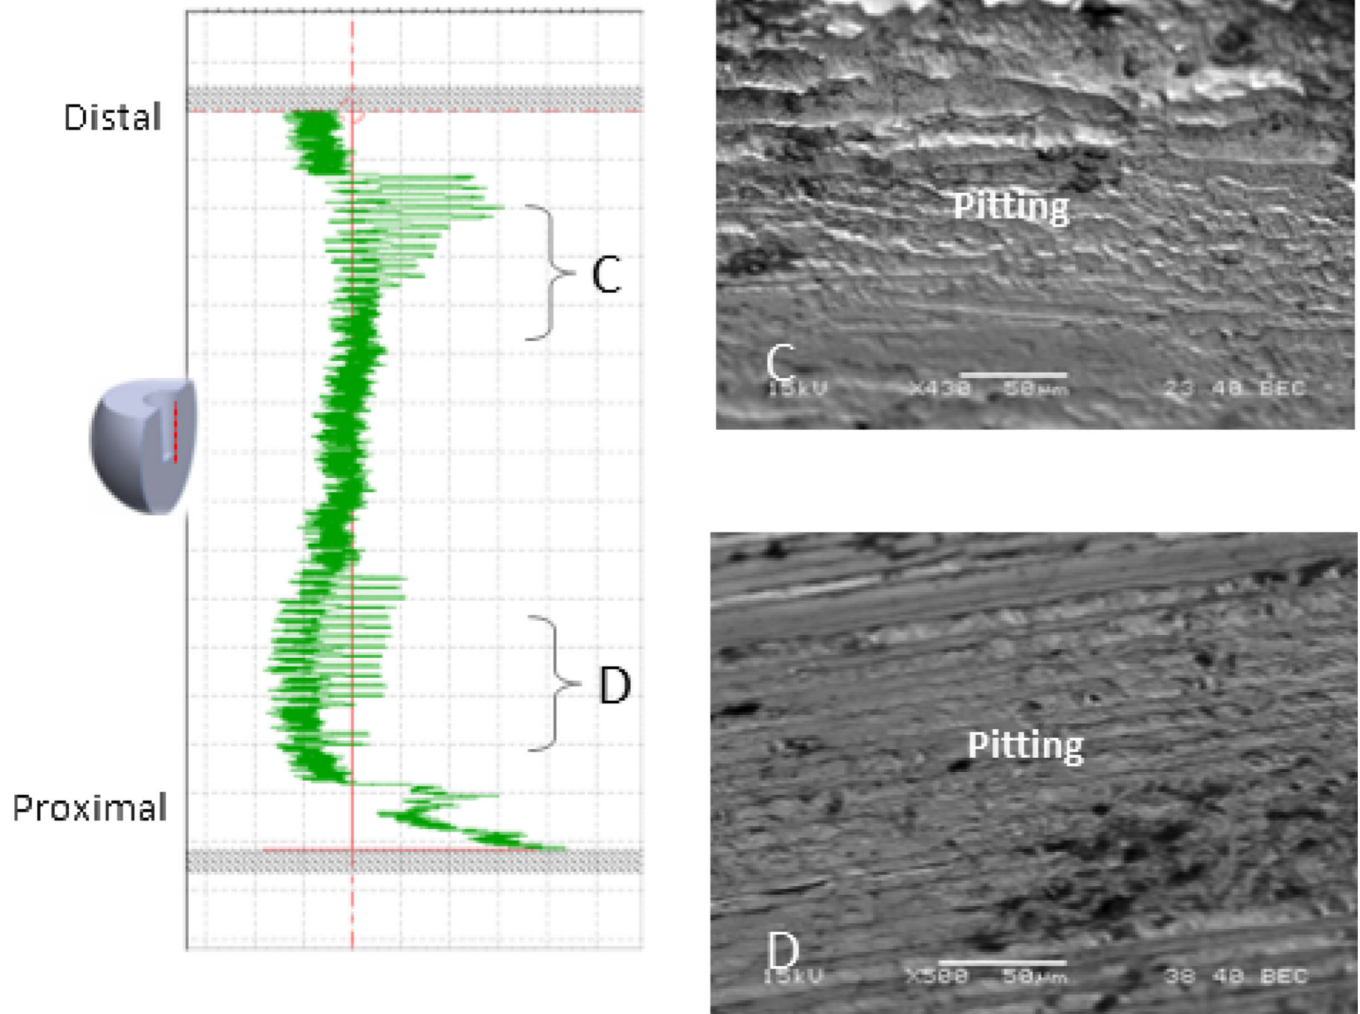
images of the head taper (Figures 12 and 13) both showed changes in surface topography (the amplitude and wavelength of circumferential grooves) consistent with the microgrooves found on the trunnions – suggesting that “imprinting” had occurred.

Figure 12. Axial profile of a metal head implanted with a “microgrooved” trunnion finish (left). Regions corresponding to the material loss, marked C and D were imaged using the SEM (right). Both regions of material loss on the Talyrond profile showed evidence of change to the as manufactured surface.

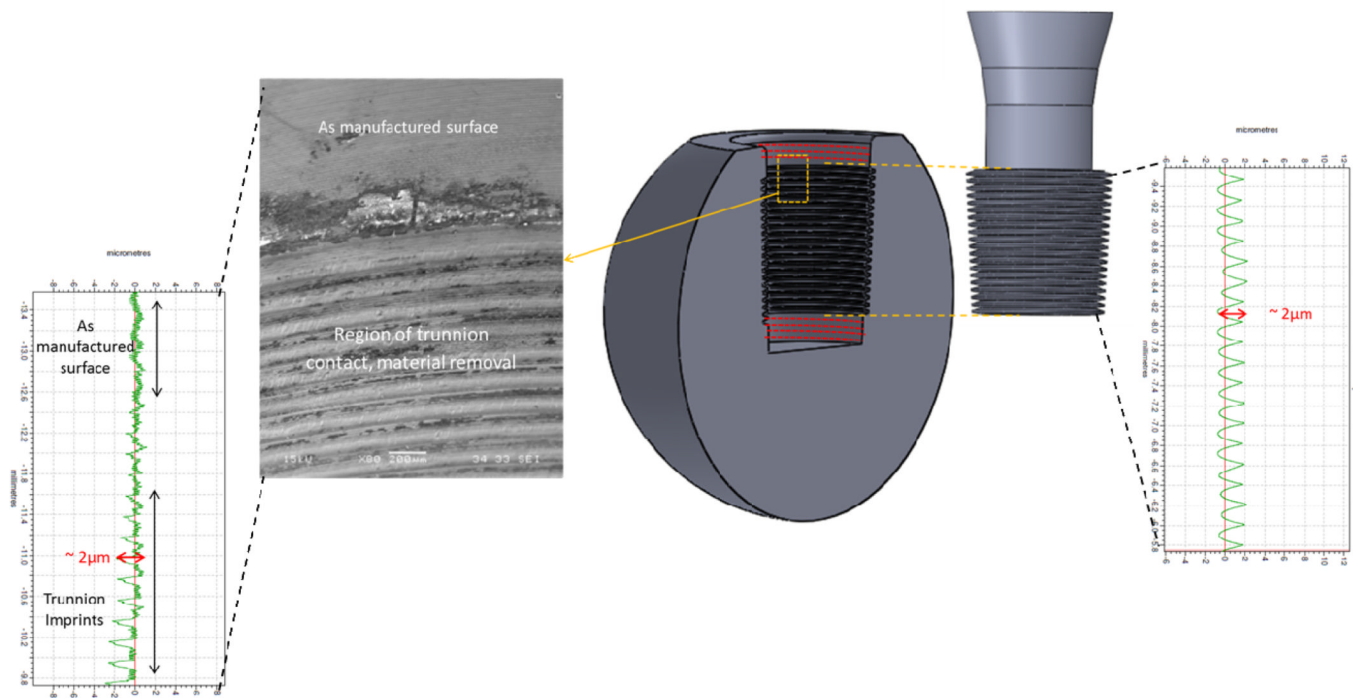
Figure 13. Schematic diagram showing the taper-trunnion interface and typical SEM image and measured profiles from head taper mated with microgrooved trunnion. The red dotted-lines represent locations used for roundness profile measurements.
