Case Report

Impella Induced Massive Hemolysis: Reemphasizing Echocardiographic Guidance for Correct Placement

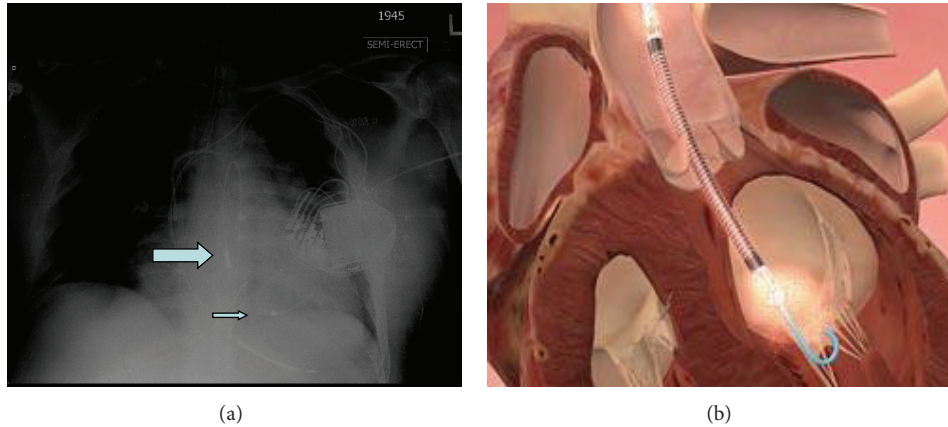
FIGURE 1: (a) An anteroposterior view of the chest showing the Impella inlet (marked with arrow) and outlet (marked with small arrow) below the aortic valve level. (b) Correct placement of Impella with supravalvular outlet (Courtesy of ABIOMED).
