Disconnection of Cobe SMARxT[®] Tubing from the Venous Outlet of the Terumo Capiiox[®] SX25RX Oxygenator During Cardiopulmonary Bypass

Jane Ottens, BSc, Dip Perf, CCP (Aust);* Robert A. Baker, PhD, Dip, Perf, CCP (Aust);†‡
Andrew J. Sanderson, BSc, Dip, Perf, CCP (Aust);* Richard F. Newland, BSc, Dip, Perf, CCP (Aust)†

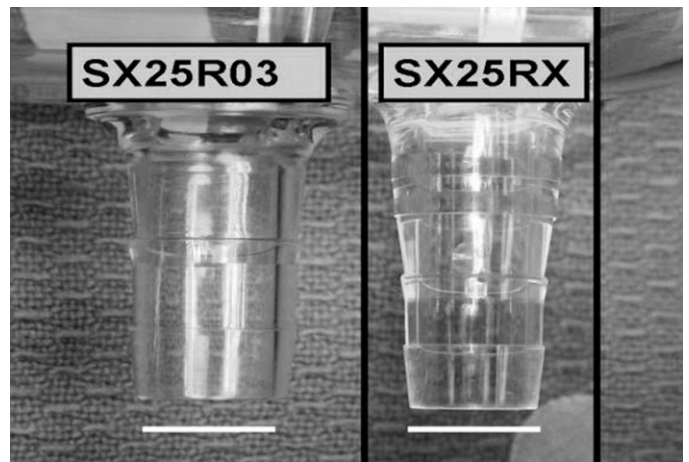
A visual inspection of both oxygenator outlet and tubing was undertaken following the operative procedure, with no apparent defects to either. Following our investigation of the incident, and inquiries to both the tubing and oxygenator manufacturers, we were informed by Terumo (Japan) that the distance between the barbs on the Capiiox[®] SX25RX venous reservoir outlet was 2 mm less than the distance between the same barbs on the Capiiox[®] SX25R03 (Figure 1). This resulted in a mismatch between the width of the cable ties that had been in use and the distance between the barbs, consequently the cable ties were straddling the two barbs, compromising the security of the connection.

Figure 1. A photograph of the venous outlet connectors of the Capiiox[®] SX25R03 and SX25RX oxygenators. The venous outlet connector of the Capiiox[®] SX25R03 is a straight 3/8 connector, while the venous outlet connector is tapered and longer on the Capiiox[®] SX25RX. The white bar is 10 mm.

The independent measurements of the venous reservoirs appeared to show no damage or manufacturing faults of the outlets. However, it did highlight the difference in design and physical dimension between the SX25R03 and SX25RX (Figure 1). The observation that SMARxT® tubing is more slippery than PVC and has a decreased grip strength relative to PVC has previously been the subject of a brief report (9). The use of precision tension cable ties is intended to increase the security of the connection and is the tubing distributor’s recommended practice.

The immediate action in response to this information was a change to the appropriate sized cable ties and a greater vigilance in the "set up" of the circuit with a check of the integrity of all manually prepared connections, incorporated into our pre bypass checklist.

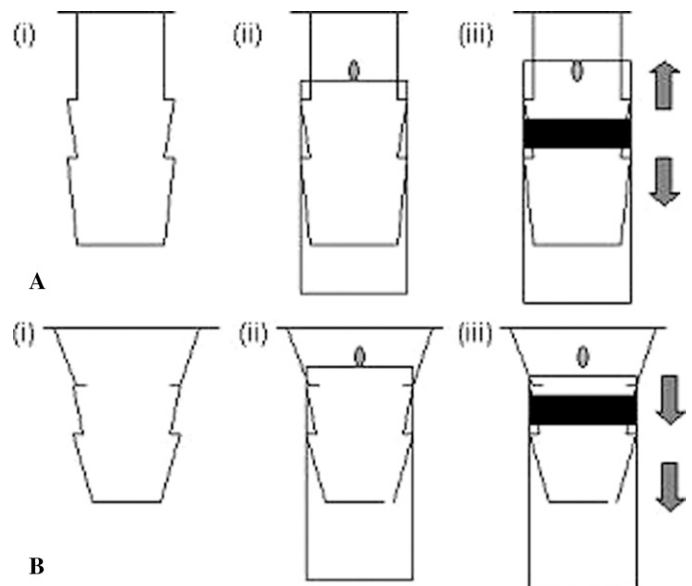
To further our investigations, we performed in-house bench testing, which revealed that both SMARxT® (Figure 2A and 2B) and PVC tubing appeared to produce a secure connection when a cable tie was positioned and a manual force applied to attempt to dislodge the tubing from the

Figure 2. A, stylized drawing of the venous reservoir outlet connector of the Capiiox® SX25R03 oxygenator (2A(i)). Figure 2A(ii) demonstrates diagrammatically the SMARxT® tubing pushed maximally onto the venous reservoir outlet connector while 2A(iii) shows the effect of cable tying to secure the connector. The act of cable tying the tubing between the bars of the connector (represented by the black horizontal bar in the diagram) forces the tubing in both directions, as shown by the arrows, to secure the connection. With the dot on the connector as a point of reference, the displacement of the tubing toward the base of the reservoir is apparent. B, stylized drawing of the venous reservoir outlet connector of the Capiiox® SX25RX oxygenator (2B(i)). With the dot on the connector as the point of reference, SMARxT® tubing is pushed maximally onto the connector (2B(ii)). The action of cable tying (the black horizontal bar in diagram 2B(iii)) between the bars on the connector forces the tubing down the taper, producing a less secure connection, as shown by the arrows.

Capiox® SX25R03 venous reservoir outlet. However we could not replicate this secure connection when force was applied to the SMARxT® tubing when connected to the Capiox® SX25RX outlet, while there was a secure connection with PVC tubing. Added to this, the action of cable tying this tapered connector may actually aid in driving the tubing down the barb of the connector on the Capiox® SX25RX (Figure 2B).

Based on our experience from these three case reports, we suggest SMARxT® 3/8" × 3/32" tubing should not be directly connected to the venous reservoir outlet connector
