Spontaneous Fractures of a Modern Modular Uncemented Femoral Stem

Chelsea N. Koch, BS · Laura Serrano Mateo, MD · Stephen Kayiaros, MD · Kevin A. Cassidy, MD · Seth A. Jerabek, MD · Alejandro Gonzalez Della Valle, MD

Received: 12 January 2016/Accepted: 1 June 2016/Published online: 21 June 2016
© Hospital for Special Surgery 2016

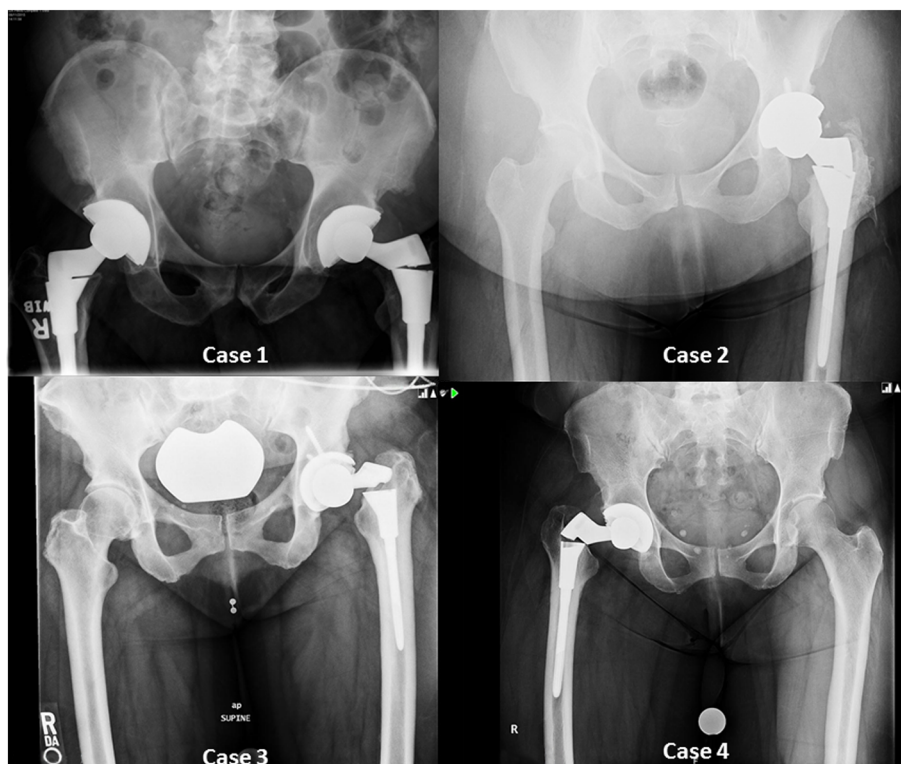
The four patients presented with EMPERION™ stem fractures (Fig. 1) between June 10 and September 15 2015. The patients were between 50 and 60 years of age (54.8 ± 4.6 years) with weights that ranged from 81 to 138 kg (103 ± 25 ; Table 1). The length of time that the devices had been implanted ranged from 1.2 to 8.3 years (4.43 ± 3.3 years). Three stems were implanted during primary total hip replacements, and one was used in a total hip revision. All four components had a high offset. No leg length or offset discrepancies existed between the operative and contralateral side, except for case 3, in which the operative side was 2 mm longer than the contralateral side prior to the fracture event. The surgeries to remove the four fractured implants were performed at an average of 3 ± 2 days following the date of fracture (range from 1 to 6 days).

Fig. 1. Anteroposterior radiographs taken following fracture of four EMPERION™ femoral stems.

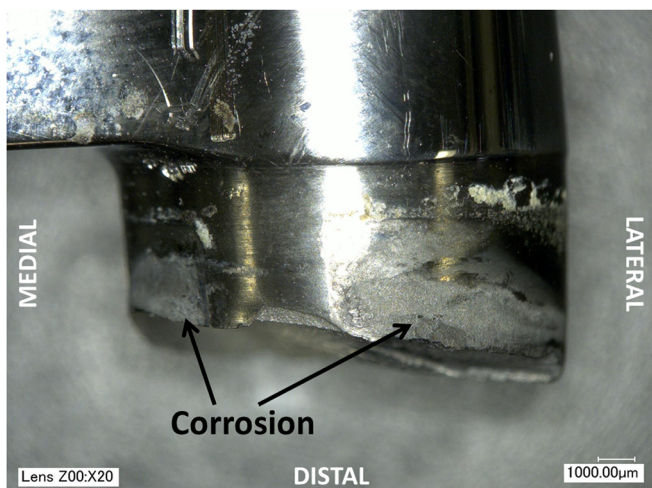
Analysis of the fracture surfaces under light microscopy and scanning electron microscopy (SEM) revealed fracture patterns consistent with fatigue due to a bending load. Fractures were initiated at the lateral aspect of the stem approximately 3 to 5 mm distal to the most proximal edge of the sleeve component (Fig. 2). Concentric beachmarks were consistent with fatigue fracture propagating from the lateral edge of the stem (Fig. 3). All four stems showed evidence of corrosion and pitting that extended across the origin of the fracture on the lateral aspect of the stem (Fig. 2), as well as discoloration in the initiation region of the fracture surface consistent with corrosion (Fig. 3). No metallurgical defects (e.g., poor microstructure and manufacturing flaws) that might have contributed to the fracture were evident in the titanium alloy at the region of fatigue crack initiation [2].

Fig. 2. All four fractures initiated on the lateral aspect of the stem cross section. Regions of corrosion and pitting were visible on both the lateral and medial aspects of the stem, which were in contact with the sleeve in vivo.

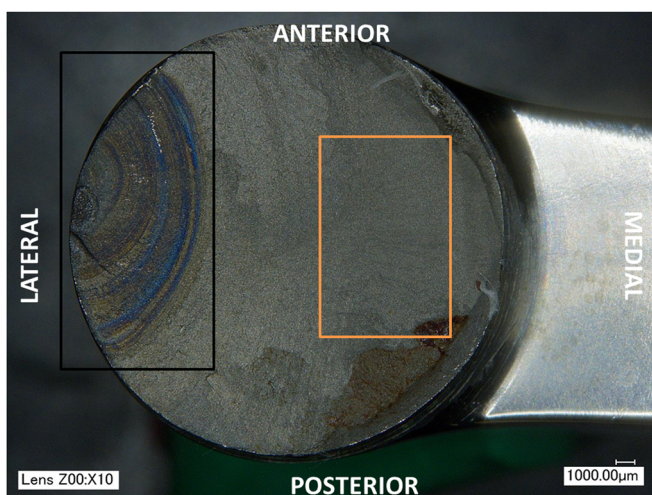
Fig. 3. All fractures exhibited concentric beachmarks moving outward from the fracture origin (*black rectangle*). Finger-like striations are visible (*orange rectangle*) moving through the region of the final spontaneous fracture, which covered about one third of the stem cross section.
