Cite this article: Ornthammarath T. 2019 Seismic damage to ancient monuments in Chiang Saen (Northern Thailand): implication for historical earthquakes in Golden Triangle area. *Phil. Trans. R. Soc. A* **377**: 20180255. <http://dx.doi.org/10.1098/rsta.2018.0255>

Seismic damage to ancient monuments in Chiang Saen (Northern Thailand): implication for historical earthquakes in Golden Triangle area

Teraphan Ornthammarath

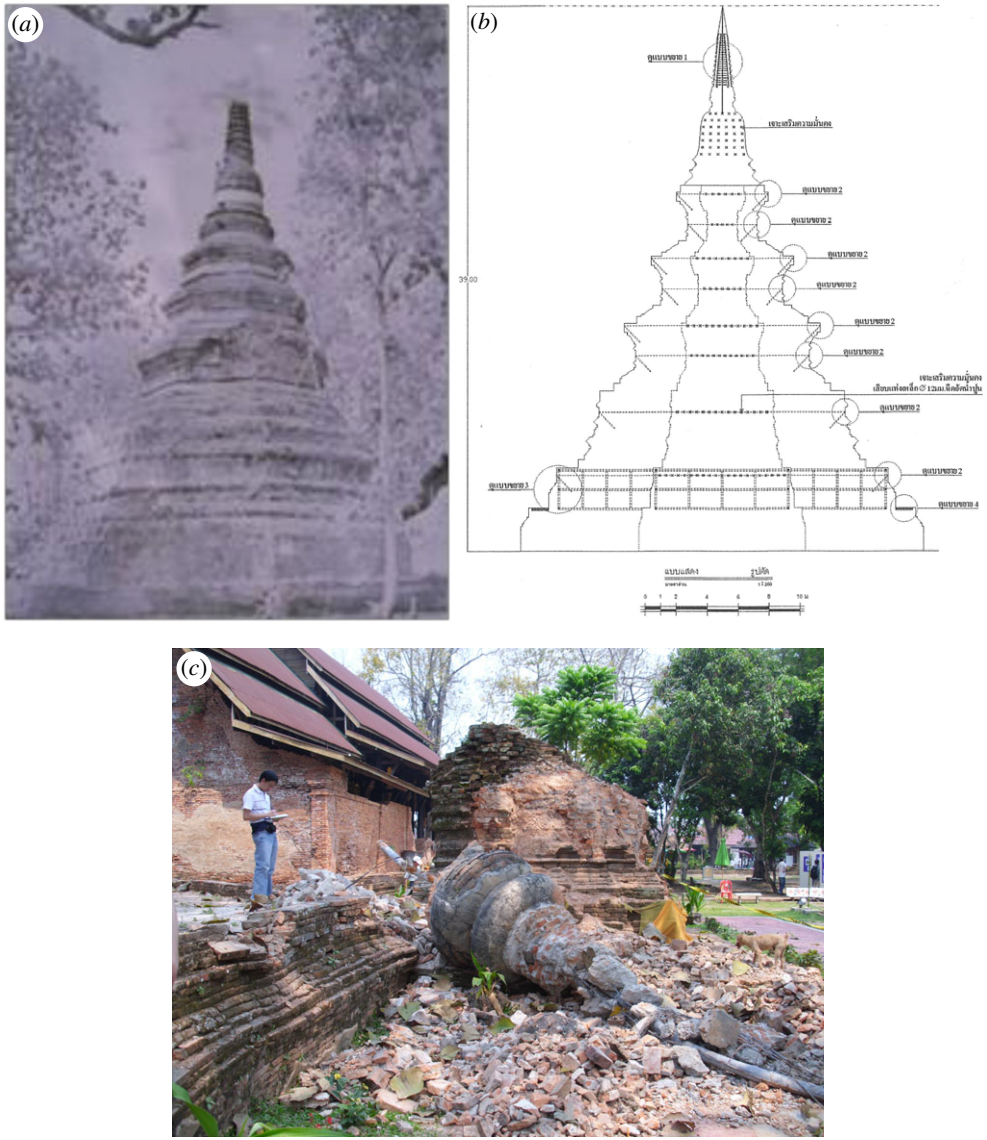
Figure 4. (a) The early photograph of Chedi Luang in 1957 (DOFA, 1979). (b) The schematic cross-section of Chedi Luang with reinstalled top spire in 2012. (c) The collapse of the 7-m spire due to the Mw 6.8 Tarlay earthquake in 2011. Its size is comparable to a person next to the toppled spire. A steel pipe could be clearly seen. (Online version in colour.)

is Chedi Luang (figure 4); this stupa has an octagonal base with superimposed platform up to the bell and a height of 35 m, making it the highest stupa in Chiang Saen. According to Lan Na and Chiang Mia chronicles [4,10], the original stupa was built in 1328 and its former height was 58 m; however, significant retrofitting was performed in 1515 [25], which is confirmed by its dome shaped architectural features in the Lan Na architectural style from the sixteenth century instead of a square solid mass [26].

After the 2011 earthquake, significant damage mainly occurred at the spire and dome. The collapse of the top spire caused additional damage to the tumulus part with large cracks as well as damage to other nearby structures. The 7-m toppled spire seems to indicate that similar damage might have occurred in the past since a steel pipe could be observed inside the fallen summit. Based on local interviews, the previous retrofitting was due to thunder strikes, which caused damage to the top of the stupa. The previous work did not seem to consider preventing damage due to earthquakes. However, the current Thai seismic design code does not have clear specific guidelines related to ancient monuments, and most retrofit work does not appear to prevent future earthquake damage. Nevertheless, the structure at the basement is still intact, and no intervention works need to be done for this part. Later, the top masonry spire was reinstalled by the Department of Fine Arts in 2012. However, additional damage occurred due to the Mw 6.1 2014 Mae Lao earthquake, which was located about 70 km from Chiang Saen. In 2014, wide cracks at the upper part of the dome and some parts of the top spire were observed. An additional factor that could explain the damage to Chedi Luang is its slenderness ratio (height per width of solid core) of about 3.88 (35/9), compared with other historic structures in Chiang Saen which sustained much less damage given the low ground shaking recorded at MEAJ station ($PGA = 0.04$ g), which is located about 30 km away from Chiang Saen. Since the modal periods of historical structures depend highly on the height, total mass, flexural stiffness and its configuration, Chedi Luang might have suffered extensively from the long period of moderate earthquakes from nearby active faults throughout the last 500 years. The early photograph of Chedi Luang in 1957 showed that the top spire was missing, indicating the high vulnerability of this ancient structure.

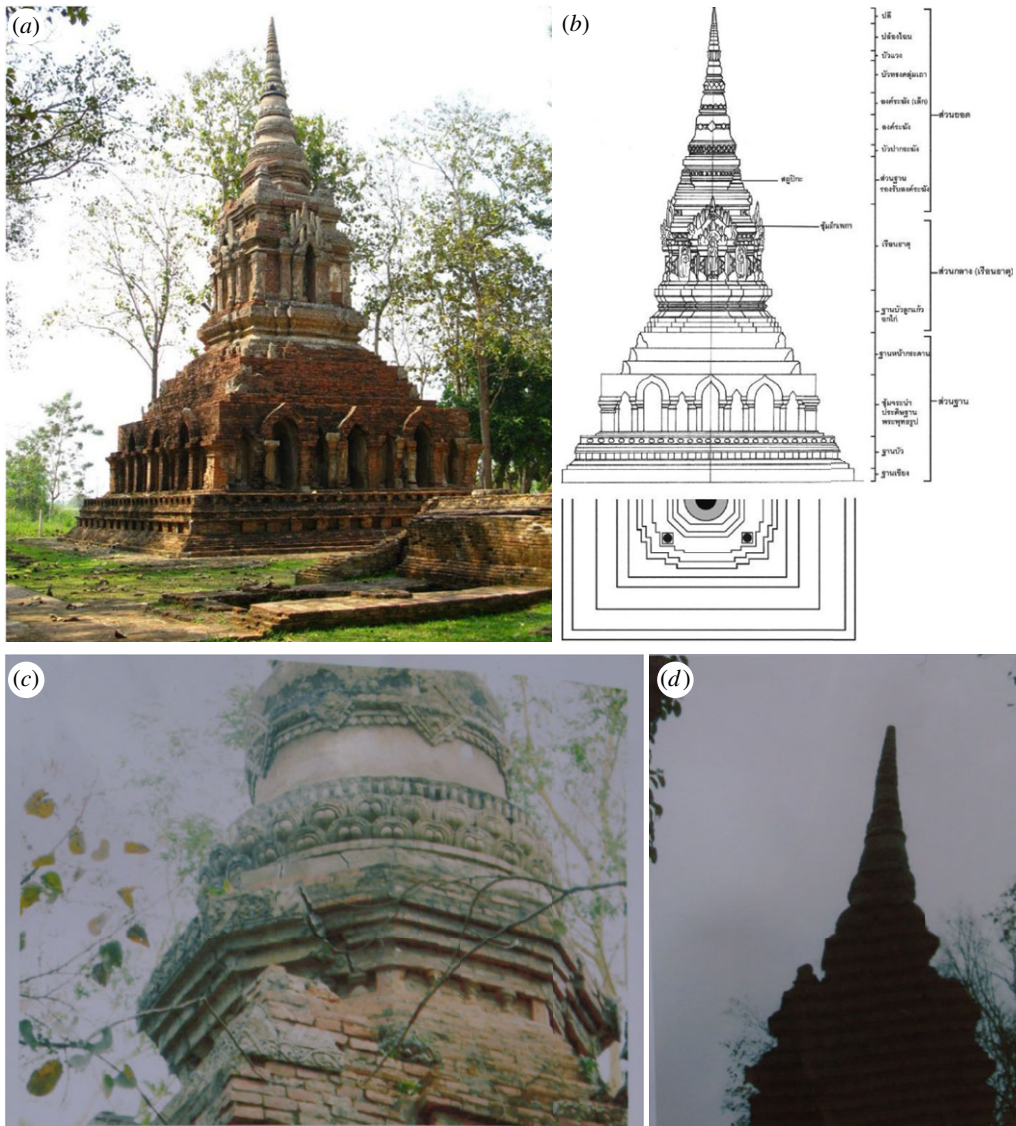
The other ancient monument in Chiang Saen that was damaged due to recent earthquakes is Chedi Pasak (figure 5). Based on the available historical records, this masonry stupa was built in 1332 in the same period as Chedi Luang. In contrast to Chedi Luang, the architectural form of Chedi Pasak is similar to the Bagan and Hariphunchai styles, which are quite common for the early Lan Na period. There is no historical record of severe damage and any significant repair works for Chedi Pasak. In addition, the original architectural form in the early fourteenth century [4,26], is still preserved. Due to a 2011 Mw 6.8 earthquake, partial damage occurred to this stupa, including wide cracks in the lower top part and clear tilt to the spire. This stupa has symmetrical planes in horizontal and vertical directions. The solid core basement is about 11 by 11 m, and it is the load bearing of the superstructure which is about 21 m in height, making it the second highest stupa and one of the oldest in Chiang Saen. However, no significant additional damage could be observed following the 2014 Mae Lao earthquake. In addition, Chedi Pasak is located within the old city centre and about 300 m from Chedi Luang, but different observed damage could be clearly noted. It is worth mentioning that its slenderness ratio is 1.9 (21/11), about half of Chedi Luang, which might partly explain the lower observed damage. However, due to its architectural characteristics and construction materials, it is quite clear that this masonry structure is also vulnerable to strong ground shaking from nearby active faults.

Figure 5. (a) Chedi Pasak before 2011 earthquake. (b) The schematic plot of Chedi Pasak in different layers. (c) Observed wide cracks at the lower top part. (d) Tilt could be clearly seen at the top spire following the 2011 earthquake in Myanmar located at 50 km to Chiang Saen. (Online version in colour.)

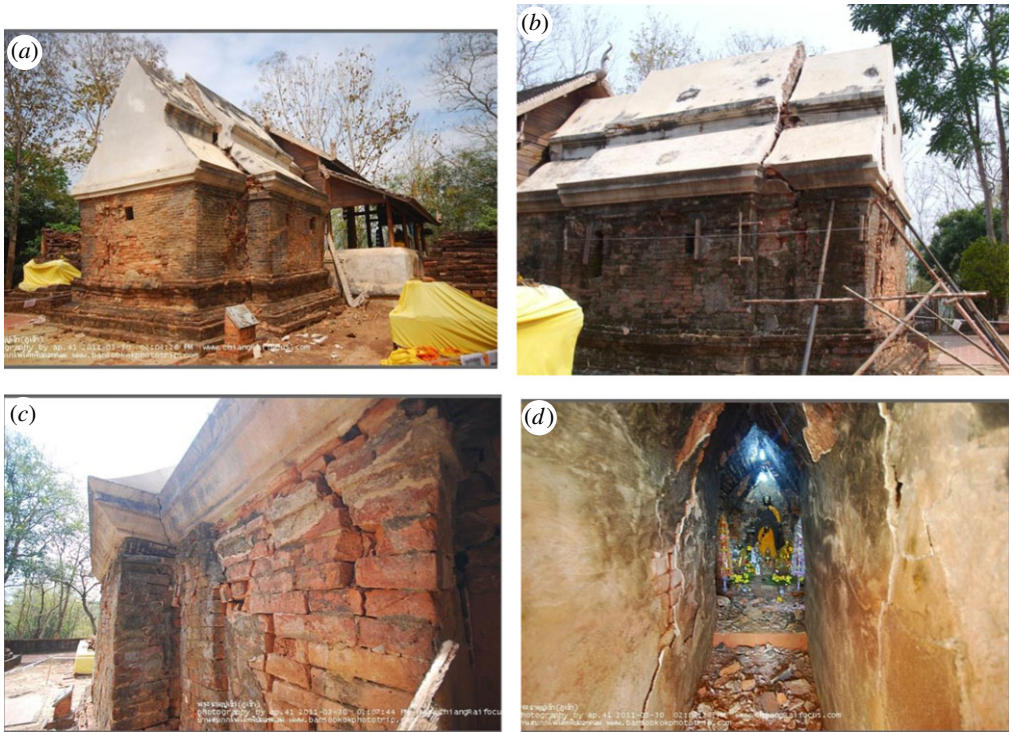
The only masonry arch structure in Chiang Saen to be heavily damaged by the 2011 Myanmar earthquake was the Pu Khao Temple (figure 6). This one-storey temple is characterized by multi-arch structures. The double-tier roof temple has a symmetric rectangle floor plan sitting on a

masonry basement. Brick masonry walls of about 50-cm thickness with 4-m height, which are the main load bearing system, have severe diagonal shear in-plane damage in all directions. Extensive cracks could be clearly observed in both interior and exterior walls. The level of in-plane damage to bearing wall could trigger partial or full out-of-plane collapse of damaged structures. Damage between walls due to pounding could be observed clearly at masonry corners. The architectural form of the double-tier roof indicates that it has been constructed since the fourteenth century. The scale of the damage led to fear of full collapse and temporary scaffoldings were installed to prevent further damage from aftershock. Based on the observed MMI VI and estimated 0.10 g PGA in this area as discussed in Section 3, the observed near collapse of historical structure under this level of ground shaking clearly indicates poor seismic performance of ancient monuments in this region.

Figure 6. (a) Pu Khao temple damage due to 2011 earthquake viewed from NE. (b) The same photograph viewed from SW. (c) Observed wide cracks at exterior walls. (d) Diagonal in-plane shear cracks could be clearly seen. (Online version in colour.)

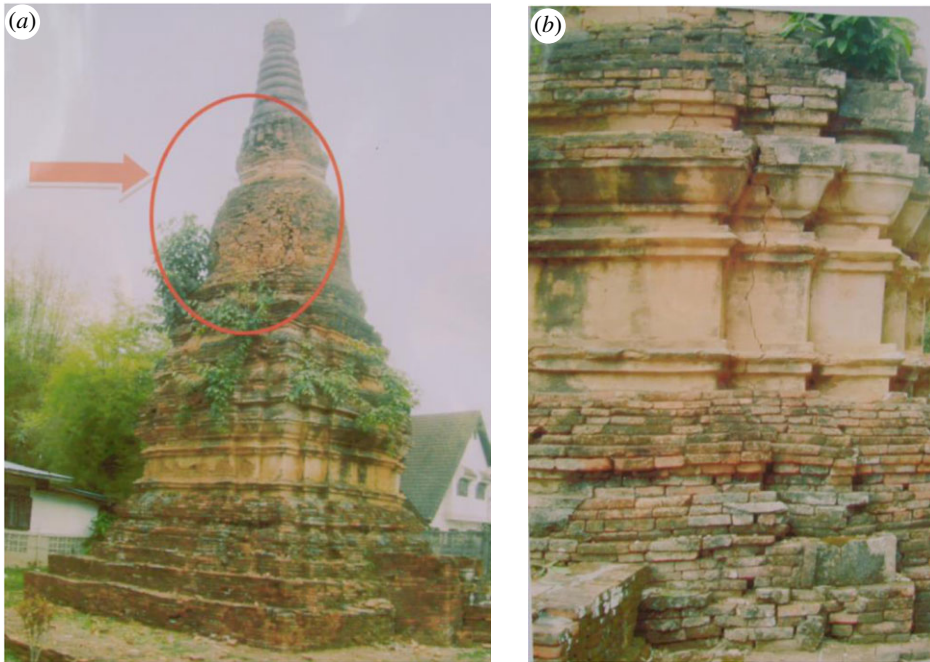
Chedi Prasad Khum (figure 7), is the only monument included in the damage survey to have been constructed in the seventeenth century, which is evident from its torus moulding architectural feature. This solid chedi was constructed of brick and mortar with a high rabbeted lotus base measuring 8 m in width and height. This has a round bell shape top with a long spire, which was a common style during the late Lan Na Kingdom. Apparent damage due to the 2011 earthquake occurred at the drum with a 5–7 cm width crack, and subsidence in parts of the superstructures could be clearly seen. In addition, vertical cracks propagated through the height of the basement, indicating the large vibration developing along the height of the structure. During vibration, the maximum displacement occurred at the top part, and the lateral inertia force is responsible for the increasing tension stress at the top spherical cone and drum part, while compressive stress mostly occurs along the basement. Since masonry structures were designed to carry self-weight in compression, less damage could be expected in the basement. However, the developed tensile stress distributed along the drum and top parts exceeds the tensile strength of masonry, and severe damage clearly confirms this shaking behaviour.

Figure 7. (a) Apparent settlement for parts of superstructures at Chedi Prasad Khum due to 2011 earthquake. (b) Observed long cracks along the basement. (Online version in colour.)

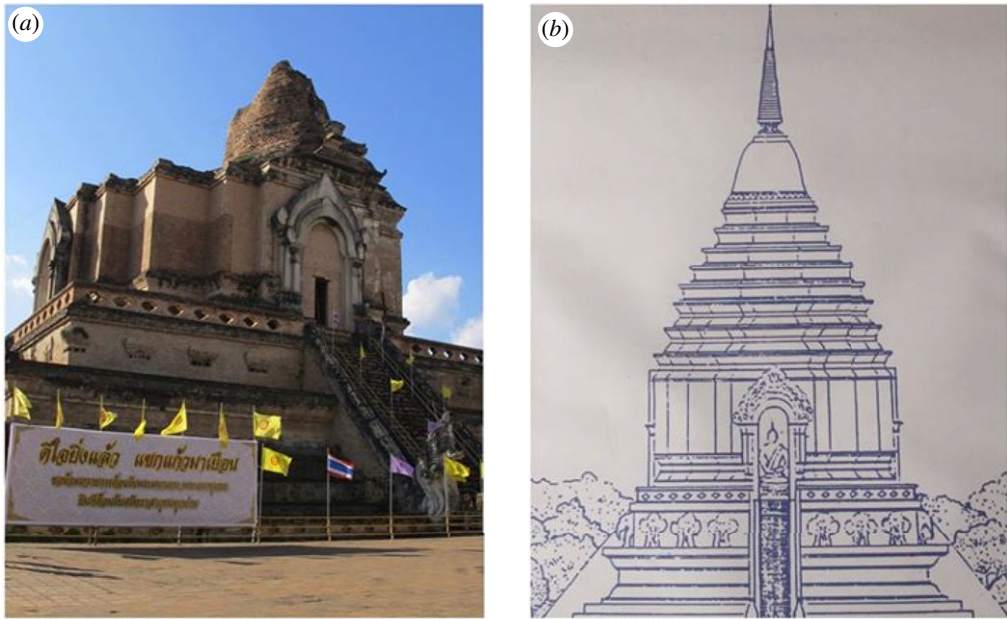
Figure 9. (a) The current ruin of Chedi Luang in Chiang Mai due to the 1545 earthquake. (b) The schematic sketch of the original Chedi Luang before collapse due to earthquake with height of 95 m. (Online version in colour.)
