# Polyethylene liner dissociation in a DePuy pinnacle cup with a manufacturer analysis of the failed component

David Keohane

Orthopaedics, Cork University Hospital Group, Cork, Munster, Ireland

**To cite:** Keohane D, Sheridan GA, Harty J, et al. *BMJ Case Rep* 2021;**14**:e238333. doi:10.1136/bcr-2020-238333

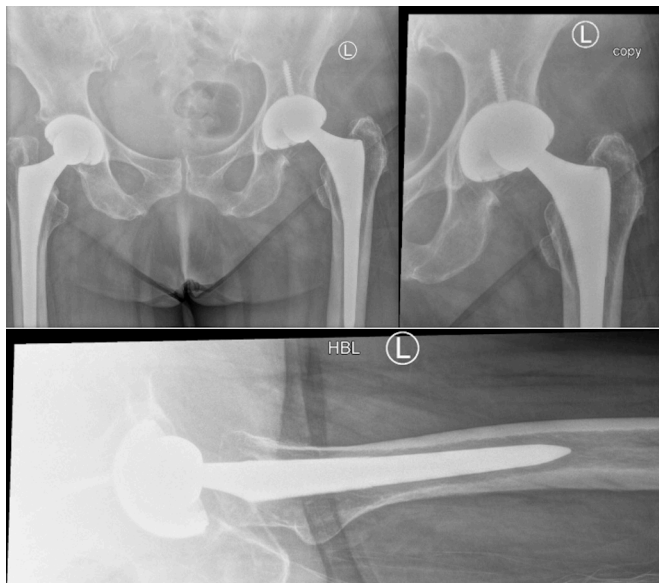
In the ED, radiographs demonstrated lateralisation of the left femoral head within the acetabular shell ([figure 1](#)).

**Figure 1** Radiograph demonstrating lateralisation of the left femoral head.

Based on the position of the femoral head on the admission images, the differential diagnoses included either dissociation or fracture of the polyethylene liner.

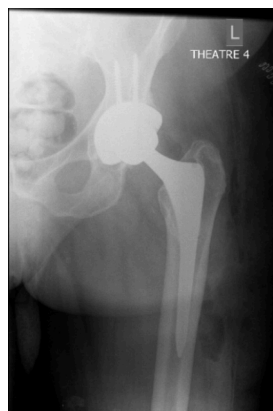
Postoperative imaging confirmed satisfactory positioning of the femoral and acetabular components ([figure 2](#)). Since the revision THA, the patient has been regularly followed up in the outpatient department, most recently at 1 year post revision, with no further complaint.

**Figure 2** Post revision radiograph.

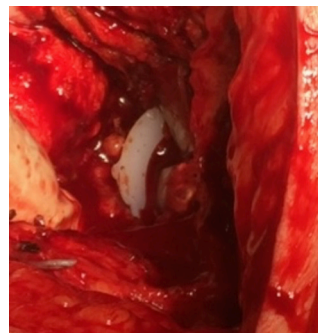
Surgical management included revision of the acetabular and femoral head components, as well as the implantation of a new polyethylene liner. Intraoperatively, dissociation of the polyethylene liner was noted (figure 3). All other components were stable on examination. On inspection, three of the six anti-rotation locking tabs were sheared away (figure 4).

**Figure 3** Intraoperative image of dissociated liner.

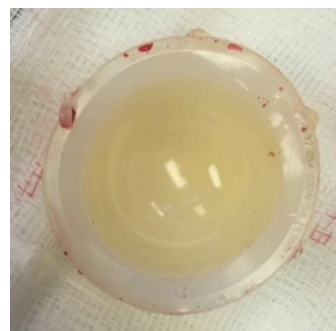
On analysis of the liner there was “no impingement or malalignment noted”. The report also noted “on the bearing surface edge wear was seen, a hood score for abrasion was visible, 3–5 deep scratching noticed and a wear scar was identified”.

**Figure 4** Explanted liner.

Of note, three of the six locking tabs were sheared away from the explanted polyethylene liner. This failure of three locking tabs appears to be a common finding in the literature.<sup>2,3,7,9</sup> The manufacturer analysis identified bearing surface edge wear in the liner. We can speculate that this surface edge wear may have been caused by subluxation of the femoral head which may have caused eccentric loading of the liner, resulting in shearing of the anti-rotation tabs and failure of the component. However we do not know why there would have been subluxation of the femoral head in the first instance.
