# Invisible Metallic Microfiber in Clothing Presents Unrecognized MRI Risk for Cutaneous Burn

J.A. Pietryga, M.A. Fonder, J.M. Rogg, D.L. North, and L.G. Bercovitch

**SUMMARY:** We report a case of a thermal burn that occurred during MR imaging likely caused by invisible silver-embedded microfibers in the fabric of an undershirt. As the prevalence of fabric containing nondetectable metallic microfiber increases in athletic and “tech” clothing, the importance of having patients change into safe facility-provided garments before MR imaging is emphasized.

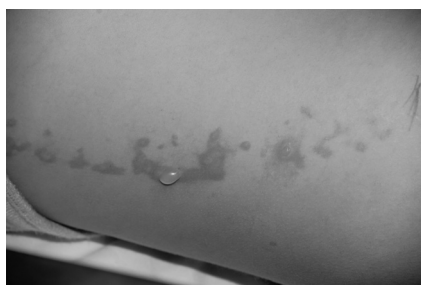
Following patient arousal from sedation, she complained of right-sided “burning” discomfort. Physical examination revealed linear erythematous blistering eruptions located along her right flank (Fig 1) and ipsilateral volar wrist where it contacted the undershirt. A dermatologic consult diagnosed a second-degree burn.

**FIG 1.** A linear erythematous blistering eruption is noted on the patient's right flank minutes after completion of the MR imaging of her brain and spine.

We hypothesize that during the study, electromagnetic eddy currents generated either within the shirt fibers concentrated at the fabric seam or between the shirt fabric seam and the patient's moist midaxillary skin resulted in significant heating and second-degree burns.

In summary, we demonstrate how, despite careful prescreening, invisible metallic microfiber in garments can fail to be detected before entering the MR imaging environment and potentially lead to patient thermal burns. To avoid this hazard, all patients should change into site-supplied MR imaging-compatible outer clothing and wear nonmetallic cotton or other safe non-trade name undergarments for their examinations. When exception is necessary, only patients wearing clearly labeled nonmetallic, non-trade name fabrics should be scanned without changing. We believe that those patients who are sedated or otherwise have diminished responsiveness are at greatest risk for thermal burns and, therefore, require the greatest scrutiny.

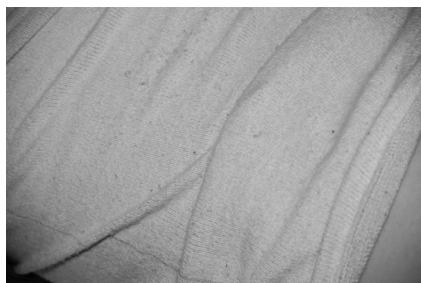
**FIG 2.** The patient wore a Boston Silver T shirt beneath a conventional cotton tee shirt during her imaging study. It was not until after the scan that it was realized that the undershirt, recommended for wear beneath her back brace, contained antimicrobial silver microfibers.

don, Pennsylvania), was it determined that the shirt fabric was impregnated with SMF. On careful review of the shirt, it was noted that the midaxillary burn corresponded with the single shirt seam.

Our patient's Boston Silver T shirt showed no visible or labeling evidence to indicate that it contained SMF and was purchased to be used under external appliances (eg, a back brace) because of its perspiration wicking and antimicrobial characteristics. The manufacturer has since voluntarily modified its label to identify the silver content with the trade label X-Static (Nobel Biomaterials, Scranton, Pennsylvania) and to specifically warn against use during MR imaging examinations. The shirt still contains no attached content label.

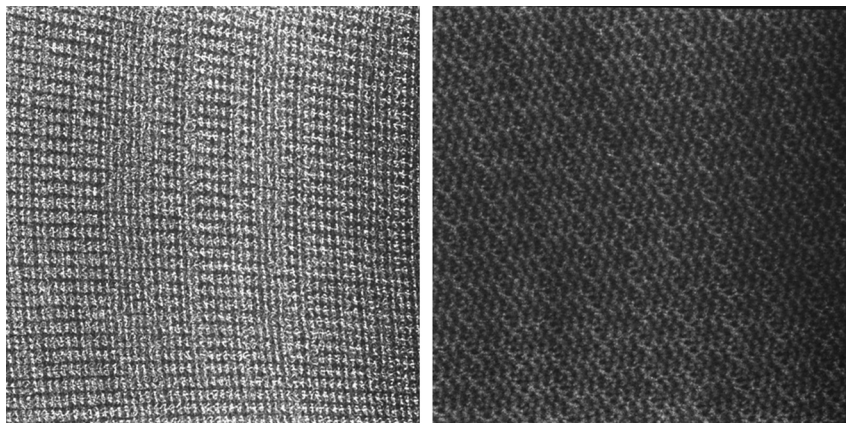
We suspect that our patient sustained cutaneous burns secondary to conductive SMF embedded in her undershirt. We retrospectively imaged the undershirt by high-resolution digital radiography (Fig 3) and demonstrated an interleaving weblike pattern of radiopaque SMF. We further demonstrated the enhanced electrical conductivity of the SMF fabric relative to control polyester and cotton fabrics by measuring the resistance by using a volt/ohm multimeter. The undershirt demonstrated low resistance (on the order of 10 ohms), which increased monotonically as a function of the distance separating the probes. In contrast, the resistance for both the cotton and polyester fabrics was infinite.

**FIG 3.** A digital radiograph demonstrating the metallic content of the fibers of the undershirt. Left image shows the radiopaque silver microwave fabric from the Boston Silver T. Comparison right image shows cotton fabric from a thermal undershirt.
