The 30 October 2020 Aegean Sea Tsunami: Post-Event Field Survey Along Turkish Coast

Abstract—On 30 October 2020, a strong normal-faulting earthquake struck Samos Island in Greece and İzmir Province in Turkey, both in the eastern Aegean Sea. The earthquake generated a tsunami that hit the coasts of Samos Island, Greece and İzmir, Turkey. National teams performed two post-tsunami field surveys on 31 October to 1 November 2020, and 4–6 November 2020, along the Turkish coastline; while the former was a quick survey on the days following the tsunami, the latter involved more detailed measurement and investigation focusing on a ~ 110 -km-long coastline extending from Alaçatı (Çeşme District of İzmir) to Gümüldür (Menderes District of İzmir). The survey teams measured runup and tsunami heights, flow depths, and inundation distances at more than 120 points at eight different localities. The largest tsunami runup among the surveyed locations was measured as 3.8 m in Akarca at a distance of 91 m from the shoreline. The maximum tsunami height of 2.3 m (with a flow depth of 1.4 m) was observed at Kaleiçi region in Sığacık, where the most severe tsunami damage was observed. There, the maximum

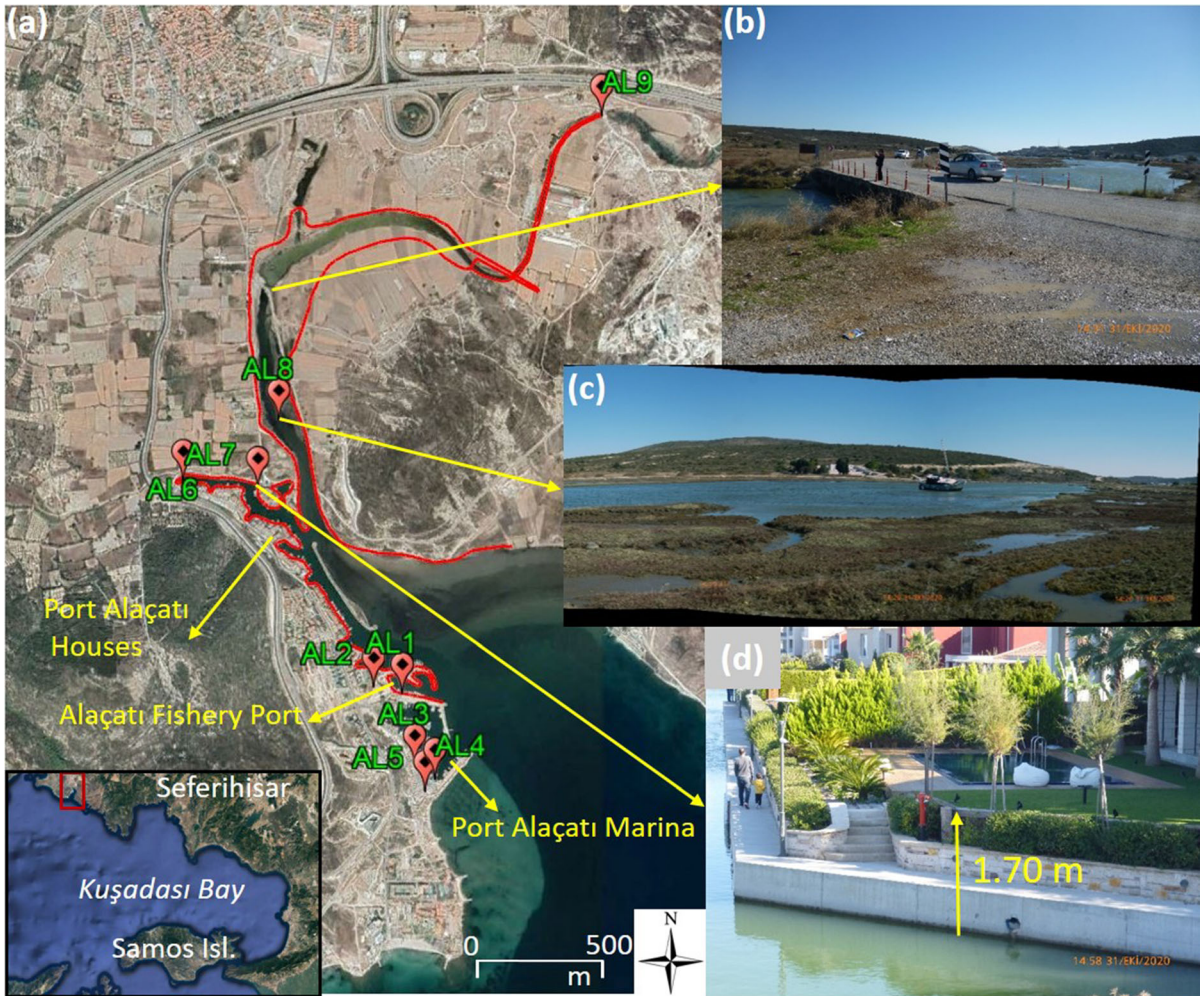
Figure 3

a Map showing the surveyed locations in Alaçatı locality (image is taken from Google Earth) The red line shows the tsunami penetration/inundation zone. **b** Tsunami traces visible on Alaçatı Azmak bridge (at ~ 30 cm above the bottom of the bridge wall) located 1.0 km away from the coastline (38.2706° N, 26.3768° E), **c** Fisher boat dragged 1160 m away from the fishery port along Alaçatı Azmak, **d** Water level increase at the garden wall of Alaçatı Port houses according to the house owner

In Alaçatı, there is a stream—*azmak* in Turkish—called Alaçatı Azmak where maximum tsunami penetration was ~ 2490 m (Fig. 3a, Table 2-AL9). The tsunami inundation mainly followed the *azmak* streambed and the flat coastal topography (Fig. 3a). A boat was dragged ~ 1160 m along the stream (Fig. 3a–c, Table 2-AL8) from its location in the

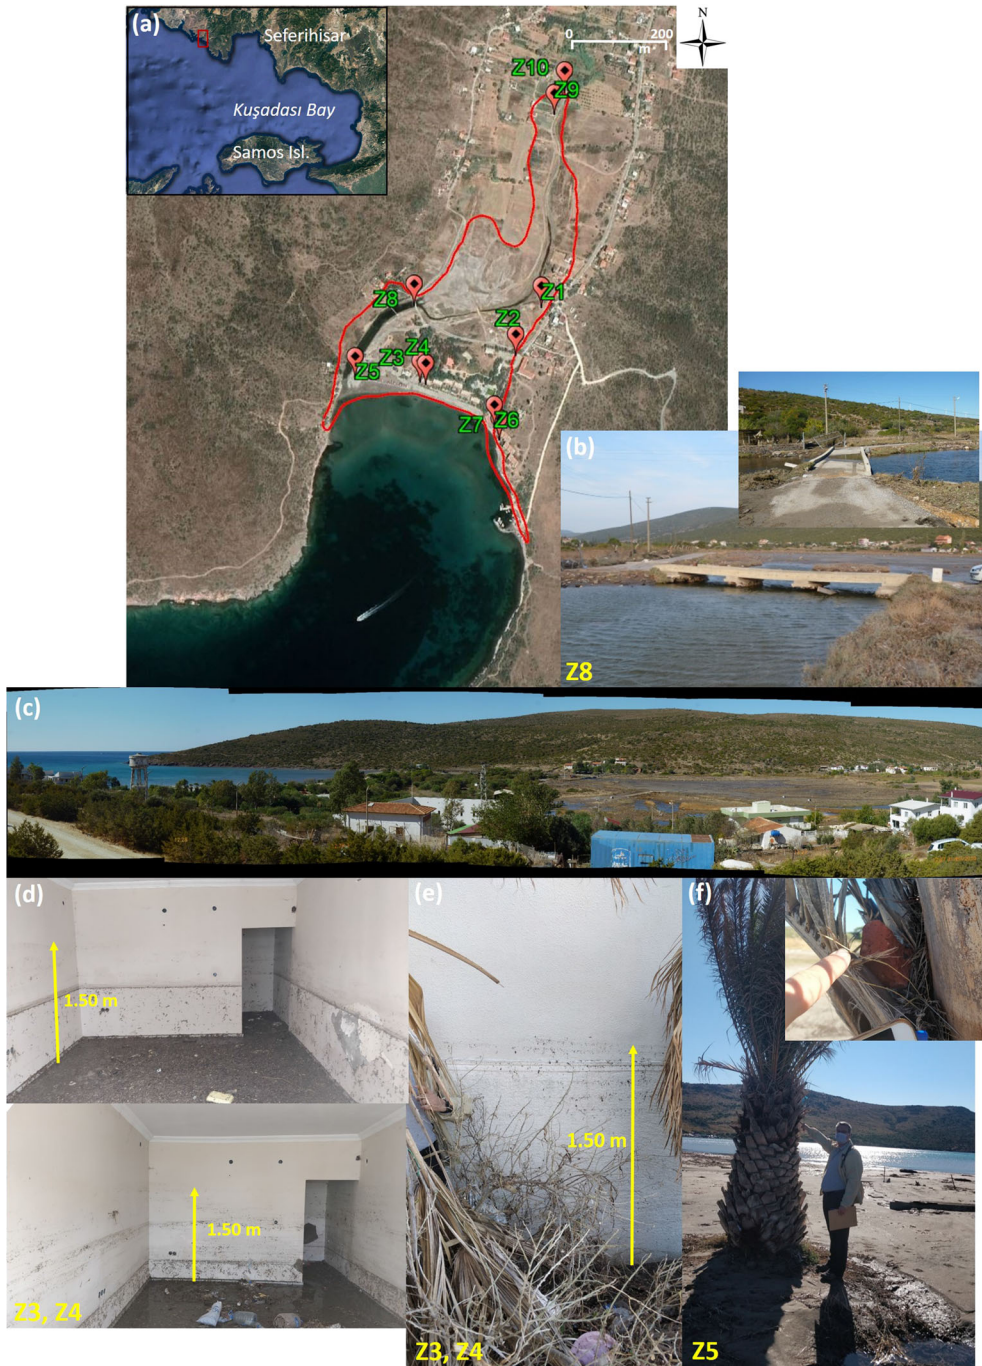
Figure 4

a Map showing the surveyed locations and the tsunami inundation zone (red line) in Zeytineli (image is taken from Google Earth). The corresponding survey location IDs are indicated at the lower left corner of each figure. **b** Damaged bridge on Zeytineli Azmak due to tsunami. **c** Panoramic view of tsunami inundation in Zeytineli. **d** Debris accumulated inside and at **e** outer wall of a house (flow depth 1.5 m). **f** Wave traces on palm tree near the coastline (flow depth 1.9 m)

direction from the sea coast. The flow depth was 1.9 m on the palm trees, 50 m away from the coastline (Fig. 4f, Table 2-Z5). Additionally, concrete blocks ($30 \times 50 \times 300$ cm), weighing approximately 1 ton, were found dragged 20–25 m inland direction and scattered from their original locations by the tsunami (Fig. 5).

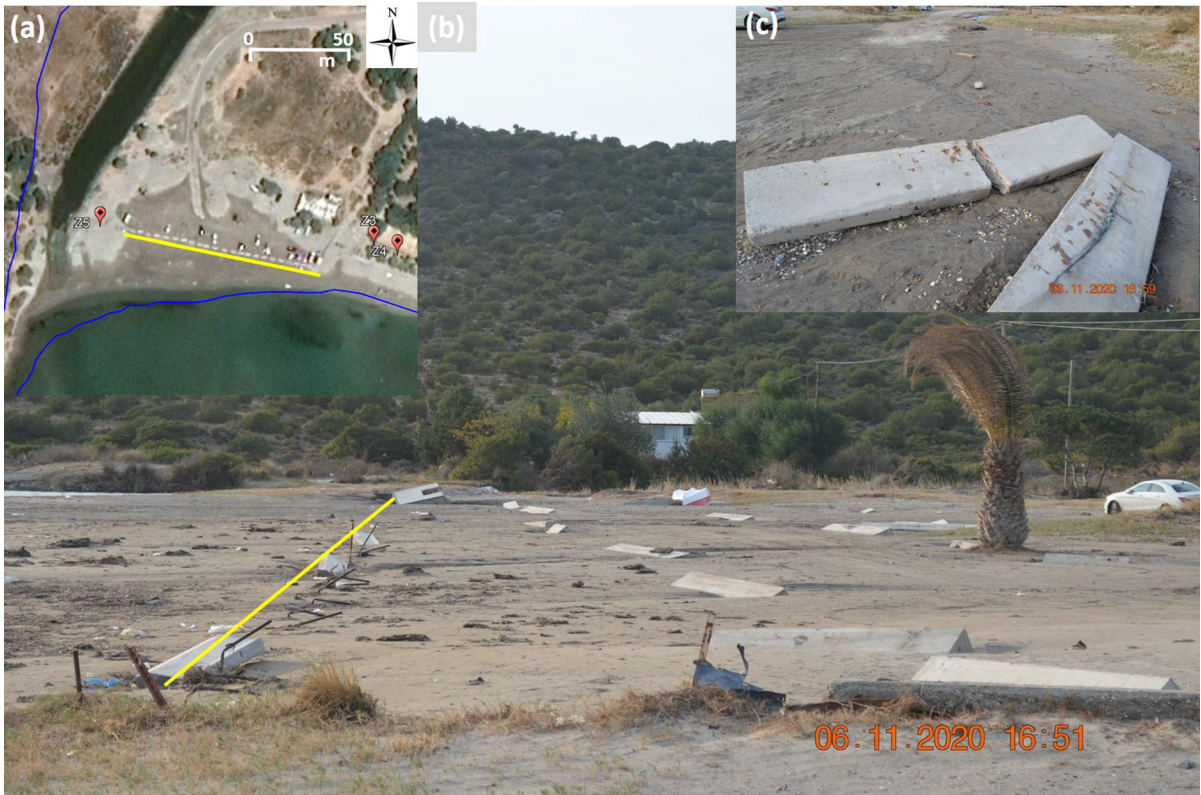
Figure 5

a Original layout of the concrete blocks in Zeytineli (image is taken from Google Earth). **b** Concrete blocks drifted and scattered by the tsunami. **c** Closer view of drifted and damaged concrete blocks. Yellow lines indicate the original location of the blocks before the tsunami

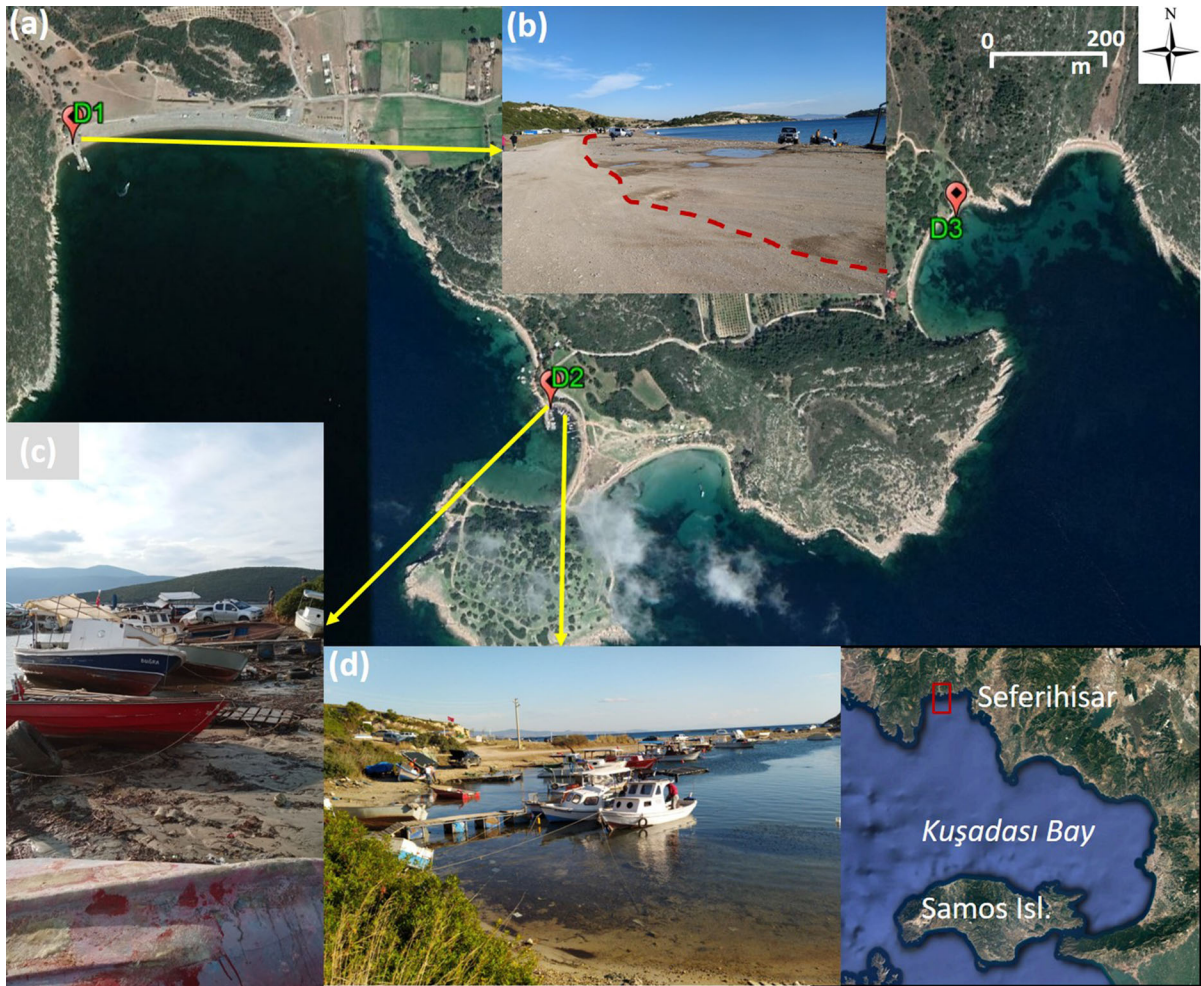
Figure 6

a Map showing the surveyed locations in Demircili (image is taken from Google Earth). **b** Small tsunami inundation (red line) in Demircili Beach on the northwestern side of the bay **c, d** Damaged boats observed in the small fishery structure on the southeastern bay of Demircili

(Fig. 6, Table 2-D1). On the other hand, considerable damage was observed by the local people and fishers on a narrow beach on the southeastern side of the bay

(Fig. 6, Table 2-D2). According to eyewitnesses, the sea receded almost 20 min after the earthquake and returned in 3–4 min. They observed this receding–

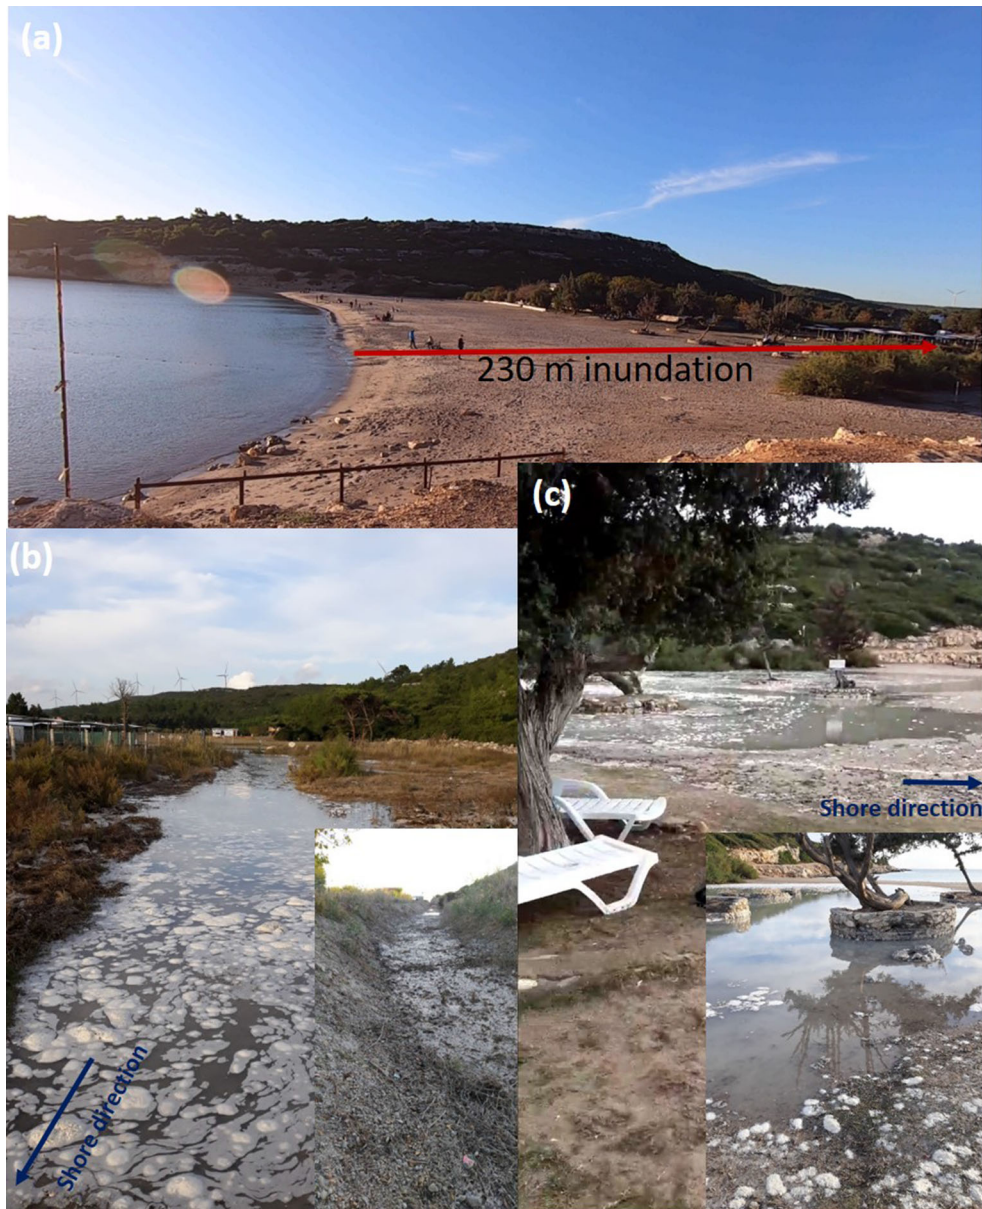
Figure 7

a Tsunami inundation area in Altinköy locality **a** on the beach, **b** along the streambed, and **c** on the beach in closer view (photos in insets (**b**, **c**) were provided by eyewitnesses)

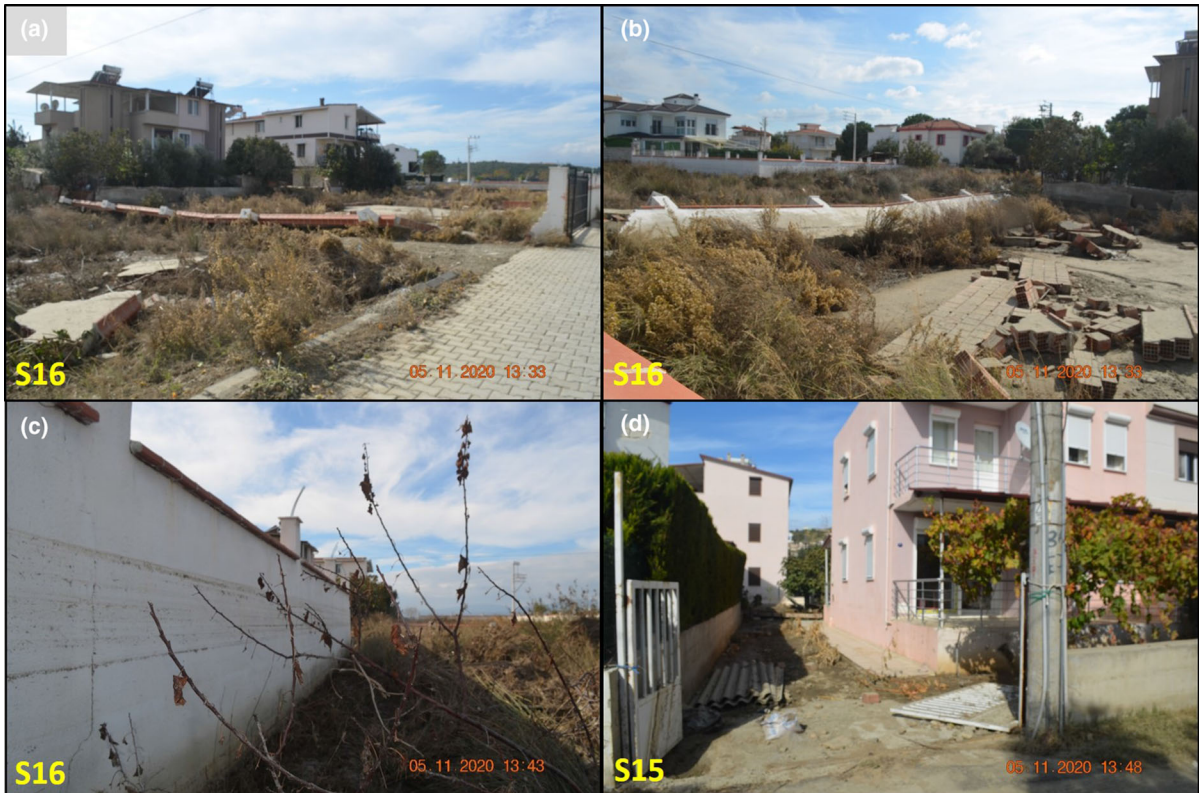
Figure 10

(Table 2-S19). The tsunami also caused significant damage to properties and houses at that location, leaving injured locals who barely survived the tsunami (Fig. 10a–d).

Observed damage on garden walls and summerhouse garden entrances at low-lying maximum inundation area in Sığacık locality **a–c** at point S16, **d** at point S15

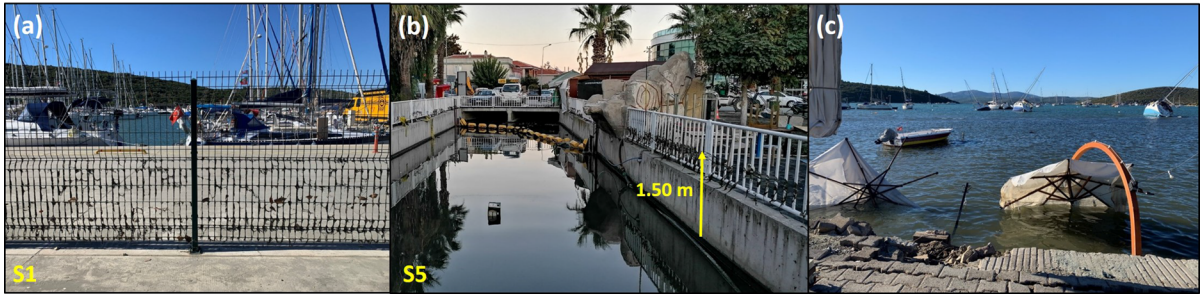
Figure 11

connected to the sea inside the marina and flooded the surrounding area with a flow depth of 0.5 m (1.5 m in the streambed) (Fig. 11b, Table 2-S5). At another local stream, further northeast from Teos Marina, the tsunami penetration caused a 1.5 m water level rise from the streambed ground overflowing the small bridge at the upstream, according to eyewitnesses (Table 2-S11). Figure 11c shows damaged boats and seafront facilities on the Sığacık coastline.

a Tsunami traces on the garden fence of Teos Marina (S1) corresponding to a flow depth of 0.9 m. **b** Tsunami flood traces on the iron fences of a local river, connected to the sea inside Teos Marina, found at ~ 210 m inland with a flow depth of 0.5 m (1.5 m in the riverbed). **c** Damaged boats and seafront facilities on Sığacık coastline

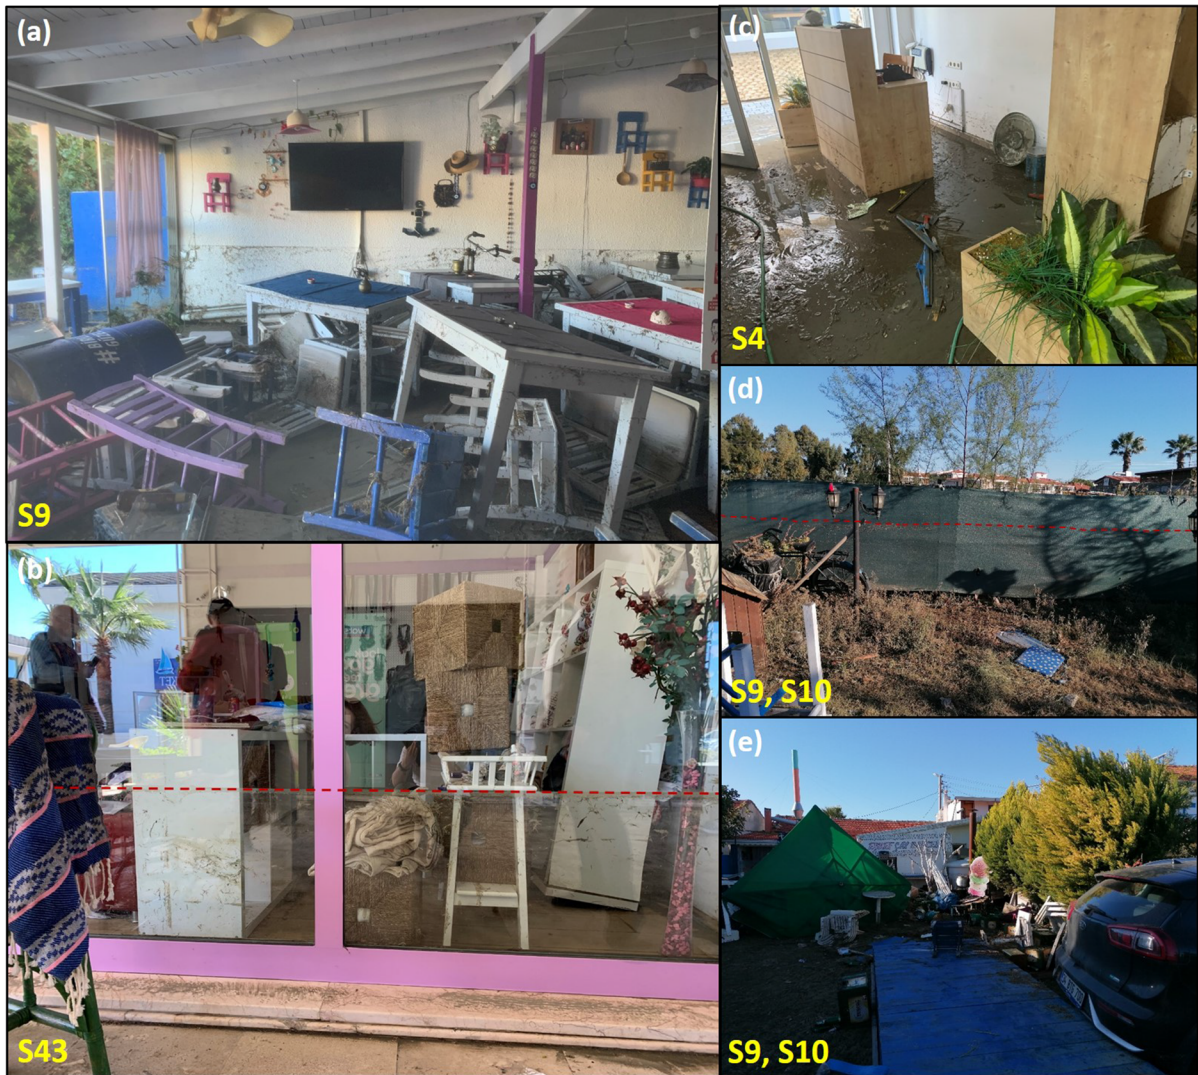
Figure 12

Kaleiçi region, located along the coastline with many cafes and shops, was heavily damaged (Fig. 12a–e). We examined the incoming tsunami dynamics in Kaleiçi from a security video recording (Appendix 3 Fig. 22). According to our inferences, the maximum sea withdrawal occurred ~ 13 min after the earthquake, while the first positive wave arrived at ~ 18 min.

Heavily damaged cafes and shops in Kaleiçi region in Siğacık locality at points a S9, b S43, c S4, d, and e S9–S10

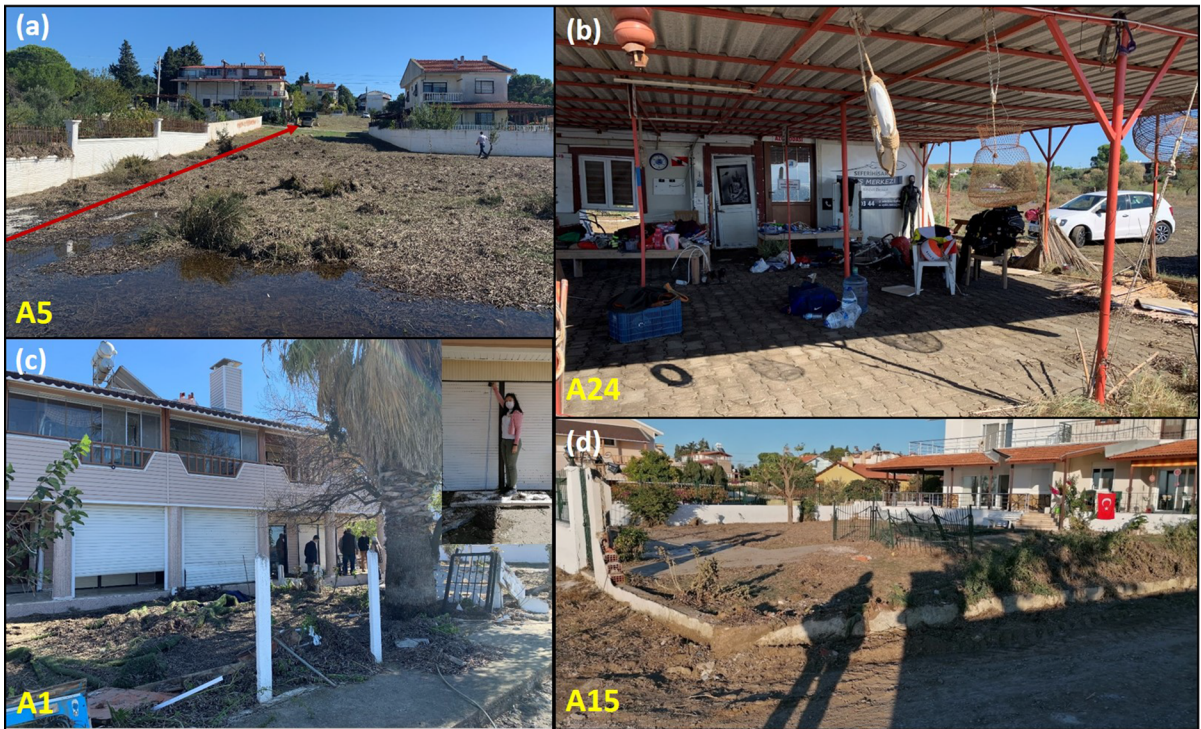
Figure 15

Seferihisar Diving Center, located in the central part of Akarca, was severely damaged by the tsunami with a flow depth of 2.2 m (Fig. 15b, Table 2-A24). Here, the sea receded ~ 180 m to a depth of ~ 4 m. The diving center owner stated that he was drifted by the incoming wave to 200–250 m inland on a sofa and barely survived the tsunami. The inundation distance here reached 280 m. He described the first wave's arrival time as 10–12 min after the earthquake, observing four to five waves with 8–10 min between successive waves.

The garden fences and walls of the shore-facing summer houses also had notable damage (Fig. 15c–d, Table 2-A15). We measured 1.9 m splash height on a vertical wall of a house located just near the shore (Fig. 15c, Table 2-A1). A boat was dragged 90 m inland by the tsunami (Fig. 16a, Table 2-A6), where a car (~ 55 m) and a water storage tank (half full) were also dragged inland by the strong waves (Fig. 16b–d, Table 2-A3).

Observed destruction on properties and tsunami debris at summerhouse gardens in Akarca **a** tsunami deposits observed at maximum runup (3.8 m) (A5), **b** destruction in Seferihisar Diving Center where 2.2 m flow depth was measured (A24), **c** destroyed concrete garden walls of a summerhouse (A1) (1.9 m splash height measurement is shown on the upper-right inset), **d** destroyed iron garden fences of a summerhouse (A15)

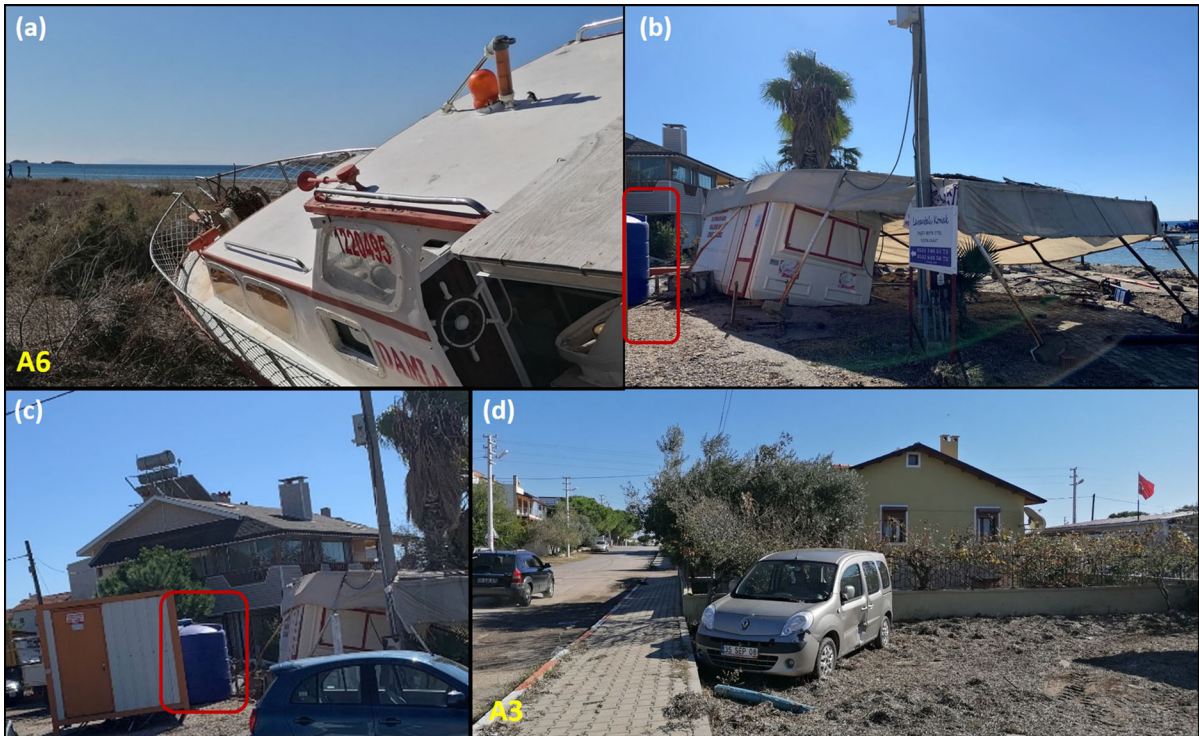
Figure 16

a A boat dragged 90 m inland in Akarca (A6). **b** Damaged shore-facing structures in Akarca fishery port area. **c** Half-full water storage tank (in red rectangles) dragged from the shoreline. **d** A car dragged 55 m inland and damaged by the tsunami at point A3

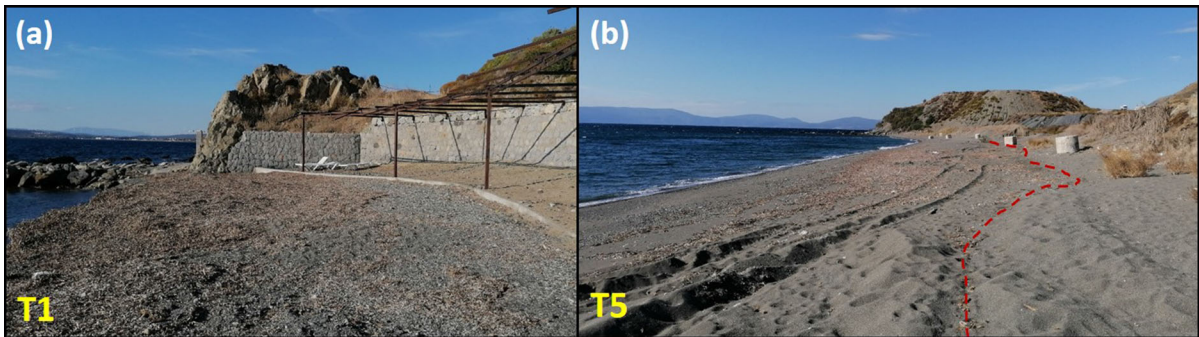
Figure 17

a Sweep deposits found at points **a** T1 and **b** T5 in Tepecik locality, where the tsunami inundation and impact was limited to these small inundation areas. The red dashed line indicates the estimated inundation border at point T5 according to the sweep deposits

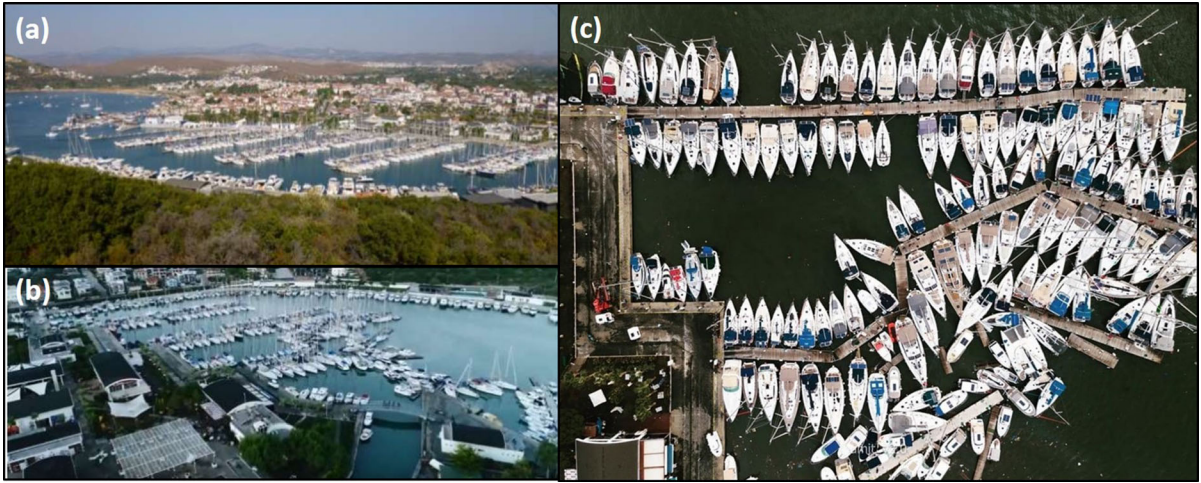
In Teos Marina (Fig. 8), four piers out of six (composed of floating pontoons) were displaced, and more than 320 boats were moved (some boats sank, and some were moved outside the marina by the tsunami). Figure 18 shows the Teos Marina's layout and the boats before (Fig. 18a) and after (Fig. 18b–c) the tsunami. There is a stream inside the marina (Fig. 8) through which the tsunami penetrated and inundated Siğacık town. The backflow of inundation through the local stream discharging to the marina basin seems to be the primary cause of the strong currents and associated damage in Teos Marina.

View of Teos Marina layout **a** before and **b** after the event with damaged pontoons (taken from a local newspaper, <https://www.sabah.com.tr/video/yasam/depremin-merkez-ussu-seferisar-sigaciktaki-tsunami-felaketi-havadan-boyle-goruntulendi-video>), and **c** after the event taken by a drone showing the damaged pontoons and boats (provided by a boat owner in the marina)

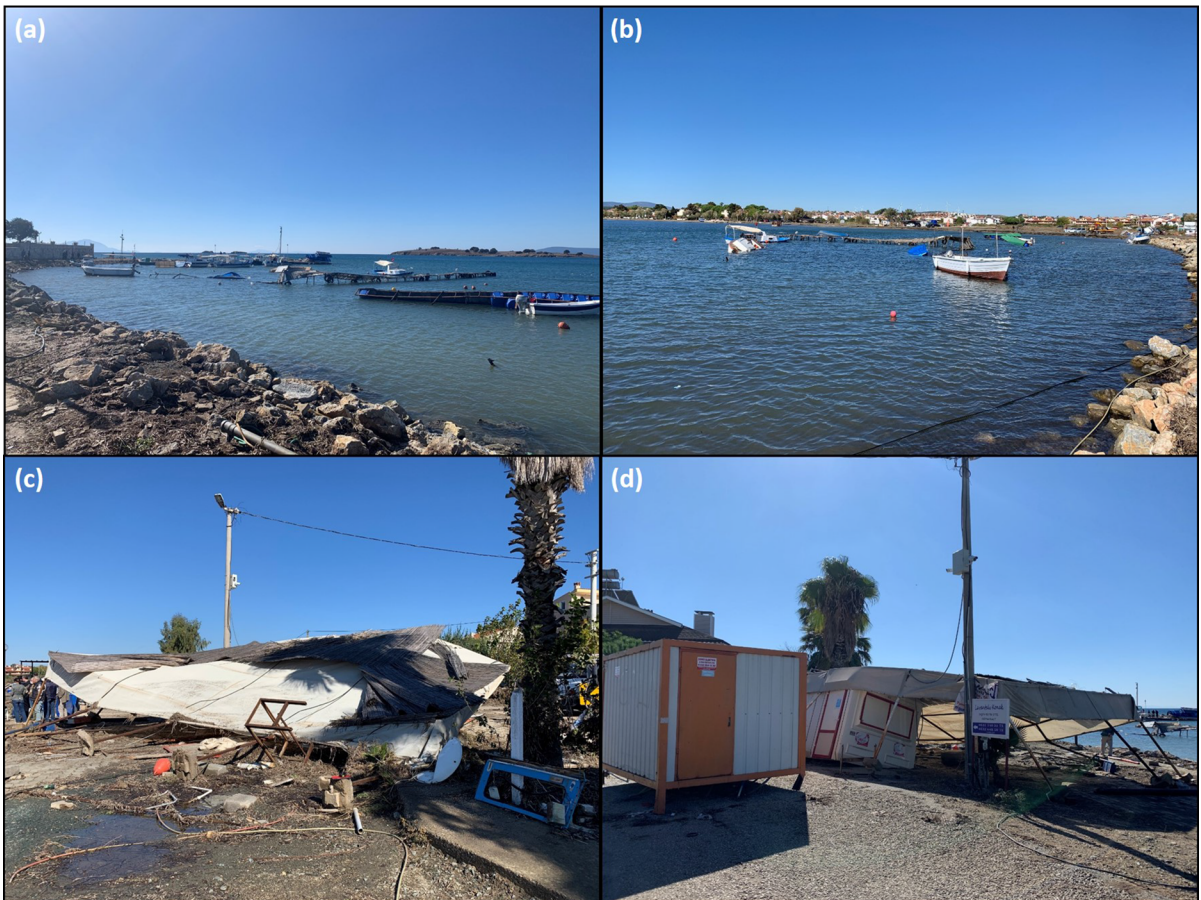
Figure 19

The small fishery port in Akarca suffered substantial damage. All of the floating piers (Fig. 19a–b) and many port facilities (Fig. 19c–d) were destroyed and became unusable. More than 20 boats were sunk, as reported by the Akarca fishery cooperative president.

Observed damage in **a**, **b** the floating piers used for berthing and mooring, and **c**, **d** the seafront harbor facilities in Akarca fishery shelter

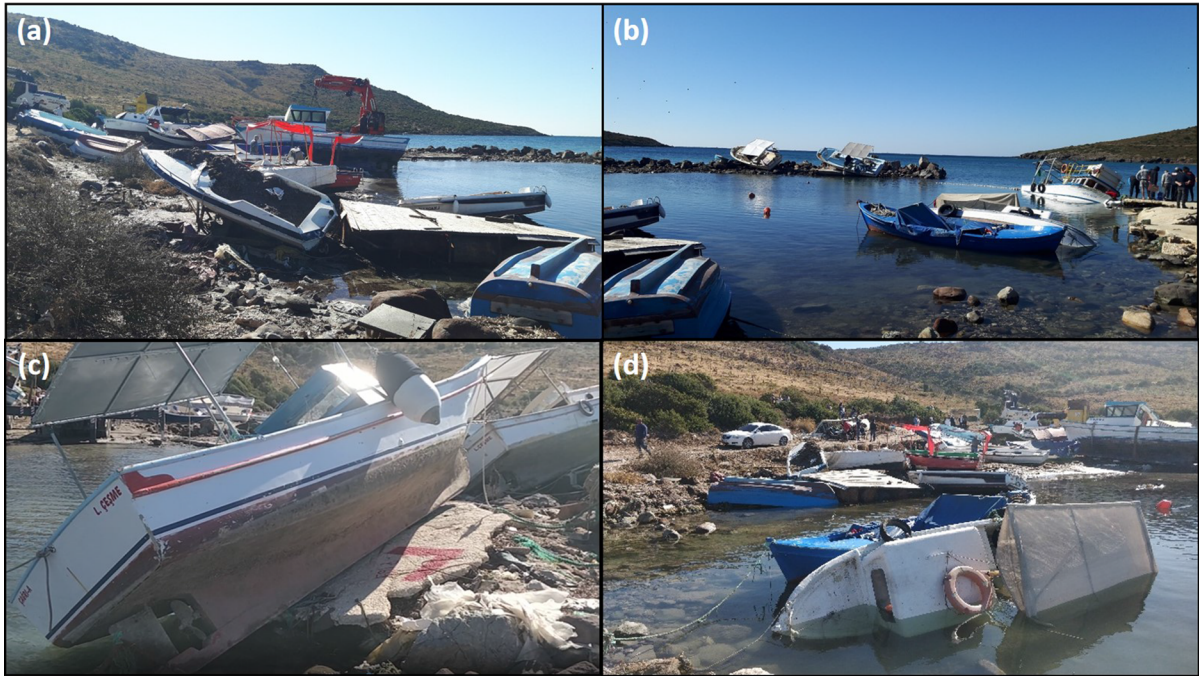
Figure 20

We also observed severe tsunami damage at another small fishery shelter in Zeytineli (Fig. 20).

Photos showing heavy damage in Zeytineli fishery shelter where all of the boats and mooring facilities were unusable after the tsunami

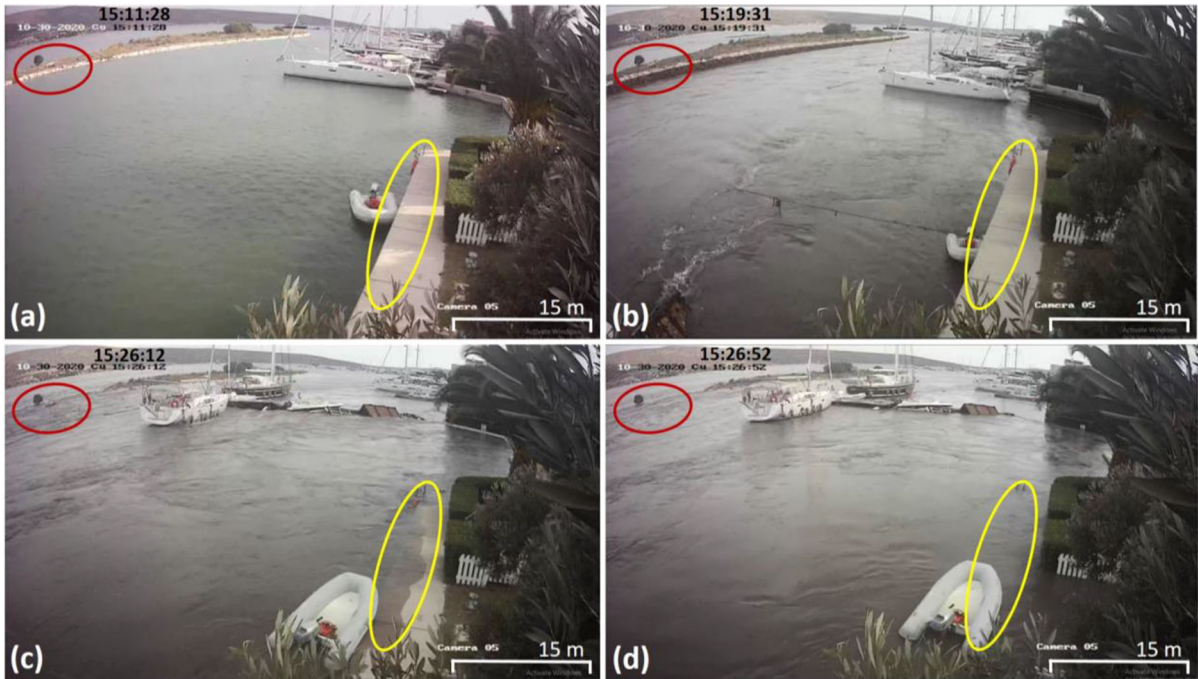
Figure 21

Security video frames showing different stages of the tsunami motion in the Port Alaçati houses, Alaçati, Fig. 3a (38.2592° N, 26.3797° E). Timestamps are in local time (GMT + 03:00), and the earthquake time is 14:51:23 (AFAD 2020). **a** No water motion 10 min after the earthquake, **b** maximum water withdrawal (~ 1.50 m), the white boat started to move from its original location, **c** start of inundation, the white and adjacent boats, and the small berthing structures were moved and damaged, and **d** maximum water level increase (~ 1.70 m) and inundation in the region. Red and yellow ellipses show water level changes at specific locations, around the small tree over the middle breakwater and quay floor, respectively

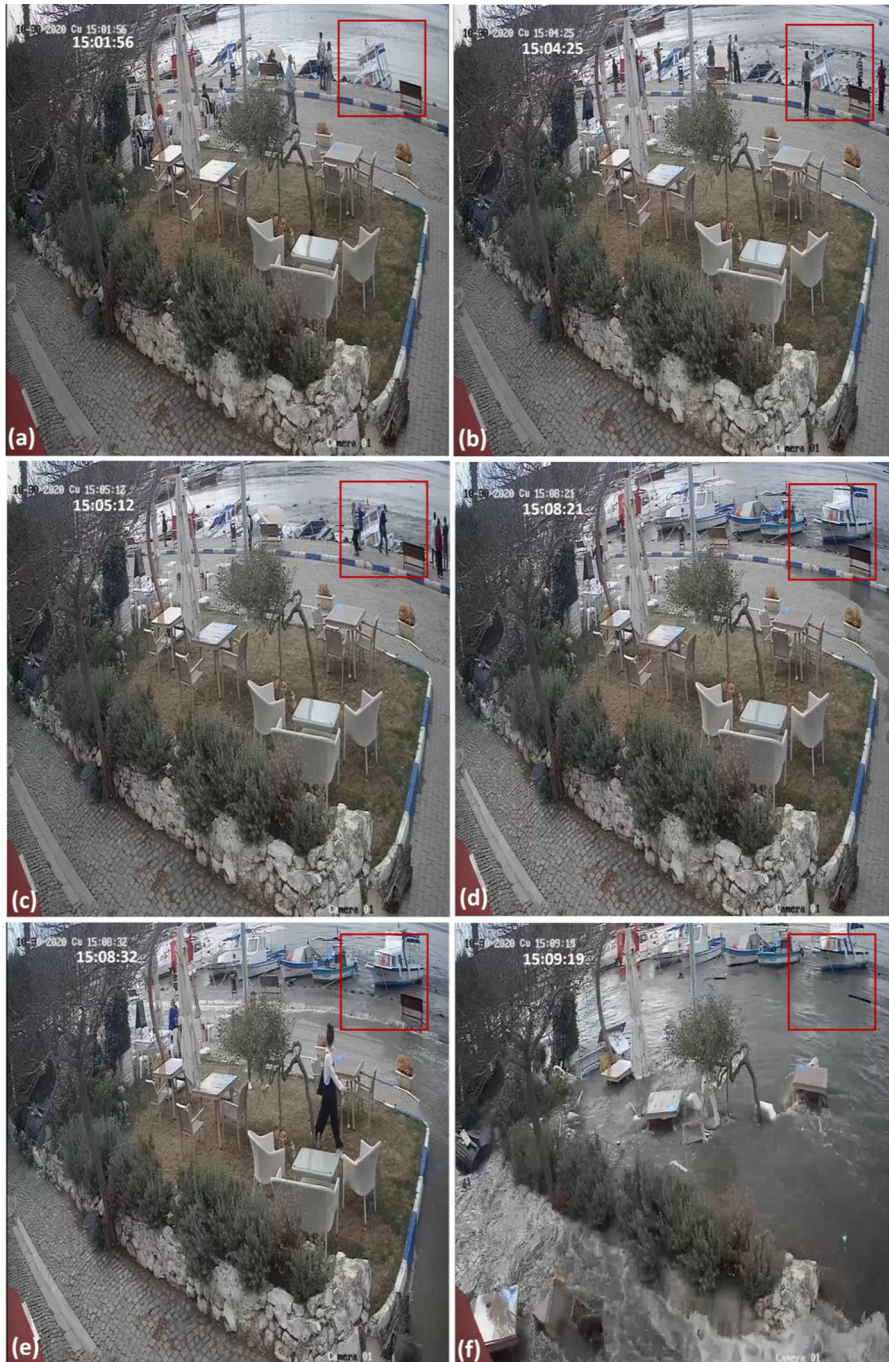
Figure 22

Security video frames showing different stages of tsunami motion in the Kaleiçi region of Sığacık (38.1953° N, 26.7856° E). Timestamps are in local time (GMT + 03:00), and the earthquake time is 14:51:23 (AFAD 2020). **a** Start of water motion, **b** maximum sea withdrawal, **c** start of the incoming wave, **d** start of inundation, **e** significant inundation, and **f** maximum inundation in the pedestrian road. The red rectangles show (i) the boat movement in all frames due to water level change, (ii) the emerging seabed material due to sea withdrawal in the frame (**b**), and (iii) the disappeared sidewalk and bench in frames (**e**, **f**) due to inundation
