## Stress fracture of femoral stem of hip resurfacing a cause of sudden onset hip pain- A case report and review of literature

Hemanta Das\*, Tahawwar Minhas, Rohit Rambani

Department of Orthopaedics, Pilgrim Hospital, United Lincolnshire Hospital NHS Trust, UK

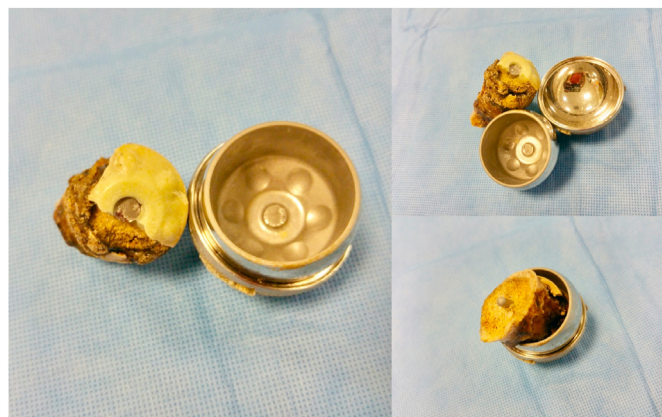
The revision surgery was performed 4 months following the onset of her symptoms. A posterolateral approach was used. Operative findings were – 200 mls clean fluid, small necrotic tissue, bone atrophy under the femoral component, soft bone, poor abductors & a broken peg. The stem of the femoral component was fractured at its junction with the dome, the dome being still well fixed with the femoral neck (Fig. 2). The acetabular component was well fixed; it was explanted & revised with a 54 mm uncemented cup using supplementary bone autograft. The femoral neck was cut & a primary uncemented stem was used. A 36mm ceramic femoral head with highly crosslinked polyethylene liner were used as

Fig. 2. Retrieved implants showing fracture of the femoral stem with the stem well fixed within the femoral neck.

Examination of the removed specimens revealed an absence of ‘beach lines’ those are indicative of failure of the material over a prolonged period.<sup>2</sup> Instead we observed only a notched area of bending on the medial side of the implant. This is indicative of an acute event.

It was noted from immediate post-operative radiographs that there was a slight notching of the implant at the lateral femoral neck. If this had indeed increased abnormal stress through the implant, the expectation was a fatigue failure within 6–16 weeks.<sup>2,7,8</sup> This did not happen for 9 years. On the other hand, the implant did fail without significant trauma, and likely as an acute event. Although not conclusive of the exact mechanism of failure, there are several possibilities for the cause of failure of the implant. It is likely to be multifactorial. There is little doubt that a trivial trauma has caused the implant to fracture and became symptomatic with pain. Our hypothesis is: There could have been bone resorption at the bone – cement interface, causing loosening and progression to the cement – implant interface too. Repeated microtrauma would have aided the loosening. This may have led to the dome slowly becoming loosened while the peg staying well fixed. The supposed trivial trauma is likely to have caused enough shearing force going across the joint leading to its failure.

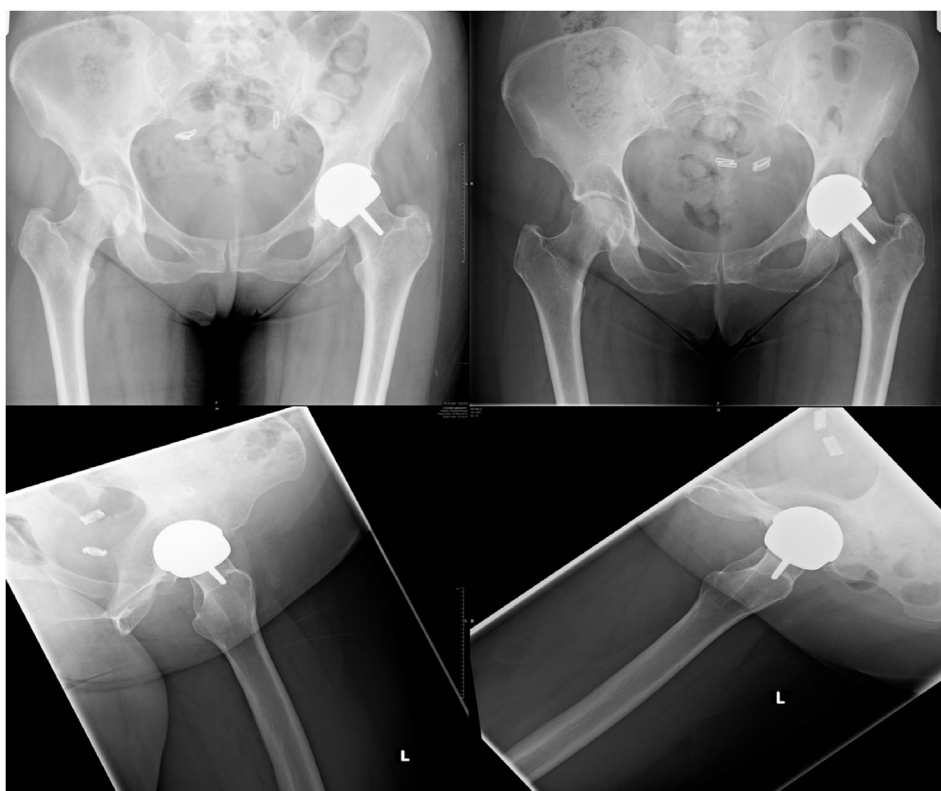
On a particular day in 2015 she experienced an acute pain in the hip as she was walking. The pain was unremitting & affected her mobility, requiring her to use a walking stick. The pain was in her left groin & anterior thigh. She felt the left leg to be shorter. Serial radiographs before & after the onset of symptoms did not reveal any significant abnormality. She had a presumed slight superior 'notching' from the very first post op radiographs that did not alter with time. We performed a MRI scan, which did not suggest any adverse features. Metal ion levels were rechecked – Cr level was marginally above normal, with a Co level within normal limit. A decision was made by the senior surgeon to revise the resurfaced hip suspecting an acute injury, most likely a fractured neck femur within the femoral component (Fig. 1).

Fig. 1. Top left and Bottom left- AP and lateral x-ray of the pelvis and left lateral hip one year after surgery  
Top right and Bottom right- AP and lateral x-ray of the pelvis and left hip at the time of patient becoming symptomatic.
