A case-driven hypothesis for multi-stage crack growth mechanism in fourth-generation ceramic head fracture

Stefano Lucchini¹, Massimiliano Baleani^{2*}, Federico Giardina¹, Andrea Martelli², Francesco Castagnini¹, Barbara Bordini² and Francesco Traina¹

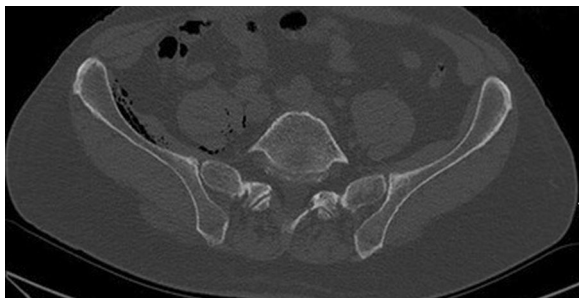
Fig. 1 An axial slice of a CT showed the gas flap between ilium and the iliopsoas muscle in the right hip

1. In Case 1, CT images show the presence of gas trapped between ilium and iliopsoas muscle, which disappeared after revision surgery. It cannot be excluded a priori that the generation of gas might be related to products released by the bore–taper interface [33, 34], which had undergone severe damage in the last phase prior to head fracture. However, no specific analyses were performed on the 12/14 male taper to investigate this issue, which deserves further investigation;
2. The two cases here presented involved a modular neck hip prosthesis. At a first glance, it could be speculated an association between fracture of ceramic heads and designs including modular necks. However, it must be highlighted that about 44% of the 29,495 CoC implants have a modular neck design increasing the probability of head fractures in modular neck designs in the analysed records.

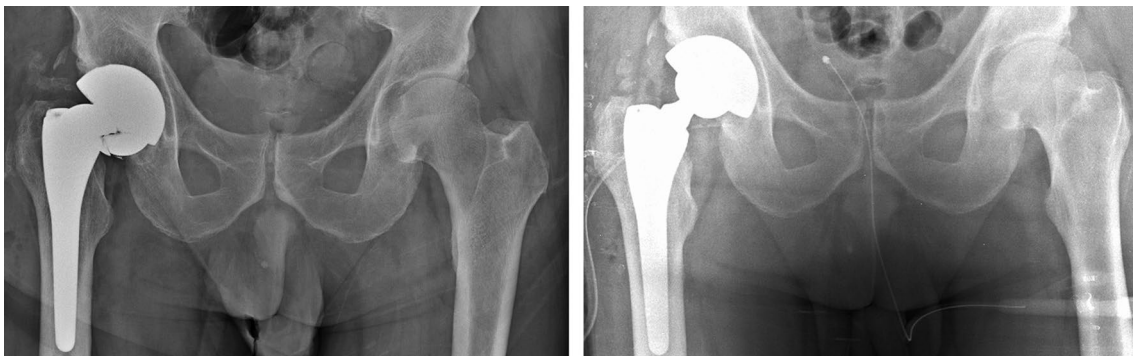
After two days, the patient returned to our emergency room: he complained of pain and could not weight-bear. The patient reported that he perceived an audible “pop” while walking followed by sudden pain in the prosthetic hip. Due to pain, he sustained a direct trauma on his right hip. The patient had no history of falls or trauma in the 12 months prior to femoral head fracture. Pelvis X-ray showed mechanical failure of the femoral head (Fig. 2).

Fig. 2 Left: preoperative X-ray showing mechanical failure of ceramic femoral head. Right: postoperative X-ray after components replacement

Revision surgery was performed replacing the fractured ceramic head, the ceramic liner and the modular neck with new identical components (Fig. 2). No signs of metallosis were observed near the implant intraoperatively at gross examination. Prosthetic joint infection was excluded by peri-prosthetic tissue culturing. The patient had a complete functional recovery, and no further complication occurred at 8.1 years of follow-up.

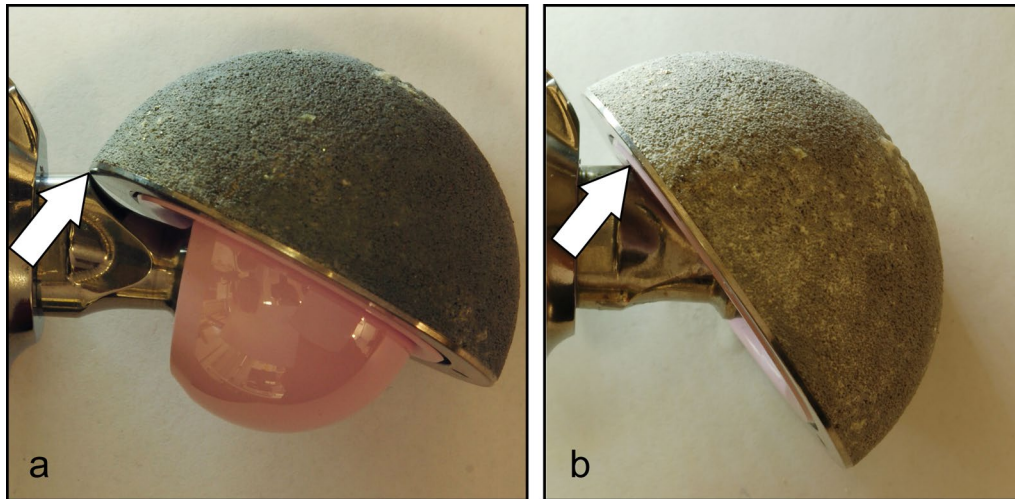
Fig. 4 **a** Impingement between the acetabular cup and the neck with the intact ceramic head. The lateral side of the neck impinges on the metal shell (white arrow). **b** Impingement between the acetabular cup and the neck without the ceramic head. The lateral side of the neck impinges on the ceramic liner (white arrow)

In the present study, the aforementioned damages were neither observed in retrieved components (remark: small rim chipping observed on the retrieved liner was due to impingement of the femoral neck subsequent to head fracture) nor reported in the clinical record of Case 2. Conversely, analysis of retrieved components of Case 1 suggests that ceramic head might fracture under severe in vivo conditions leading to repeated impact load within the bore. Indeed, the fragment appearance of the

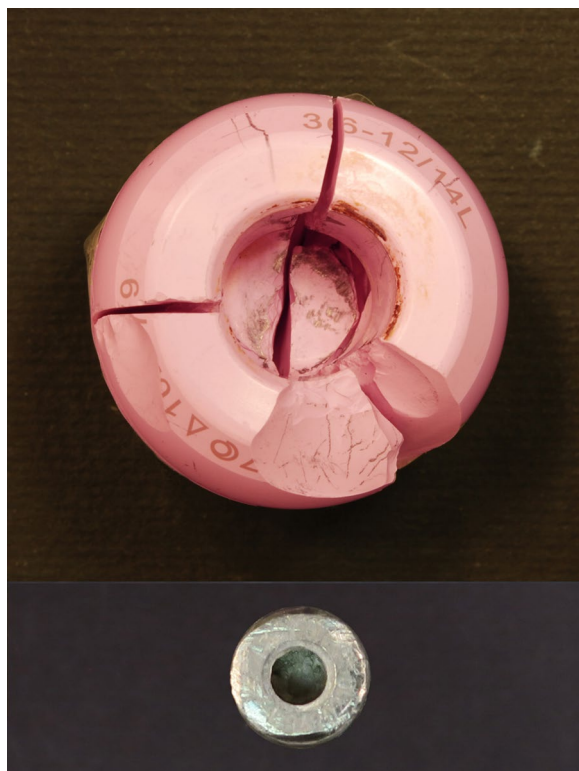
Fig. 5 Top: Main fragments of the fractured ceramic head (caudal view). Black stains are visible at the top of the head bore. Bottom: 12/14 male taper (cranial view). The taper cross section is irregular in shape and smaller in size than that of a new taper. The top of the taper is damaged

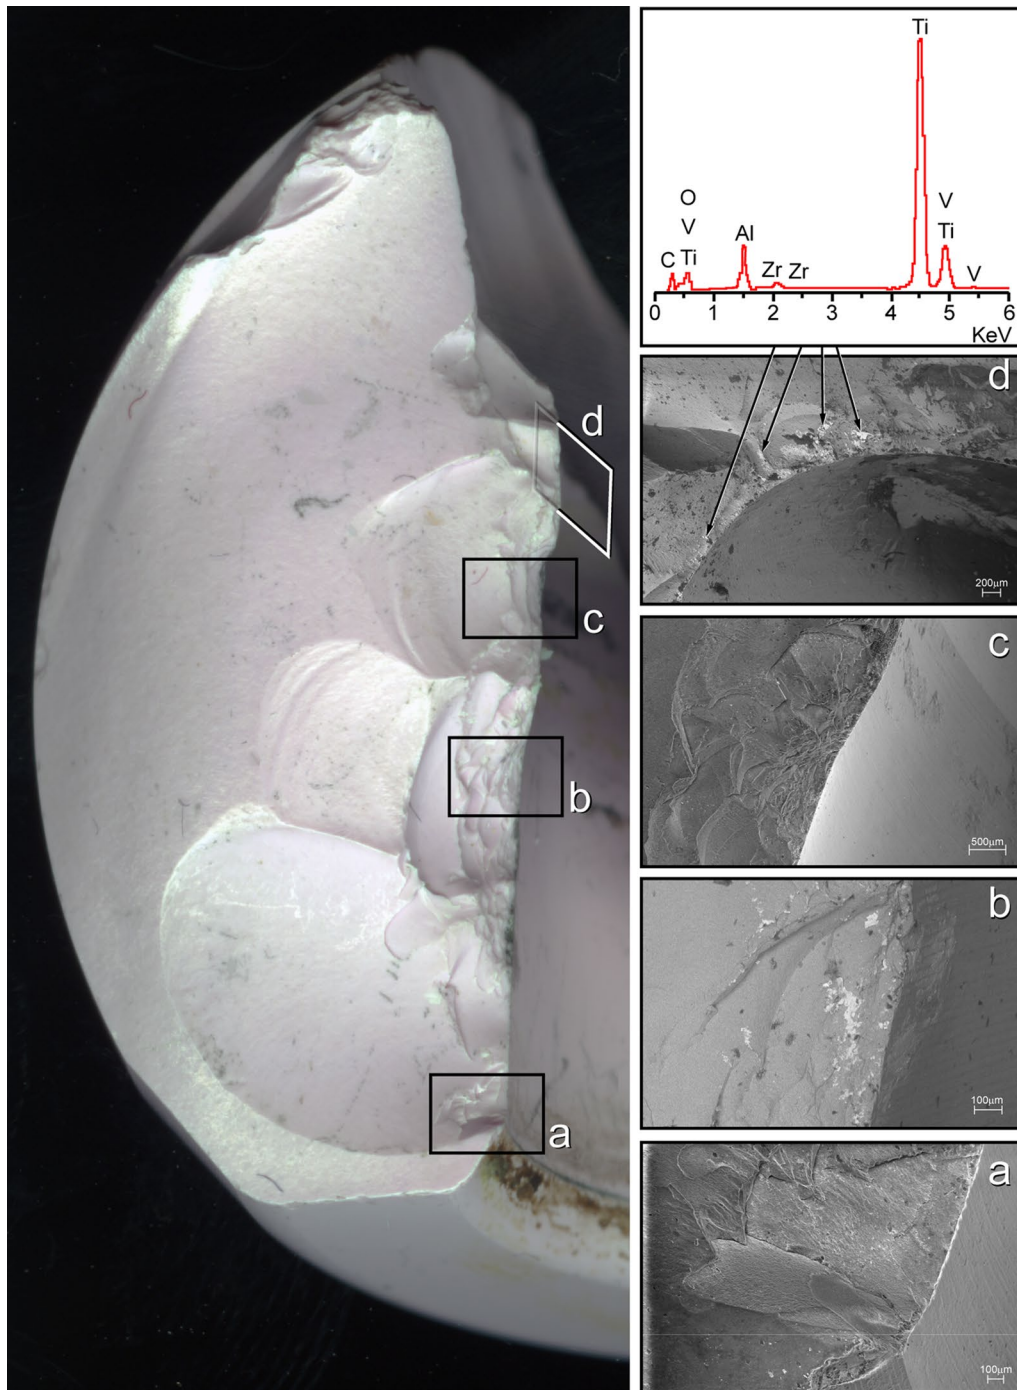
However, fracture surface features suggest that fracture originated at the lower level of the bore–taper contact, radiating outwards and upwards (Fig. 6). Several secondary cracks were found at the level of the proximal end of

the neck taper, which gradually shifted towards the top of the head bore (Fig. 6). Indeed, secondary cracks were found at the corner of the head bore (Fig. 6). Chipping, associated with the transfer of Ti-alloy, was found on the bore surface near secondary fracture origins. SEM-EDX analysis revealed the presence of titanium particles spread on or scattered over the fracture surface. Titanium particles were found on smooth and semielliptical regions of the fracture surfaces (Fig. 6).

Fig. 6 Left: fracture surface of the main fragment. **a** Possible origin of the ceramic fracture. **b** Secondary crack originated at the level of the proximal end of the neck taper. **c** Secondary crack originated at the level of the proximal end of the neck taper following to the first shift of the taper. **d** Secondary crack originated at the level of the proximal end of the neck taper following to the second shift of the taper (note: the tip of the taper impacts to the top of the head bore). EDX spectrum revealed that particles on the fracture surface are made of Ti-alloy

1. Radial vertical microfractures originated at the lower engagement level due to localized high stress areas. Different causes might have contributed to generate the undesired high stress areas, such as angular taper mismatch, incomplete seating, fretting-corrosion of the 12/14 male taper or a combination of these. Although no history of previous falls or remarkable trauma was found in clinical records, it cannot be definitively excluded that the patients had minor trauma. Whatever the root cause is, it seems likely that titanium taper and ceramic bore damage occurred simultaneously, determining progressive increase in the amplitude of the pistoning/rocking micromotion of the head along/about the neck. Neck damage allowed progressive taper shift towards the top of the head bore. This shift changed the loading condition of the ceramic head, stopping the propagation, if any, of the microfractures located at the original lower engagement level;

2. Head catastrophic fracture occurred due to pistoning of the head over the neck due to gross relative motion allowed by damaged 12/14 male taper. Indeed, repeated impacts of the head bore to the taper tip promoted the nucleation of additional radial vertical fatigue fracture that propagated until catastrophic fracture occurred without a concurrent or previous remarkable trauma.

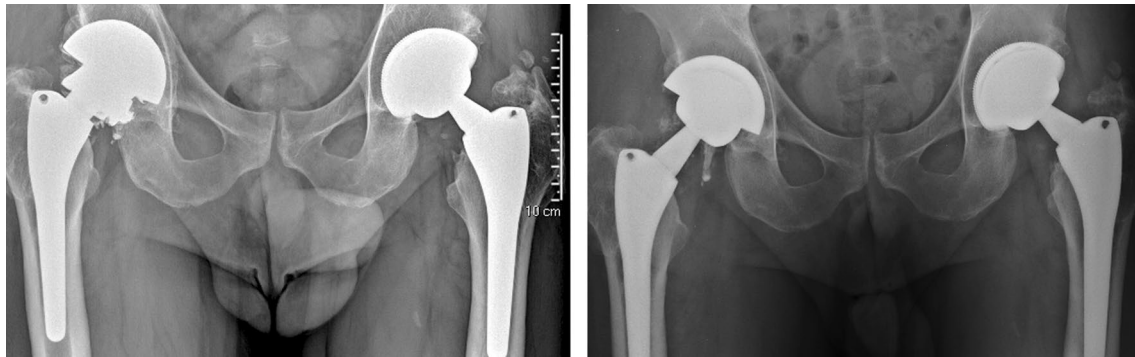
Fig. 7 Left: preoperative X-ray showing mechanical failure of ceramic femoral head. Right: postoperative X-ray after components replacement

a ceramic femoral head (Biolo^x® Delta 40 mm medium neck), a ceramic liner (Biolo^x® Delta 40 mm) and a modular neck with valgus and increased offset configuration

(Modula OZ), respectively (Fig. 7). The patient had a complete functional recovery, and no further complication occurred at a 5.5-year follow-up.
