Brief Report

A Brief Report on the Collapse of Self-Built Houses on 29 April 2022, in Changsha, China

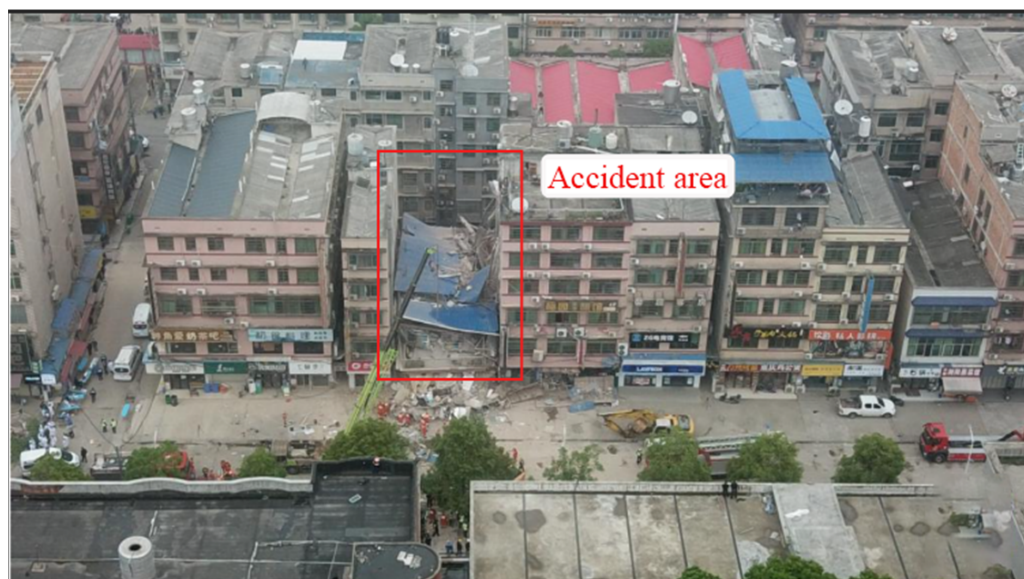
Figure 3. Photo of the collapse site.

At around noon on 29 April 2022, this self-built house in Wangcheng District collapsed instantly, raising a sky full of dust. After the building collapsed, the walls' debris piled up two stories high. According to a report on 6 May, the search and rescue work at the site of the “4.29” particularly significant resident self-built house collapse in Changsha City has been completed, with a total of 10 people rescued and 53 dead at the accident site [18].

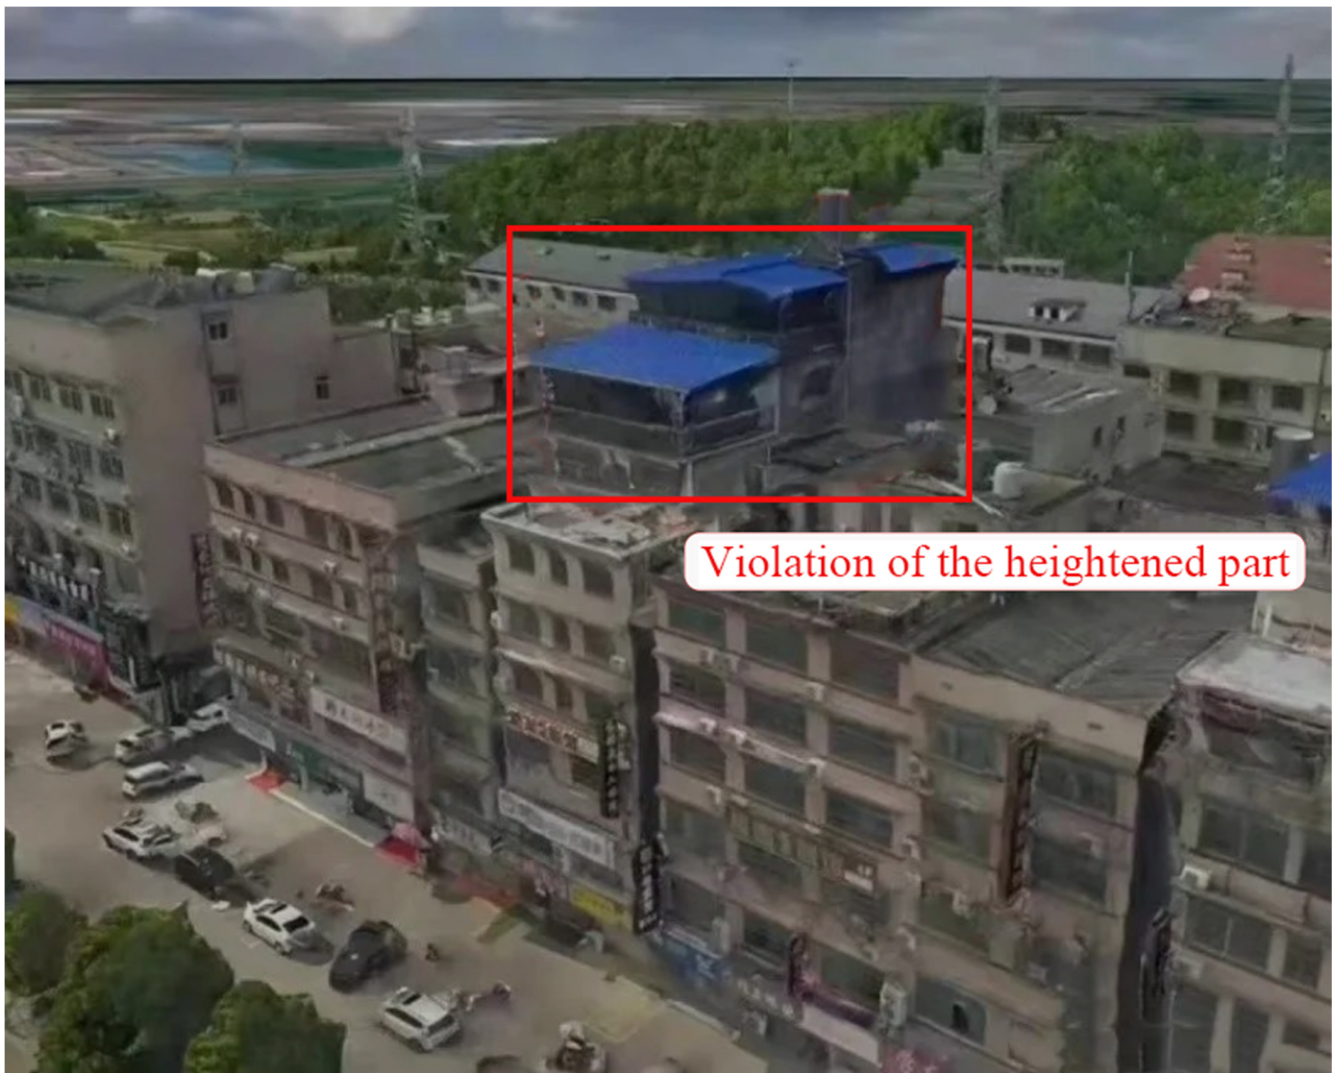
Similar to many previous collapses, photos of the building before it collapsed can be quickly found online to analyze the original structure of the building. As shown in Figure 5, the building appears to have been topped with a two-story attic by the owner, resulting in a total of eight (or seven and a half) stories. Figure 6 illustrates how the owner's self-built house has become taller over the past decade. This self-built roof covering is not an isolated phenomenon. The covered floors are colored steel tile roofs. This material is easy to construct and inexpensive. Even if violations are found and need to be removed, it causes little economic damage compared to reinforced concrete and is used by many homeowners. However, while covering, it can also bring significant safety risks, quickly leading to uneven settlement of the foundations, and collapse. Similar incidents had occurred in many places before the collapse of self-built houses in Changsha. [20].

Figure 5. Collapsed building original structure.

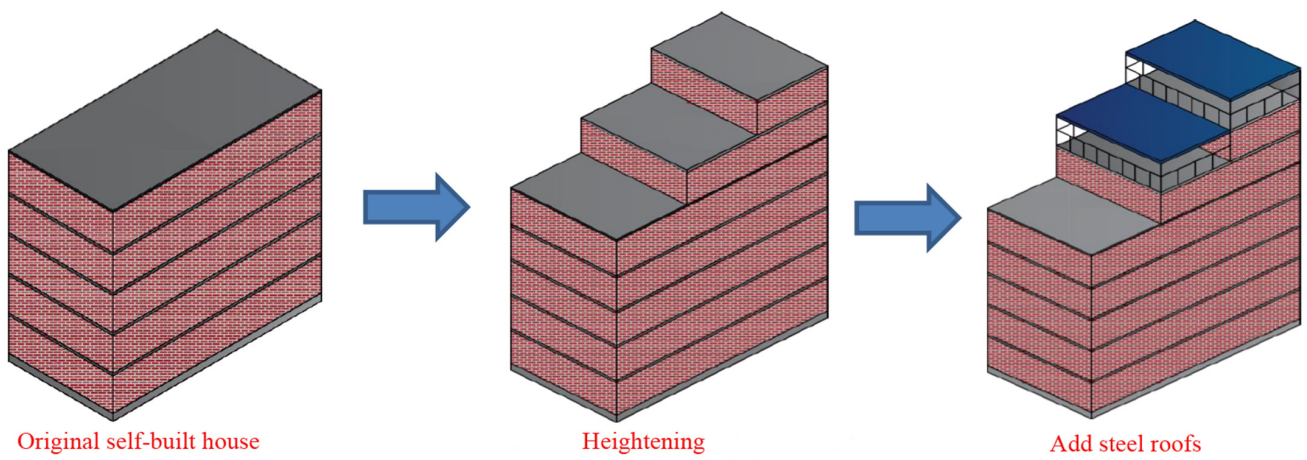
Figure 6. Remodeling of the self-built house over the past decade.

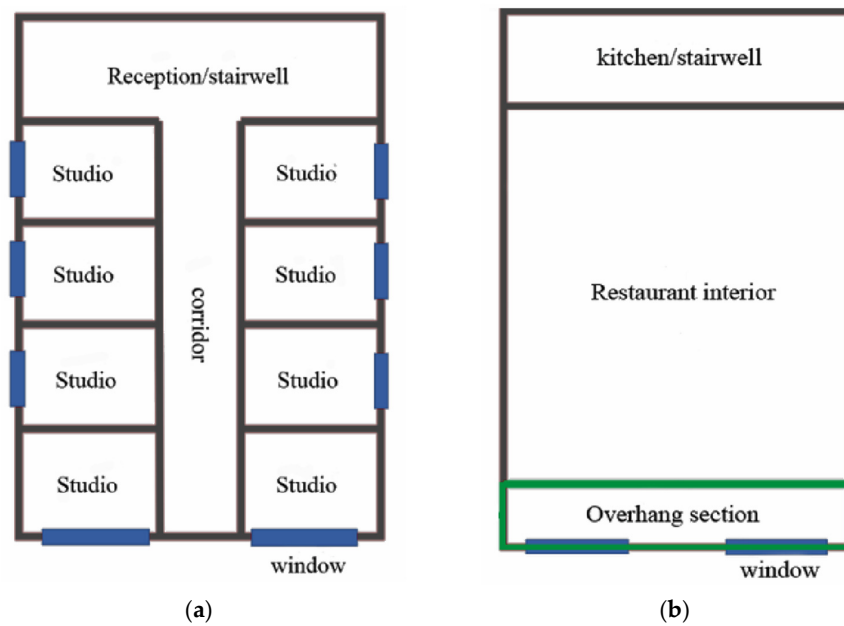
By analyzing the internal structure of each floor from the bottom up, it is known that the building has corresponding structural hazards. Since the corresponding internal structural layout was not found from the bottom up, the style of similar buildings in the surrounding area was analyzed to infer the structural characteristics of the original building. As seen in Figure 7a, no apparent beams and columns were found in the internal structure of the building on the 4–6th floors, which are all brick and concrete structures. However, when we walk to the dining room on the 2nd floor, we can find the corresponding transverse structural beams on the top but no longitudinal structural beams. This leads to the transfer of forces from the transverse load-bearing beams directly through the brick masonry to the floor, and this collapse occurs when the load is high, as can be seen in Figure 7b [21].

Figure 7. (a) Internal structure diagram of layers 4–6; (b) The internal structure of the restaurant on the 2nd floor.

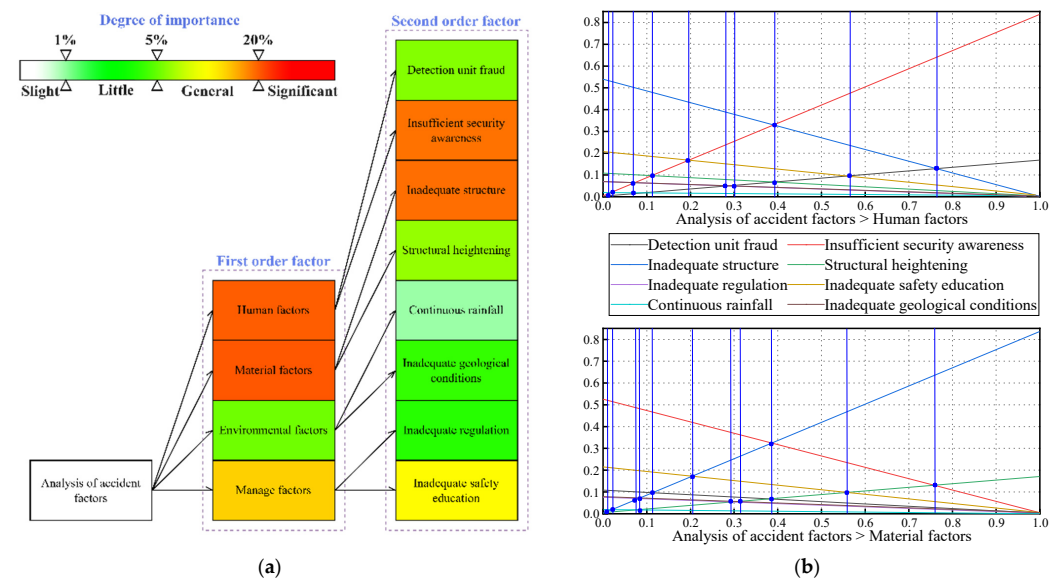
Hierarchical analysis (AHP) is a standard accident analysis method combining qualitative and quantitative methods to calculate the weight of each factor. In this report, the factors of accident causes were extracted from the accident investigation report and summarized from four aspects: human factor, material factor, management factor, and environmental factor. The factors summarized are: Detection unit fraud, Insufficient security awareness, Inadequate structure, Structural heightening, Inadequate regulation, Inadequate safety education, Continuous rainfall, and Inadequate geological conditions. In this report, 10 experts—including scholars, field engineers, and designers—were invited to score the relevant factors. The weights of each factor can be calculated by combining different experts' scores (see Table 2) with yaahp software, as shown in Figure 9a. Among them, the judgment matrix's consistency (CR) test is required. These data's consistency index (CR) is 0.0454 < 0.1, so they meet the consistency requirement. Based on the hierarchical analysis (AHP) results, a fuzzy comprehensive evaluation analysis was conducted and the degree of importance of different factors was obtained, as shown in Figure 9a.

Sensitivity analysis can determine the impact that a change in a factor’s weight has on the overall weight. This report focuses on sensitivity analysis through V12.9 version of Spssau software. The degree to which the uncertainty of each element affects the target is examined by holding all other factors at their baseline value [25]. The analysis reveals that Insufficient security awareness and Inadequate structure have the most significant impact on the weights (see Figure 9b). This shows that the related analysis method learns that people’s awareness and building structure have the most critical influence. This provides an essential direction for the development of future preventive measures [26–28].

Figure 9. (a) The analytic hierarchy process method derives the weight of each influencing factor; (b) Analysis of sensitivity for human factors and material factors [29].
