Helix-fixation leadless pacemaker delivery catheter reeling in intracardiac tissue and becoming stuck: A case report

KEYWORDS Leadless pacemaker; Complication; Tricuspid valve; Helix-fixation; Catheter stuck
(Heart Rhythm Case Reports 2024;10:479–482)

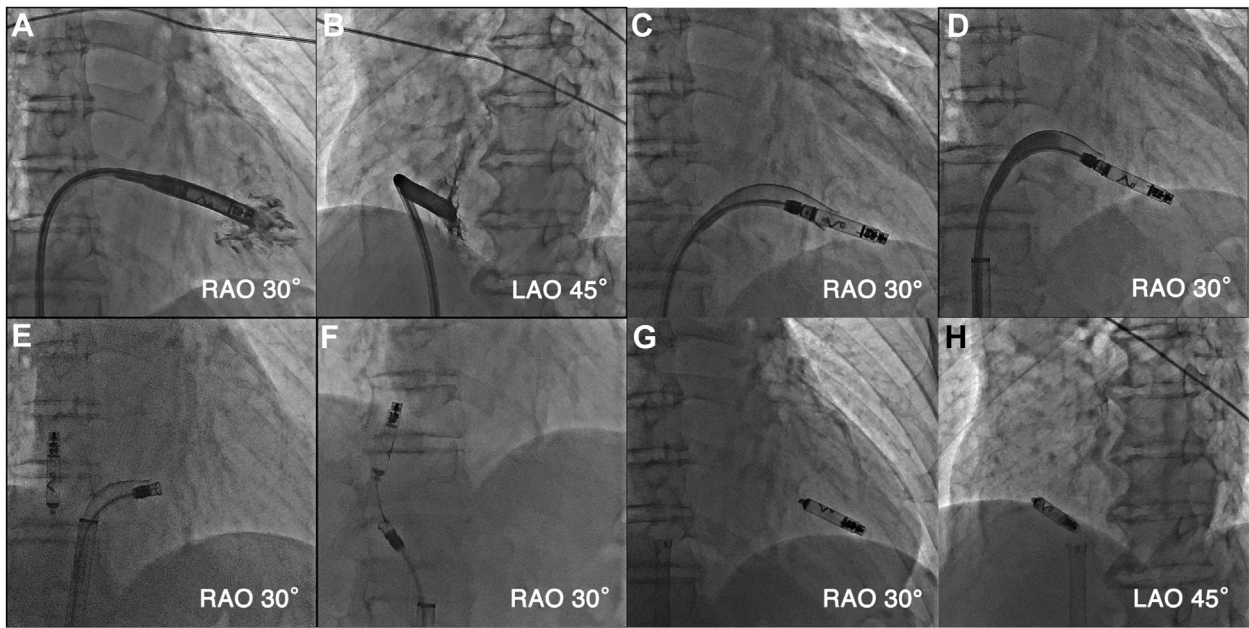
A 74-year-old man was referred to our department for syncope. He had a history of an extensive encircling pulmonary vein isolation 3 years prior. His Holter electrocardiogram showed atrial fibrillation accompanied by sinus arrest for 5 seconds. The patient was diagnosed with syncope due to sick sinus syndrome, and the implantation of an Aveir VR LP (Abbott Medical, Chicago, IL) was scheduled. First, the LP was deployed onto the apical septum (Figure 1A and 1B). However, the pacing threshold was unacceptable even after waiting for 5 minutes; thus, the operator attempted to recapture the device and change its location. The protective sleeve did not advance beyond the middle of the device (Figure 1C and Supplemental Video 1). The rotational handle was rotated counterclockwise. However, although the chevron marker rotated, the system became stuck and could not be removed. Additionally, the protective sleeve retracted after it was rotated counterclockwise and it could no longer be advanced beyond the docking cap (Figure 1D and Supplemental Video 2). We assumed that the helix was fixed

to the myocardium. Thus, we then released the LP and attempted to extract the delivery catheter. However, the LP migrated into the right atrium immediately after it was released. Contrarily, the delivery catheter became stuck around the tricuspid annulus. The delivery catheter, not the LP, was trapped and stuck in the intracardiac structures (Figure 1E). Hence, a surgical removal of the delivery catheter was considered, but the catheter was successfully removed when the handle was rotated clockwise (Supplemental Video 3). It was assumed that the tissue had coiled around the catheter by the counterclockwise rotation and was loosened by the clockwise rotation, allowing the catheter to be retrieved. The LP was retrieved using an Aveir retrieval catheter (Figure 1F). The catheter was oriented by the first operator, and the snare was operated by the assistant to catch the LP floating in the inferior vena cava. Another Aveir LP was successfully implanted after the LP that had migrated was retrieved (Figure 1G and 1H). No tissue was found adhering to the retrieved delivery catheter or LP. Figure 2A and 2B shows transthoracic echocardiography before and after the procedure, respectively. Tricuspid

Figure 1 A, B: An Aveir VR leadless pacemaker (LP) (Abbott, Chicago, IL) was deployed onto the apical septum, but it was recaptured because of an unacceptable pacing threshold. C: The protective sleeve could not be advanced beyond the middle of the LP. D: The sleeve could no longer be advanced beyond the docking cap after counterclockwise rotation, and the catheter could not be retrieved. E: The catheter remained stuck, and the LP was dislodged after its release. F: The LP was successfully retrieved using an Aveir retrieval catheter. G, H: Another Aveir LP was successfully implanted after the LP that had migrated was retrieved.

and rotated. If the protective sleeve does not advance smoothly, the Aveir system should be placed back in the tether mode and the position of the delivery catheter should be changed.

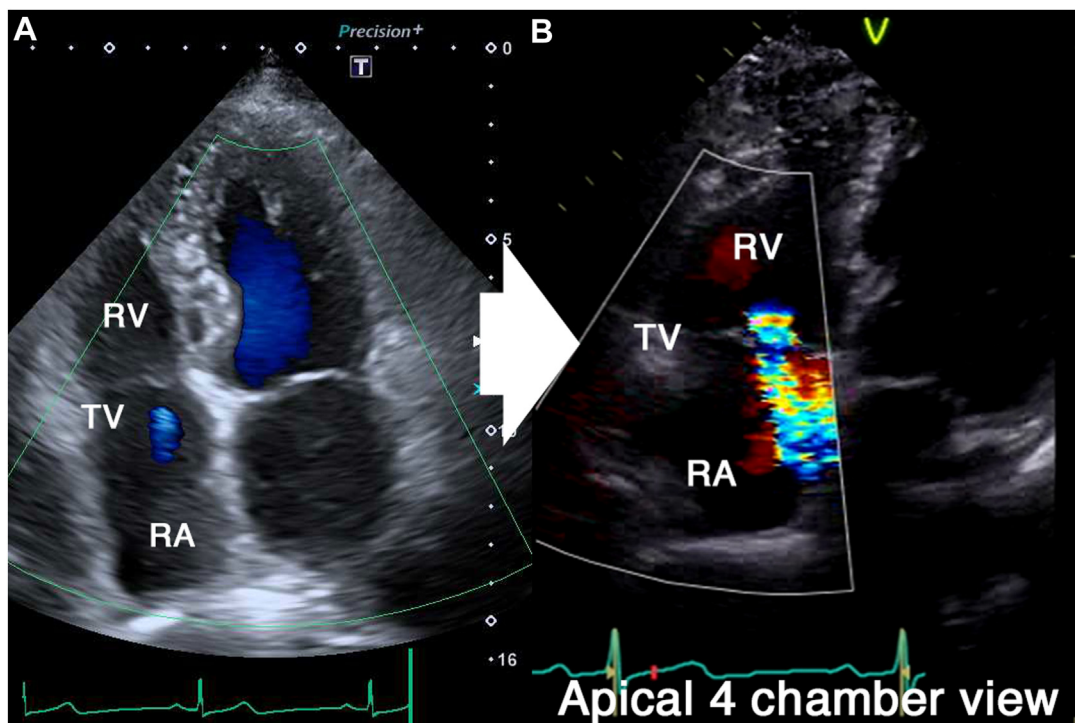
regurgitation worsened from trivial (Figure 2A) to moderate (Figure 2B). However, he had no symptoms of right heart failure and was discharged on postoperative day 4. We performed in vitro experiments to replicate this complication

Figure 2 Transthoracic echocardiography before (A) and after the procedure (B). The tricuspid regurgitation worsened from trivial (A) to moderate (B). RA = right atrium; RV = right ventricle; TV = tricuspid valve.

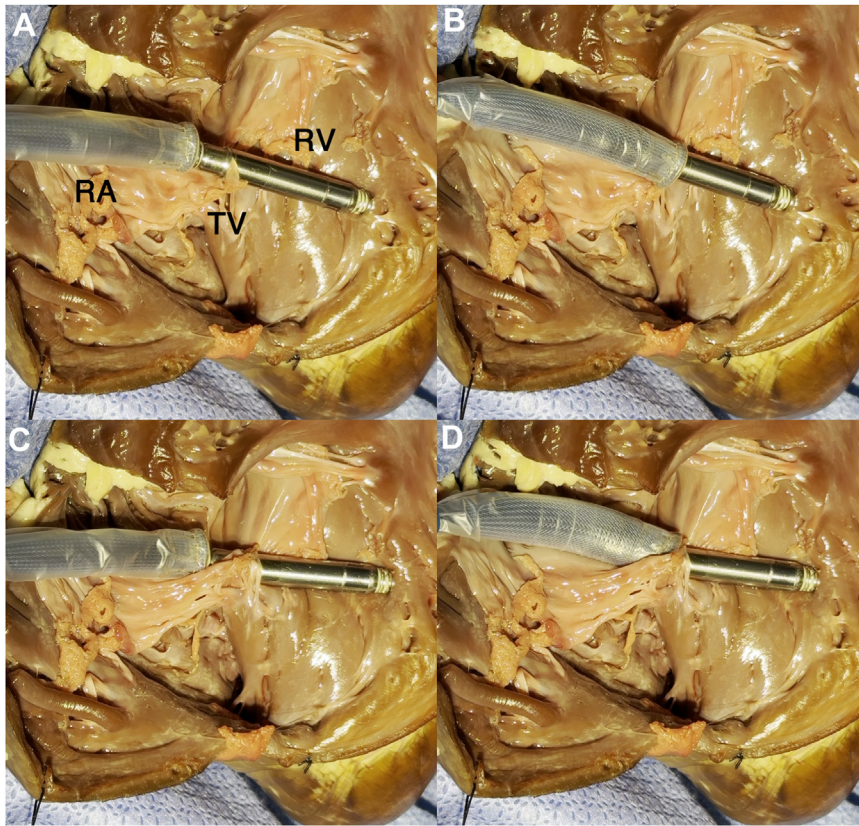
using a porcine heart purchased at a butcher shop. The porcine tricuspid valve leaflet became tightly caught between the docking cap and LP (Figure 3A and Supplemental Video 4). The protective sleeve could not be advanced beyond the

Figure 3 In vitro experiments were performed to replicate the Aveir (Abbott, Chicago, IL) delivery catheter becoming caught on and reeling in the porcine tricuspid valve (TV) leaflet. **A:** The porcine TV leaflet was tightly caught between the docking cap and leadless pacemaker. **B:** The protective sleeve could not be advanced beyond the middle of the device. **C:** The catheter began to reel in the leaflet with counterclockwise rotation; however, the pacemaker was successfully released from the myocardium. **D:** Compared to that before the counterclockwise rotation, the protective sleeve could be advanced even less.

middle of the pacemaker (Figure 3B). The catheter reeled in the leaflet with counterclockwise rotation; however, the pacemaker was successfully removed from the myocardium (Figure 3C). Compared to that before the counterclockwise rotation, the protective sleeve could be advanced even less (Figure 3D and Supplemental Video 5). However, a situation in which the delivery catheter remained stuck even after releasing the LP could not be replicated, and it was difficult to determine where the tricuspid valve tissue or chordae had become stuck on the catheter.

stuck after the LP was released in the ex vivo experiment. However, by rotating the catheter in the opposite direction, the tissue that had become caught was successfully released without causing any significant damage. Considering the slight increase in the tricuspid regurgitation after the procedure, it should be reasonable to hypothesize that the catheter had become caught on either the tricuspid valve, its chordae, or both.
