# Severe Metallosis After Total Elbow Arthroplasty—A Case Report

Arkan S. Sayed-Noor · Göran O. Sjöden

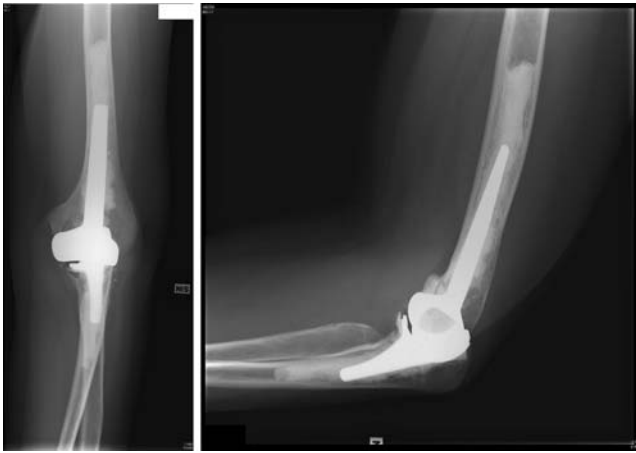
In year 2000, a 64-year-old female patient was operated on with unlinked Kudo type 3 with metal-backed ulnar component (Biomet UK Ltd.) TEA for primary osteoarthritis of the left elbow. No perioperative complications were reported and the patient was satisfied with the results 1 year after the operation. At that time, a follow-up X-ray showed acceptable positioning of the prosthesis components with no radiolucencies (Fig. 1).

**Figure 1** Radiographs taken at 1-year follow-up (year 2001) showing a Kudo TEA in an acceptable positioning without radiolucencies.

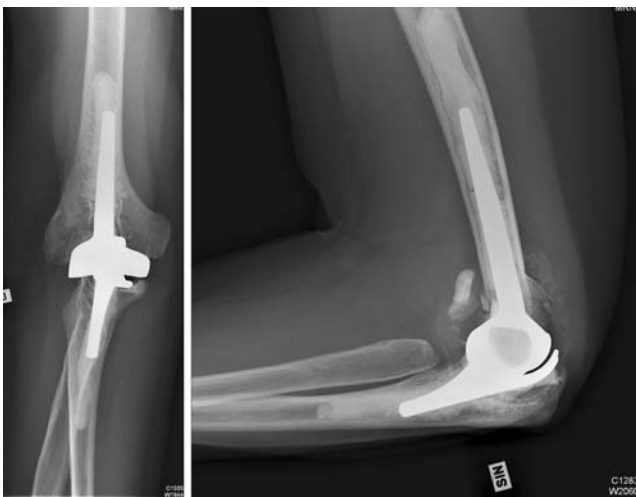
In January 2006, the patient presented with a history of increasing pain in her operated elbow. The clinical examination revealed mild to moderate swelling, mild warmth, and redness and tenderness of the elbow. The range of motion was 10° to 100° (slightly decreased compared to previous examinations). The X-ray showed mild valgus tilting of the ulnar component, thin radiolucent line around the humeral component, and breakage of the cement mantle (Fig. 2). The laboratory investigations showed leukocyte count=9,800 cell per cubic millimeter, C-reactive protein=72 mg/L, and erythrocyte sedimentation rate=44 mm/h.

**Figure 2** Radiographs taken when the patient presented with increasing pain in her operated elbow (year 2006). They showed PE wear valgus tilting of the ulnar component radiolucency around the humeral component and fracture of the cement mantle.

Radiographically, metallosis can be seen as a radio-dense line, described as “the bubble sign” by Su et al. [15] and as metal-line sign by Weissman et al. [17]. Moreover, it can resemble heterotopic ossification [11]. A more consistent but less specific radiographic finding in patients with histologically proven metallosis is osteolysis around the prosthetic components [5,7,8]. In our patient, manifestations of PE wear with subsequent tilting of the ulnar component, radiolucent zone around the humeral component, and cement mantle fracture were noted.

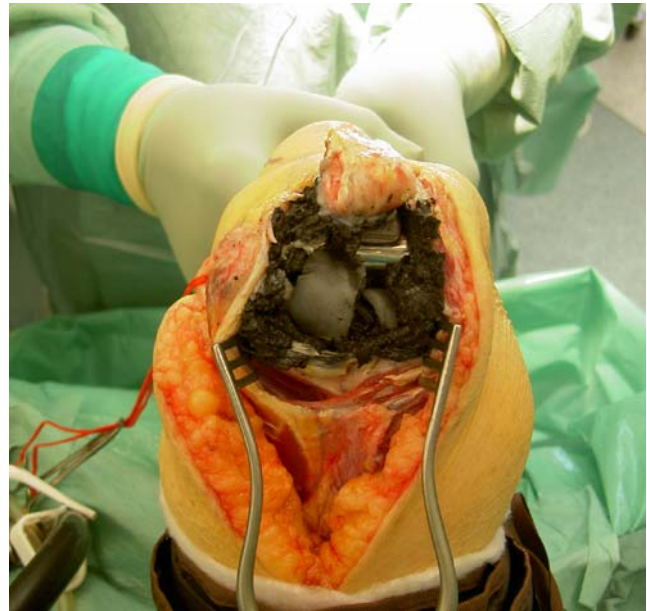
In April 2006, the patient was operated on in the lateral decubitus position with the use of a tourniquet. The TEA was approached through a posterior triceps split. Once opened, the elbow showed severe metallic debris of the soft tissues and synovium which was filled with black synovial fluid (Fig. 3). After a thorough irrigation of the whole joint,

**Figure 3** Severe metallosis invading the TEA components and the surrounding soft tissues.

the components of the prosthesis including the surrounding cement were removed. There was an extensive wear of the polyethylene (PE) part of the ulnar component. The removal of the loose components caused a small defect of the humerus. Five deep soft tissue biopsies for bacterial culture and sensitivity testing were taken. A Discovery elbow system (Biomet Orthopedics, Warsaw, IN, USA) was then inserted using a gentamicin-added cement with no pressurization (Fig. 4).

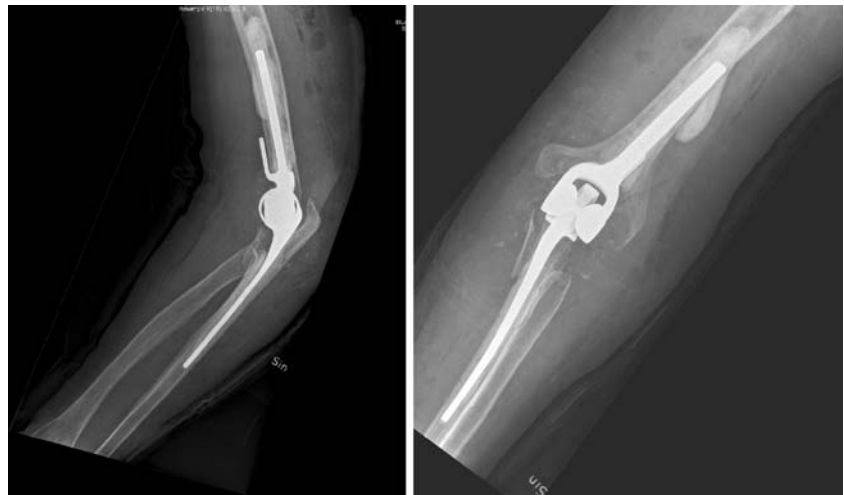
**Figure 4** Radiographs of the revision surgery using the Discovery elbow system. Asymptomatic cement leak from a bony defect in the humerus.
