Laryngoscope. 2013 March ; 123(3): 757–766. doi:10.1002/lary.23665.

Cochlear Implant Electrode Misplacement: Incidence, Evaluation, and Management

Yu-Lan Mary Ying, MD, Jerry W. Lin, MD, PhD, John S. Oghalai, MD, and Robert A. Williamson, MD

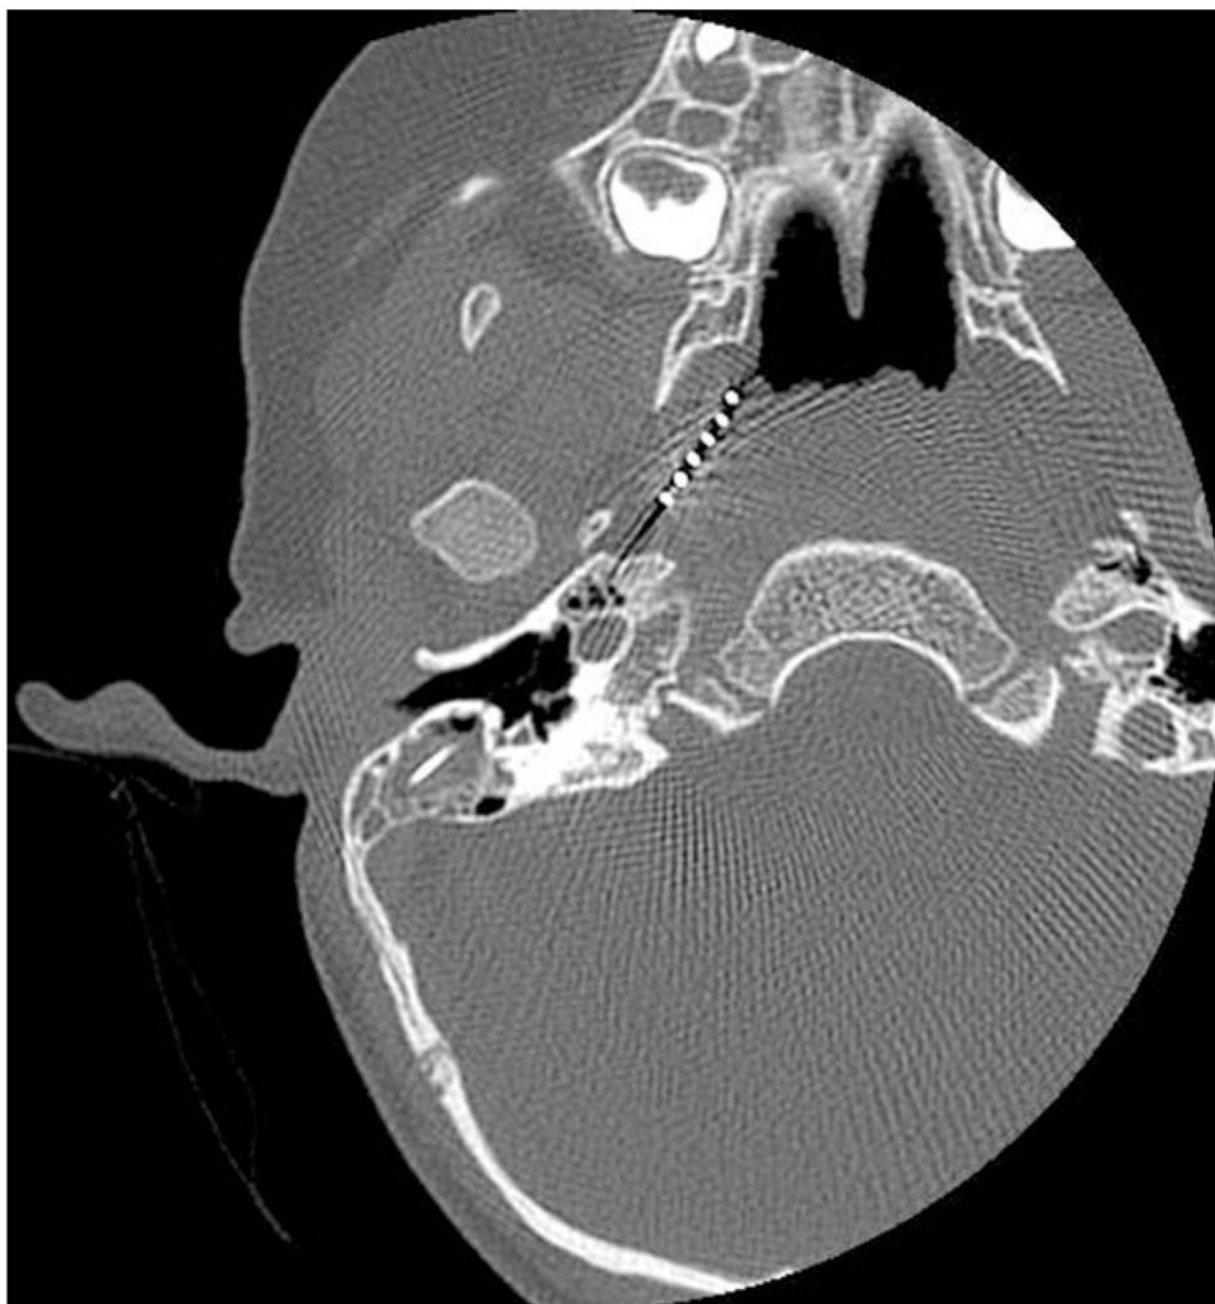
demonstrate any behavioral responses to stimulation. A CT scan showed the electrode extending into the eustachian tube with the distal tip in the posterior aspect of the nasopharynx (Fig. 1). Explantation and reimplantation was performed. The cochleostomy was enlarged, and full electrode insertion was achieved. Intraoperative impedance measurement was normal, and intraoperative plain film verified the correct placement of the electrode array within the cochlea.

Fig. 1.
Electrode array extending into left eustachian tube with distal tip in nasopharynx.

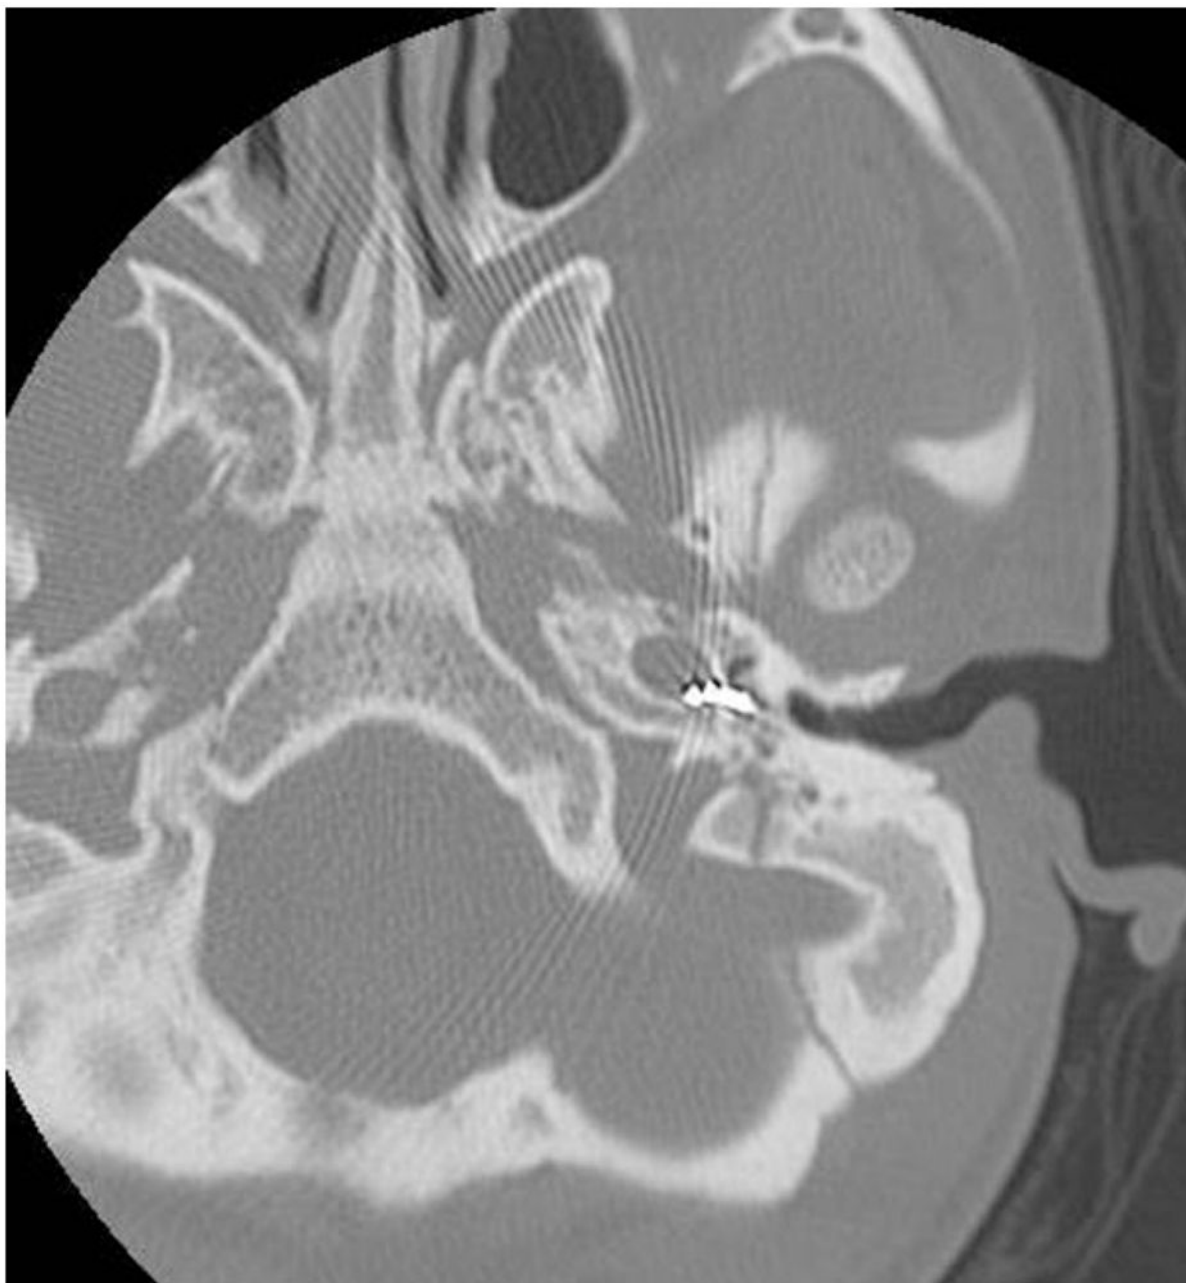
A 14-year-old female with Down syndrome, history of cleft palate and lip repair, and bilateral sensorineural hearing loss presented 8 years after cochlear implantation for evaluation of her left cochlear implant. She had undergone left-sided cochlear implantation at an outside facility when she was 6 years old. She was still aided in the contralateral ear and used some signing for communication. Reportedly, the patient had some responses to the implant initially; however, the device had not worked well for many years, and she was not responding to auditory stimuli. Recent programming and increasing stimulation through five of the electrode sites elicited unusual responses, such as repeated swallowing and facial twitching, which are suggestive of nonauditory stimulation. A CT scan demonstrated the electrode array to be situated in the hypotympanum and extending into the carotid canal. The tip of the electrode could be seen extending about a third of the distance into the carotid canal at the level of the first turn (Fig. 2).

Fig. 2.
Electrode array tip extending into the carotid canal at level of first turn.

Management options were discussed with the family. Before considering surgical intervention to remove the implant, an angiogram was recommended to assess the integrity of the internal carotid artery. Available imaging studies could not delineate the status of the carotid artery. The recommended intervention was to perform a staged procedure to remove the old implant with possible endovascular intervention, if necessary, and then reimplant a new device at a later date. The parents ultimately sought another opinion, and the patient was lost to follow-up.

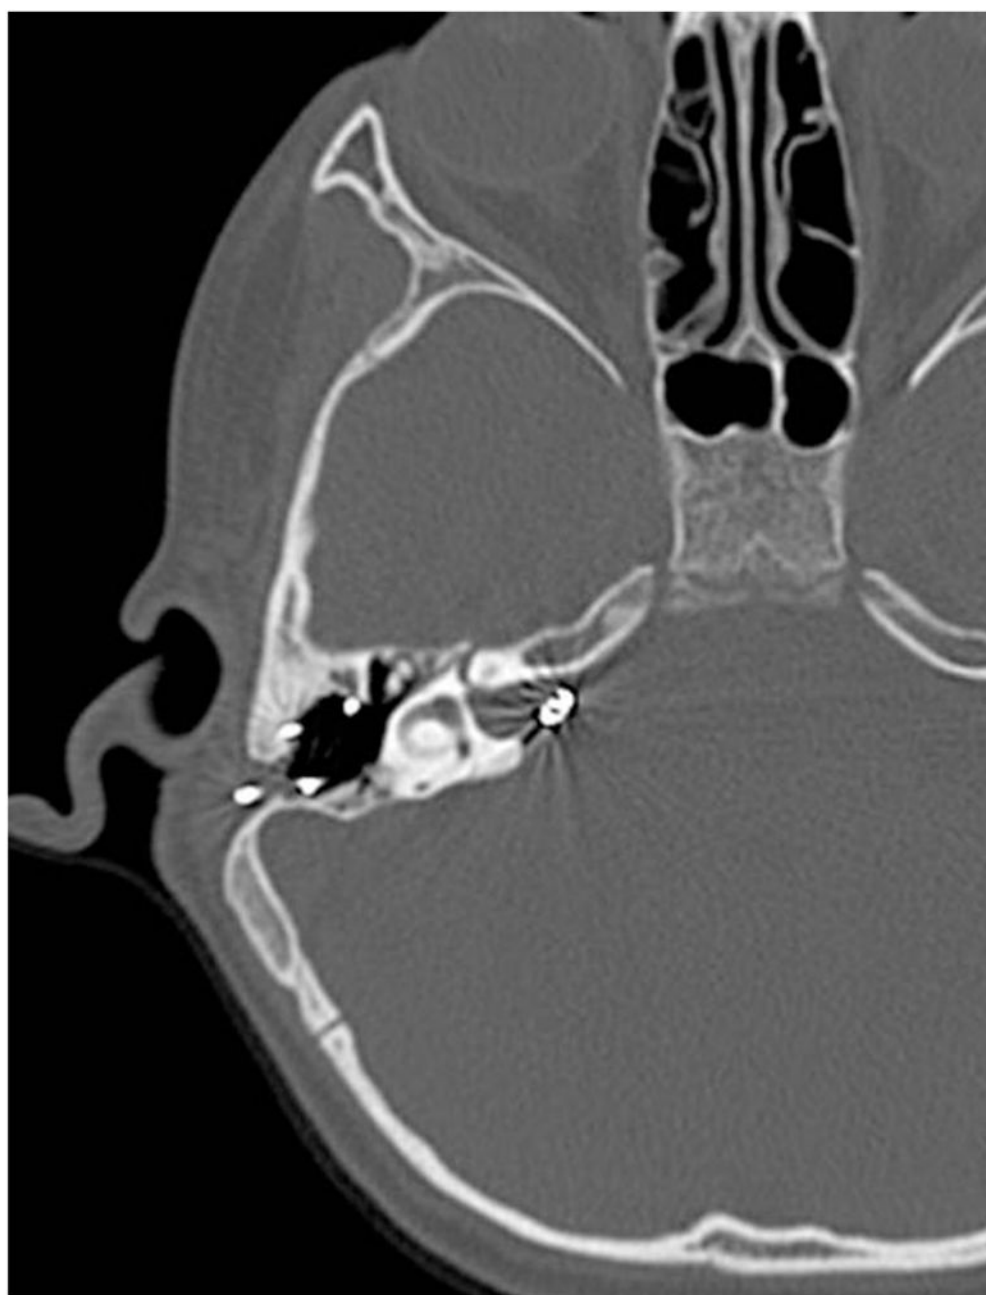
A 4-year-old male with a history of congenital profound bilateral sensorineural hearing loss presented for evaluation of a right cochlear implant placed at another facility 2 years earlier. Parents reported no benefit in speech or language development since the implantation. Audiologic testing demonstrated normal impedance, but irregular telemetry mapping. Despite several adjustments, there was no significant improvement in patient's auditory perception or behavioral response. CT scan of temporal bones demonstrated the electrode array to be positioned within the internal auditory canal (Fig. 3). After multidisciplinary discussion and planning, the patient underwent a modified translabyrinthine approach to visualize the malpositioned electrode within the internal auditory canal as it was being removed, and simultaneous reimplantation of a new cochlear implant into the cochlea via a new cochleostomy. Postoperative CSF rhinorrhea was managed with eustachian tube plugging and middle ear obliteration, and subsequently resolved.

Fig. 3.
Electrode array position within the internal auditory canal.

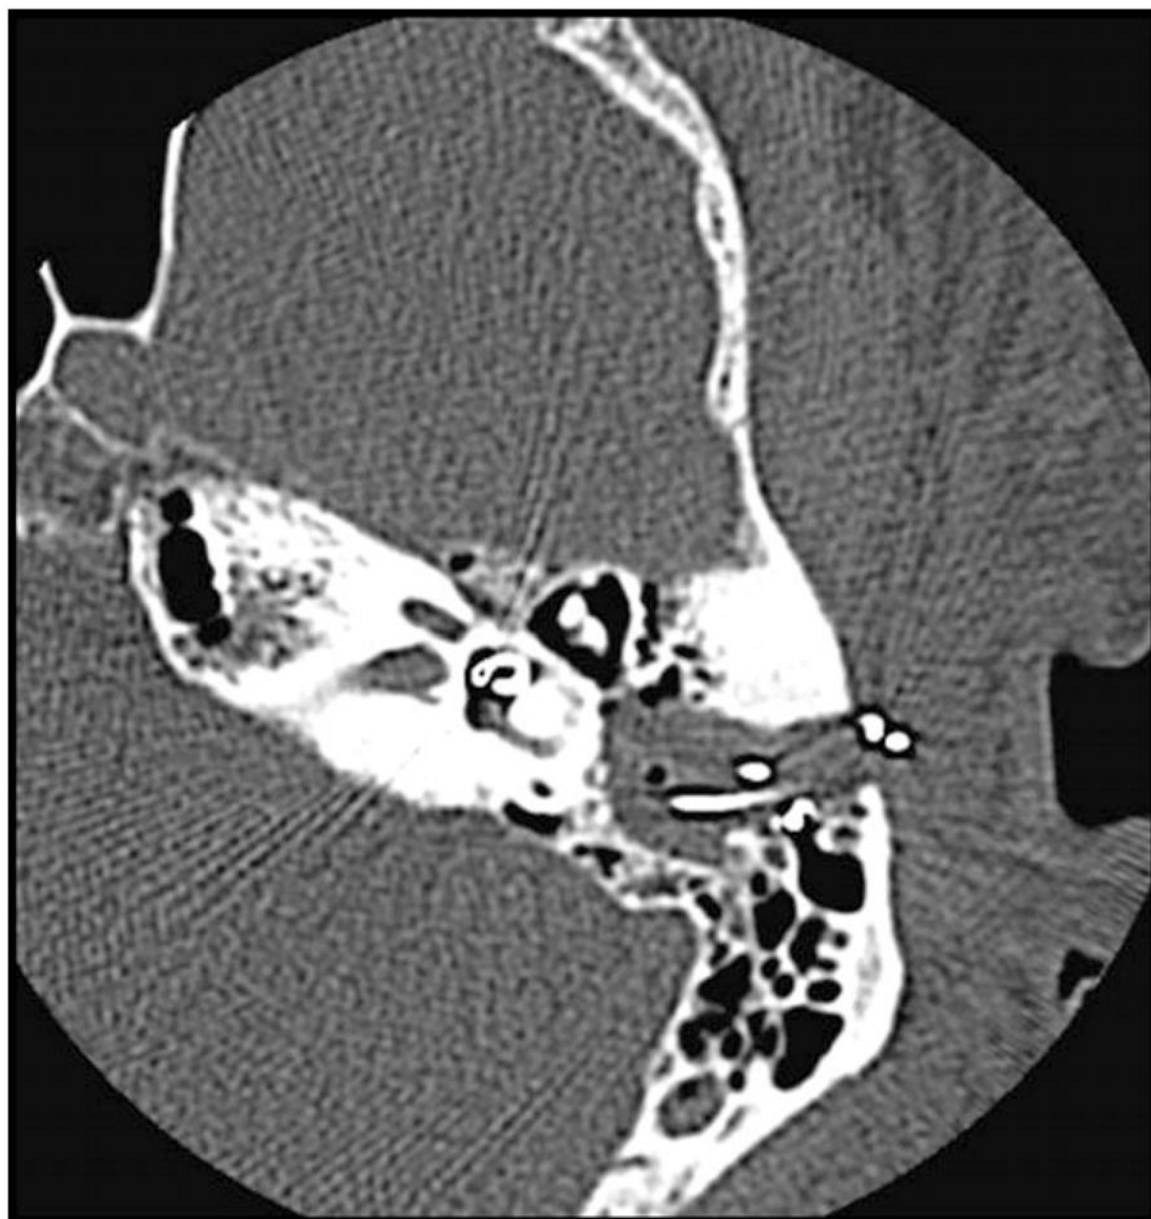
Postoperatively, the patient became acutely vertiginous overnight with grade II nystagmus to the right. CT temporal bone demonstrated the electrode to have pierced the thin bone above the round window and coursed superiorly and posteriorly, extending into the vestibule, immediately anteromedial to the lateral semicircular canal (Fig. 4). The patient underwent explantation and reimplantation of a second device in the left ear the following day. In the revision procedure, the bony round window niche was drilled away to visualize the round window membrane. Electrode insertion through the round window was performed. Intraoperative impedance and NRT measurements were normal. In addition, intraoperative fluoroscopic imaging confirmed electrode placement within the cochlea.

Fig. 4.
Electrode array extending into the vestibule.
