## Case Report

# Acetabular Liner Dissociation following Total Hip Arthroplasty: A Rare but Serious Complication That May Be Easily Misinterpreted in the Emergency Department

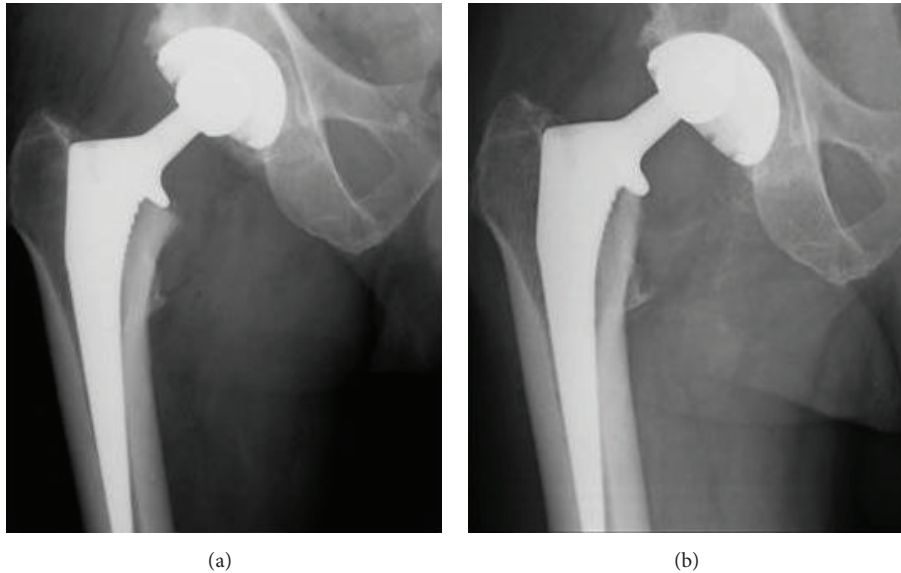
FIGURE 1: (a) Previous AP Hip X-ray demonstrates satisfactory component positioning. (b) AP Hip X-ray from ED attendance demonstrates acetabular liner dissociation. Comparison to (a) shows grossly eccentric superior migration of the femoral head within the acetabular shell.

On review of X-rays from both previous ED attendances, there was evidence of acetabular liner dissociation (Figures 1 and 2). The patient was scheduled for urgent acetabular revision surgery.

The aetiology of locking mechanism failure is believed to be related to shell geometry design and liner material properties in the adverse environment of increased torque or component impingement [7–9].

At time of revision surgery, there was evidence of soft tissue metallosis with significant damage to the surfaces of both the femoral head and acetabular shell. The polyethylene liner had completely dissociated from the shell and lay within the adjacent soft tissues. Though acetabular shell orientation was satisfactory, concern over integrity of the locking mechanism necessitated revision. A 58 mm Pinnacle Sector shell with screw augmentation, a 58/32 mm Marathon highly cross-linked polyethylene liner, and a 32 mm metal Articul/eze femoral head were implanted (DePuy, Warsaw, IN, USA).

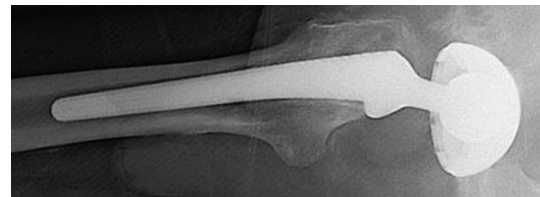
FIGURE 2: Lateral X-ray shows medial migration of the femoral head within the acetabular shell and excludes a dislocation as it confirms the prosthetic femoral head lies within the acetabular shell on a tangential view.
