Technical Note

Metallosis: A diagnosis not only in patients with metal-on-metal prostheses

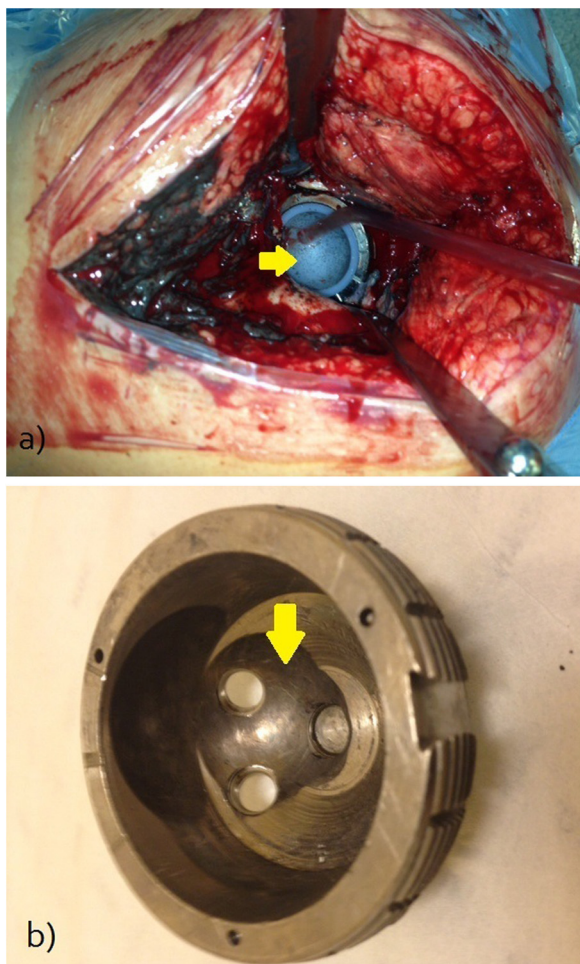
Fig. 4. (a and b) A 55-years-old man with metallosis. Intra-operative pictures of the procedure showing extensive metallosis; metal impregnation of the replaced polyethylene liner component (a), as well as wear of the acetabular metal dome (b).

extensive tissue damage [9]. In the reported case, drainage of the large pelvic collection was also required. CT imaging allowed not only the diagnosis of the initially missed pelvic collection, but also contributed to the correct surgical planning. A successful collection drainage through a transacetabular approach during the prosthesis revision was performed.
