Author manuscript Ground Water. Author manuscript; available in PMC 2017 November 01.

Published in final edited form as: *Ground Water*. 2016 November ; 54(6): 871–877. doi:10.1111/gwat.12417.

# Evidence for elevated levels of arsenic in public wells of Bangladesh due to improper installation

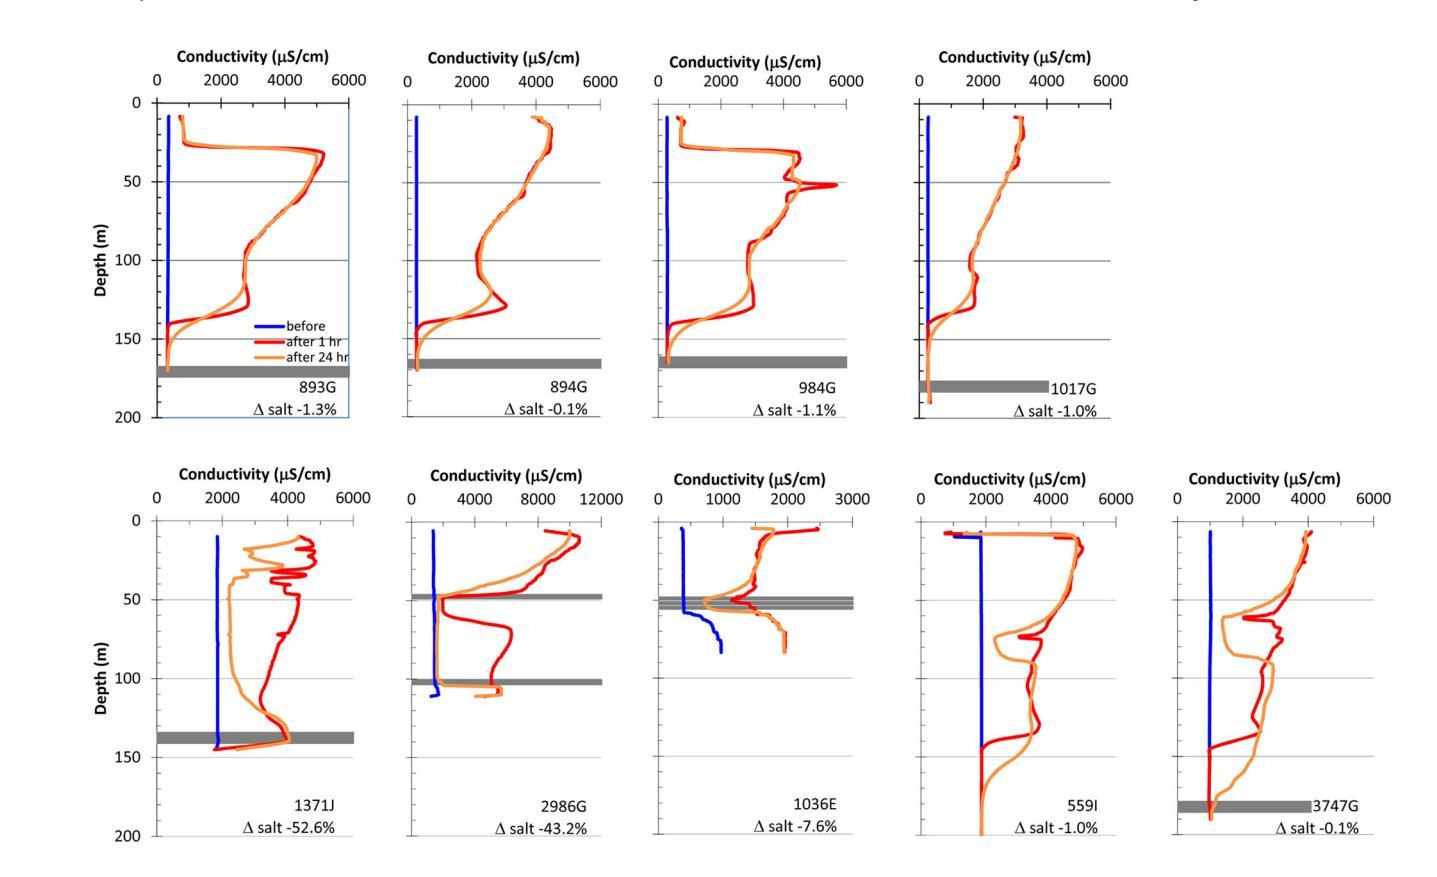
#### Figure 2.

With the exception of one well (1036E), the conductivity profiles were essentially uniform before spiking. Of the total of 9 wells that were spiked, 4 showed little or no difference between conductivity profiles collected after 1 hr and 24 hr. In some cases below a shallow rapid rise, conductivities gradually declined with depth by about a factor of two, starting from maxima of  $3000-5000 \mu$ S/cm. In each of these 4 wells, this was followed by a rapid decline to conductivities of ~300  $\mu$ S/cm at about 130 m depth that was indistinguishable from the pre-spike background, indicating that the salt had completely dissolved. The sharp drop-off in conductivity was centered at the same depth at 1 hr and 24 hr, but broadened from a width of about 10 m to 30 m over the intervening period. A few features in the conductivity profiles recorded after 1 hr due to brief interruptions in the descent of the salt wheels were also smoothed over time at shallower depths. An inventory of excess salt within each of the wells is calculated by subtracting the pre-spike conductivity from measurements at 0.5–1 m intervals at 1 hr and 24 hr and summing over the entire depth range of the increase in conductivity. Within 1%, there was not change in the excess salt over background inside these 4 wells between 1 hr and 24 hr after spiking (Fig. 2).

Within 1 hr of spiking, the conductivity profiles for the 5 other wells already show localized decreases indicative of dilution with fresher water (Fig. 2). In the case of well 1371J, declines in conductivity recorded within 1 hr indicate multiple leaks within the upper 50 m and an additional leak at about 70 m depth. For well 2986G, a more pronounced reduction in conductivity to almost background values after 1 hr extended from about 50 to 60 m depth. After 24 hr, conductivities were uniformly low across the entire 50–100 m interval in both these wells. The excess salt over background in these two wells decline between 1 hr and 24 hr after spiking by 53 and 43%, respectively (Fig. 2). Conductivity profiles for wells 1036E, 559I, and 3747G all show a single well-defined minimum after 1 hr that expanded to a width of 20–30 m at 24 hr. The minima in conductivity expanded primarily downwards but did not quite reach initial background values after 24 hr. Within this group of 3 wells, only in the case of well 1036E did the excess salt decline measurably by 7.6% between 1 hr and 24 hr after spiking.

Profiles of conductivity obtained before and after spiking of 9 wells >90 m deep with >50  $\mu$ g/L As when tested in 2012–13. The horizontal grey bands indicate the depth range of the slotted PVC screens documented with the downhole camera. The bottom screen of well 1036E was not reached because it had been partially filled with sediment and the bottom screen of well 559I was blocked by a brick fragment (Fig. 3). Also listed are the changes in salt content over background in each well (%) between 1 hr and 24 hr after spiking.

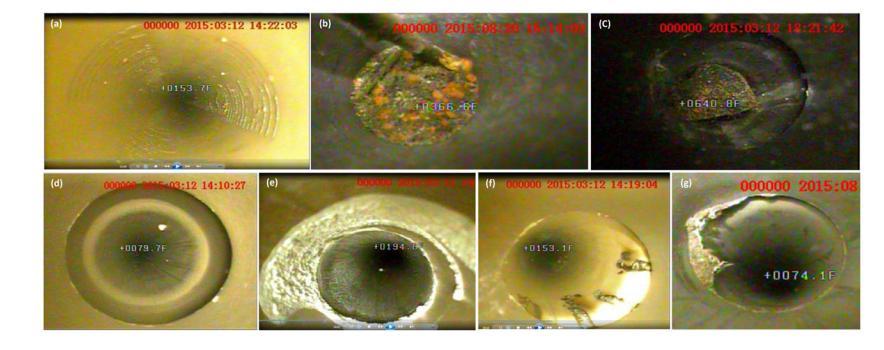
#### Figure 3.

The videos obtained with the downhole camera were used to record the depth and status of each of the PVC joints and other features inside the 9 wells under investigation. The video camera was prevented from reaching the lower screen by sediment in well 1036E and by a single piece of brick in well 559I (Fig. 3). Most striking was the discovery of a slotted PVC screen inserted at 46–49 m depth in well 2986G and another 3 screens installed in series between 48 and 56 m depth in well 1036E. The depths of these screens correspond closely to the onset of the decline in conductivity recorded in both wells (Fig. 2). No shallow screens were observed in the remaining 3 leaky wells. The downhole camera did not detect a single broken or split PVC pipe, nor any obviously failed joint. Deformations and the presence of drip-like features around the joints, possibly PVC glue or precipitated calcium carbonate, were systematically compiled from the video records (Table 1). There was no systematic difference in the appearance of the PVC joints within and outside the leaky intervals identified by the declines in conductivity.

Examples of screen shots of the downhole camera video. (a) shallow screen in well 2986G, (b) bottom of well 1036E filled with sediment and a twig, (c) brick fragment at the bottom of well 559I, (d) clean PVC joint, (e) joint streaks of PVC glue, (f) drip features that may indicate intrusion of water through the joint, and (g) joint deformed to an oval shape. See Table 1 for a compilation of the different types of joints recorded from the video.
