CASE REPORT

Myopotential oversensing notified by Lead Integrity Alert in a patient with implantable cardioverter defibrillator with a dedicated bipolar epicardial sensing lead

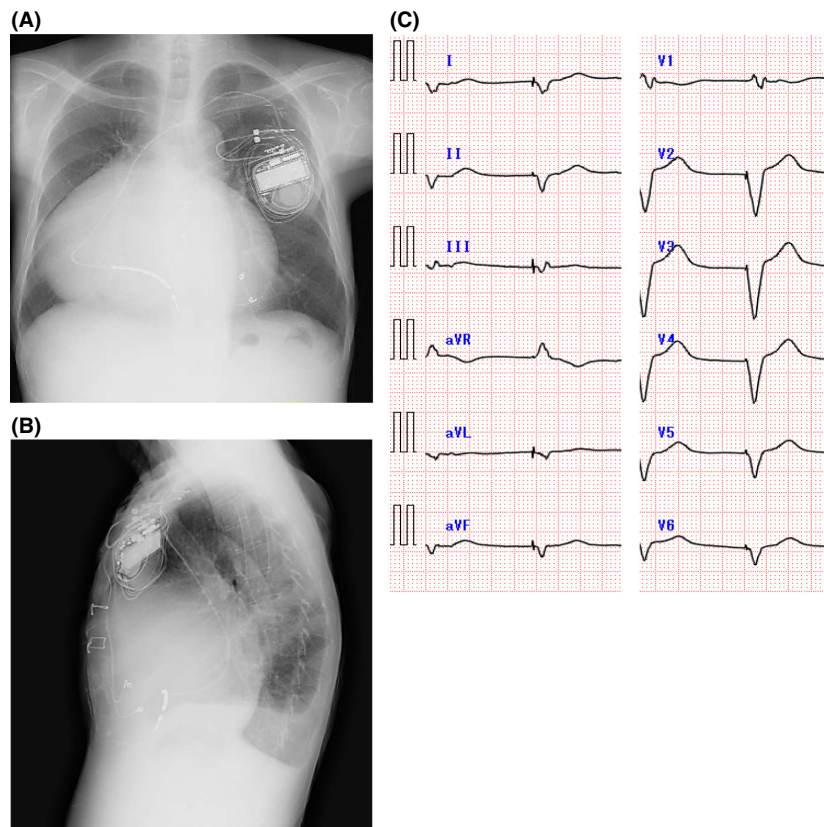
Nineteen years after his first ICD implantation, he was referred to our clinic because his ICD was making a ringing noise. Chest radiograph was used to reveal large cardiomegaly with a cardiothoracic ratio of 78% (Fig. 1A and B) and no signs of lead fracture or dislodgement. Twelve-lead electrocardiogram showed atrial fibrillation with RV pacing (Fig. 1C). Emergency examination revealed that the ICD rang because of the LIA. The number of intervals to detect (NID) VF extended from 24/32 to 30/40, in accordance with the LIA algorithm. However, the measurement results of the device and leads were all within acceptable ranges: RV pacing threshold was 2.1 V at 0.5 msec; sensed R wave was 4.4 mV; and pacing lead impedance was 323 ohm. According to the examination data, two of three LIA criteria were met: (i) sensing integrity counter (SIC) had been counted 53 times within three consecutive days and (ii) nonsustained VT (NSVT) had occurred more than twice during 1 month. Stored intracardiac electrogram showed that the very high-frequency, low-amplitude, and short-duration potential caused LIA, suggesting myopotential oversensing (Fig. 2A). Fortunately, only short improper pacing inhibition and no

Figure 1. Posteroanterior (A) and lateral (B) views of chest radiograph and 12-lead electrocardiogram image (C) during emergency examination in the ICD clinic just after the LIA alert.

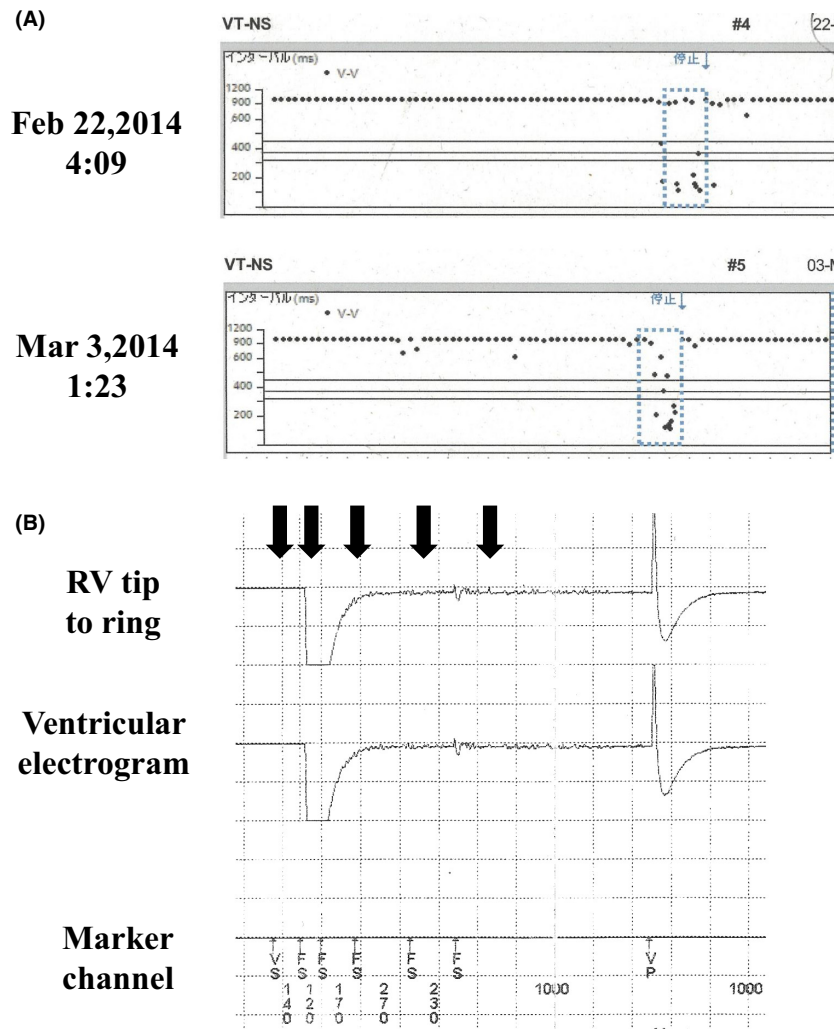
inappropriate shock delivery had occurred. Usual provocation maneuvers for myopotential oversensing such as Valsalva maneuver, left arm rotation, or palm apposition were unsuccessful. Because the causal episodes were seen at 4:09 AM and 1:23 AM (Fig. 2B), we questioned the patient carefully about what he did at these times. He told us that he was asleep at those times and that he often turns over using his left arm during sleep. We let him turn his upper body from the prone position using his left arm, and the noise and accompanying oversensing were successfully provoked (Fig. 3A and B), leading to the diagnosis of myopotential oversensing. We gave him instructions both to avoid the prone position and using his left arm to turn over during sleep. The incidence of NSVT and SIC decreased, and he was free from inappropriate shock delivery and improper pacing inhibition for 12 months until he died due to progressive heart failure.

Figure 2. Interval plots and intracardiac electrogram image of LIA. (A) The interval plots at 4:09 AM on February 22, 2014 (upper), and at 1:23 AM on March 3, 2014 (lower). (B) The intracardiac electrocardiogram image at 1:23 AM on March 3, 2014. High-frequency and low-amplitude potentials (black arrows) were detected as NSVT, which caused LIA.

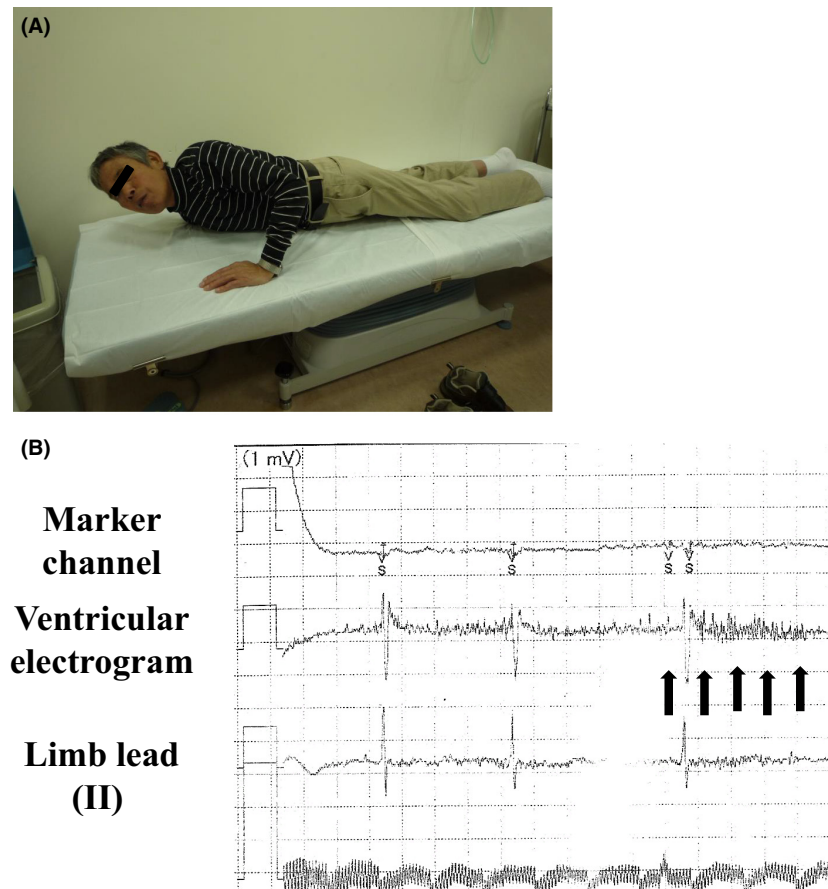
Figure 3. The provocation maneuver for myopotential oversensing. (A) Provocation. The patient turned his upper body from the prone position using his left arm. (B) Intracardiac electrogram image during provocation. Characteristic potentials (black arrows) for the LIA were induced with improper pacing inhibition during the turning movement.
