CASE REPORT

Iatrogenic displacement of high-speed bur during third molar removal

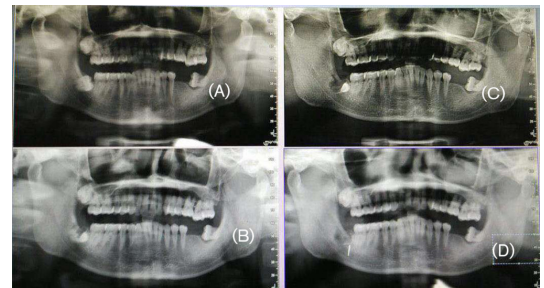
Figure 1 Sequence of panoramic view radiographs showing sectioning of tooth.

the last radiograph, a thin radio opaque material resembling a tip of a bur is seen embedded in the mandibular bone, distal to the tooth 47 (figure 1). Vertically, it was inferior to the apex of tooth 47 and located superior to upper cortical margin of right inferior alveolar canal (figure 2). Clinically, blood clot was seen within the extraction socket and no metal fragment were visible. There was minimal hypoesthesia reported by the patient at right lower lip. He was able to differentiate sharp and blunt stimulation and could do two point discriminations on the affected area. Clinically, the neurosensory deficit was diagnosed as neuropraxia. Sensory function at right lateral border of tongue was normal. A cone beam CT was done to identify the size and exact position of the bur segment in a three-dimensional view. The bur segment was later removed under general anaesthesia on the following day.

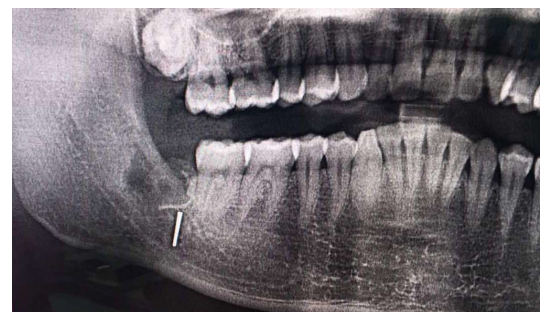
Figure 2 Panoramic view showing displacement of bur segment into mandible.

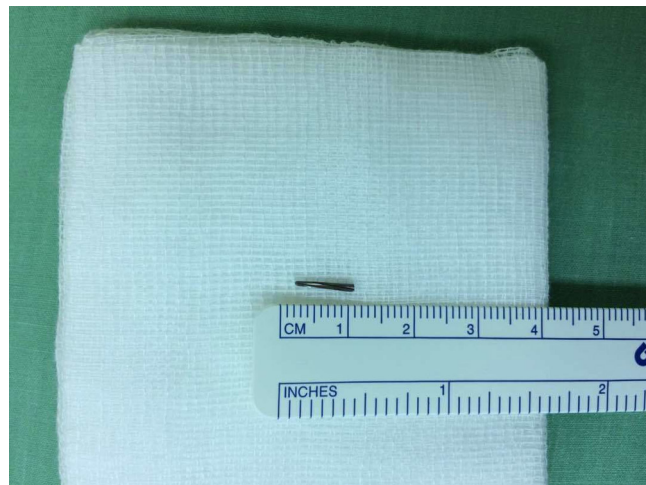
Figure 4 Removed bur segment.

Usage of a high-speed handpiece in third molar surgery is not recommended and is not a common practice. High-speed handpiece is a rotary instrument powered by compressed air, rotates at a speed of around 200 000–800 000 rotations per minute. Usually, thin burs made of steel with tungsten carbide or diamond coating are typically used with this handpiece for general dental works. These burs used with high-speed handpiece are comparatively thinner than the burs used with slow-speed handpiece in surgical cases. These thin high-speed burs are not designed to cut hard cortical bone, therefore the risk of fracture is higher when used inappropriately if it is used for bone removal.

Removal of fractured displaced bur was done under general anaesthesia. The previous surgical incision was extended to increase the access. The mesial relieving incision which was done at midbuccal of 47, extended inferiorly and anteriorly to the vestibule. The distal relieving incision was extended laterally to the external oblique ridge. Cortical bone lateral to the extraction socket was carefully removed to expose the bur fragment. Once the bur segment was clinically visible, it was secured with an artery forceps and carefully removed. The removed segment was measuring 9 mm (figure 4). Inferior alveolar nerve was not visible after the removal of the bur fragment.

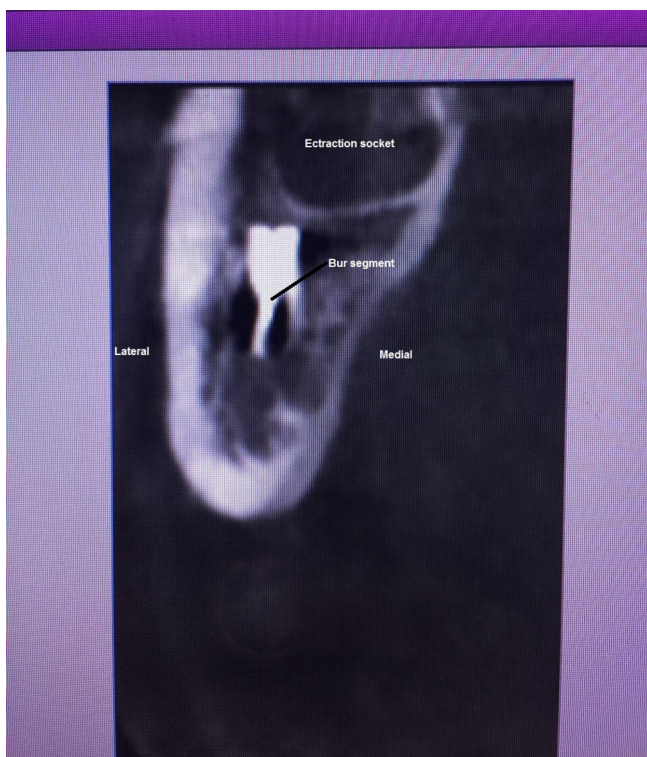
found fully embedded in the outer cortex of mandibular bone, lateral to the previously removed crown of tooth 48 (figure 3). In relation to the inferior alveolar canal, the bur was positioned close to the superior cortex of the canal. Size of the bur segment was 9 mm in length.

Figure 3 Coronal view of cone beam CT scan showing the position of bur segment in three-dimensional view.

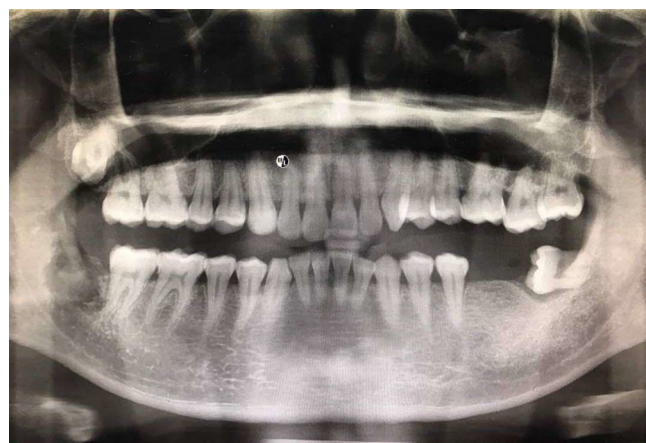
Postoperative panoramic view radiograph showed complete removal of the bur fragment (figure 5). The wound healing was good without any infection or tissue breakdown. On postoperative 2 weeks review, the neurosensory disturbance had resolved completely and the patient was discharged from follow-up.

Figure 5 Postoperative panoramic view showing complete removal of the bur segment.
