Hindawi Case Reports in Cardiology Volume 2018, Article ID 6195045, 4 pages https://doi.org/10.1155/2018/6195045

# Case Report

# Electromagnetic Interference from Left Ventricular Assist Device (LVAD) Inhibiting the Pacing Function of an Implantable Cardioverter-Defibrillator (ICD) Device

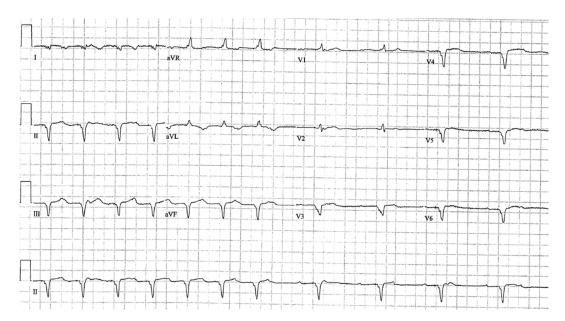
A 60-year-old female with history of ovarian cancer, doxorubicin-induced dilated cardiomyopathy, and advanced heart failure had a Medtronic cardiac resynchronization-defibrillator (CRT-D) device placed in May 2010. The patient had implantation of HeartWare LVAD for destination therapy in August 2011 due to progression of heart failure and functional decline. The postsurgical course was complicated by ventricular tachycardia and multiple episodes of pump thrombosis. Interrogation of the CRT-D device in December 2011 (as well as subsequent device checks) revealed that the patient had evidence of complete heart block with no escape rhythm at ventricular backup rate

FIGURE 1: DDD pacing followed by VVI pacing showing an underlying rhythm of complete heart block.

of 40 (Figure 1 EKG). The CRT-D pulse generator was changed to a St. Jude Medical Assura model (3357-40C CRT-D) device in June 2014 once it reached its elective replacement indicator.

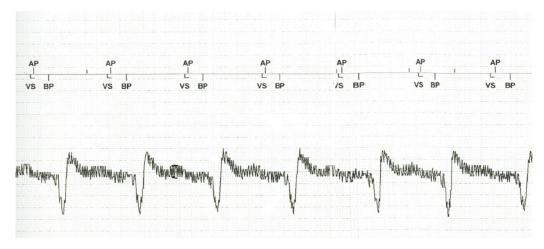
FIGURE 2: Pacing in asynchronous (DOO) mode with oversensing (marker annotations not affecting pacing mode) seen prior to the A paced marker.

at 0.75 at 0.5 ms. There was a continuous external noise with a mean amplitude of 1 mV detected by the ventricular sense amplifier of the RV lead. The intracardiac electrograms (IEGMs) showed an increase in a baseline noise signal compared to prior device-based recordings—the amplitude of which correlated with the increase of the LVAD pump rotation speed. The device was reprogrammed to nonsensing mode (DOO) allowing consistent pacer function of the ICD (Figure 2 IEGM). These setting changes meant that the tachytherapy function of the ICD was mandatorily disabled, as the device was set to a nonsensing mode.

The LFA filter is a proprietary option in St. Jude Medical devices that suppresses low-frequency signals with the intent to mitigate T-wave oversensing. As with any "band-pass filter," in addition to attenuating specific frequencies, they may also enhance or amplify other event frequencies, such as EMI, myopotential, R-waves, and far P-waves. The new VAD cannula position/orientation resulted in injection of the EMI signal more efficiently in the sensing antenna of the existing ICD lead. Additionally, the "sensibility" setting on the St. Jude device decays to baseline maximum sensitivity just prior to the A paced event—thus explaining why EMI was most consistently sensed in this window.

The EMI oversensing issue was resolved by turning off the "low-frequency attenuation" (LFA) filter, which had resulted in amplification of the high-frequency VAD signal. This allowed the device to function in a sensing/ tracking mode (DDD) without inhibition by noise from the LVAD with RV sensitivity threshold of 0.3 mV and permitted functional tachytherapy.
