CASE REPORT

Intraoperative detection of stuck leaflet after implantation of a mechanical aortic valve: a case report

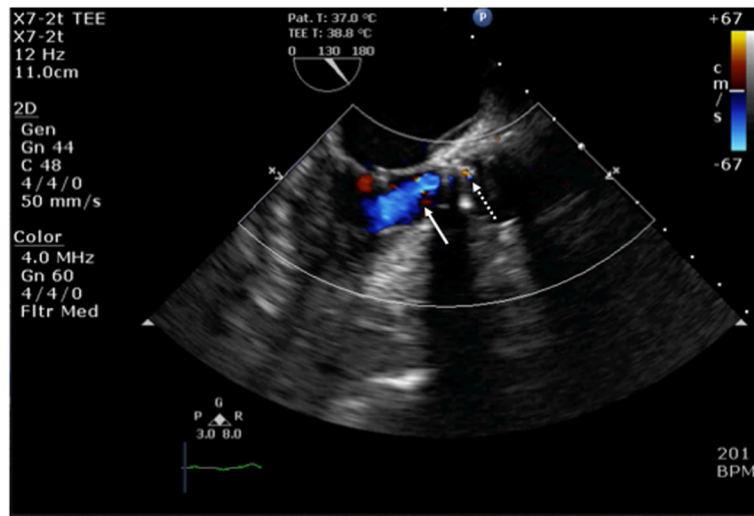
CPB was performed in a standard manner. After aortic cross-clamping, the native aortic valve was resected and replaced with an 18-mm mechanical aortic valve (ATS-AP360, Medtronic Inc., USA) using the non-evert mattress suture technique. After rewarming, the heart was de-aired and the cross-clamp was removed. After declamping of the aorta, a 3-µg/kg/min dopamine infusion was started. IO-TEE was performed to study the new prosthetic aortic valve before weaning off CPB (Fig. 1).

Fig. 1 A mid-esophageal aortic valve long-axis transesophageal echocardiography image reveals an aortic regurgitation jet and its acceleration flow. White arrow indicates aortic regurgitation, and white dotted arrow indicates its acceleration flow

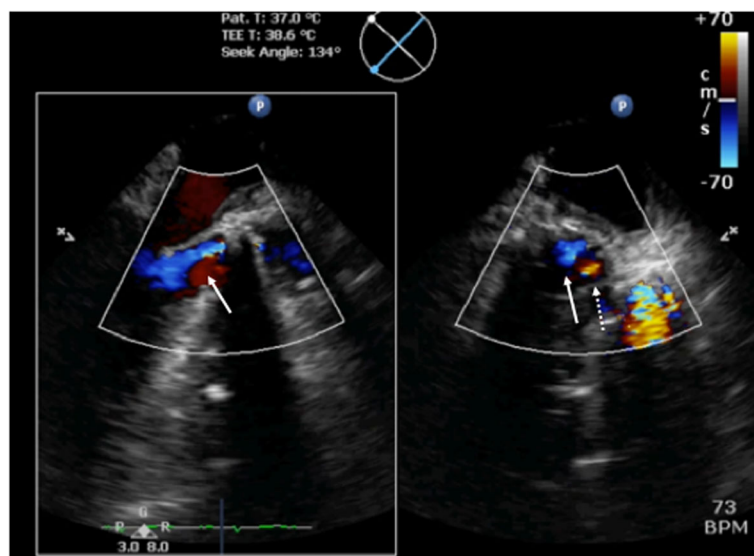
The mid-esophageal aortic valve short-axis view revealed that the mechanical bileaflet prosthetic valves were inserted in an ordinary position, which indicated that the two hinges were not located on the coronary ostia. The mid-esophageal aortic valve long-axis view revealed the presence of aortic regurgitation jets (Fig. 1), toward the anterolateral papillary muscle. The width of the regurgitation jet was 0.73 cm, indicating severe aortic regurgitation. LIVE xPlane, using a CX50 (Philips Medical Systems, Bothell, WA, USA), revealed that the regurgitation had originated in the intra-sewing ring of a non-coronary cusp

and was not located at the point of the hinges (Fig. 2). At the time, the cause of the abnormal severe transvalvular leakage was unknown. Thus, we decided to perform a second CPB. After re-aortic-cross-clamping and aortotomy, residual suture material placed in the sewing ring was observed to be caught in one leaflet, interfering with the closing of the leaflet. Upon cutting the residual suture material, the leaflet began to move appropriately, and non-interference with the leaflet motion was confirmed. Weaning from the second CPB was very smooth. After CPB weaning, IO-TEE showed no transvalvular leakage

Fig. 2 Using LIVE xPlane, a mid-esophageal aortic valve long-axis transesophageal echocardiography image (left image) and aortic valve short-axis transesophageal echocardiography image (right image) were taken, with the image inverted from right to left. Acceleration flow was recognized in the non-coronary cusp of the intra-sewing ring white arrow indicates aortic regurgitation and white dotted arrow indicates its acceleration flow

ultrasonic probe. However, the cause of transvalvular leakage could not be diagnosed by only IO-TEE. After re-aortic-cross-clamping and aortotomy, we finally diagnose that residual suture materials interfering with mechanical aortic valve leaflet closure.

into the mechanical prosthetic valve. The postoperative course was uneventful.
