Breakage and migration of a high-speed dental hand-piece bur during mandibular third molar extraction

Two case reports

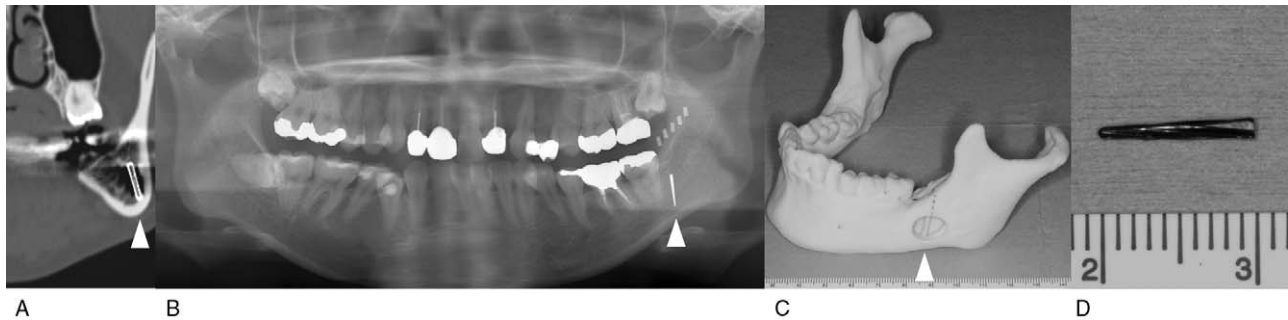
Figure 1. Case 1. (A) Preoperative computed tomography. (B) Preoperative panoramic radiograph with a stent that enclosed the radiopaque materials. (C) Three-dimensional model created based on the preoperative computed tomography. (D) The foreign body.

A 36-year-old woman visited a dental clinic for dental treatment, and a foreign body in the left mandible was incidentally detected on panoramic radiograph. The patient was referred to our department for removal of the foreign body in the left mandible. The patient had no remarkable medical or trauma history, but she received left impacted mandibular third molar extraction 8 years ago. Physical and intraoral examination did not show abnormal findings. Preoperative CT examination revealed a straight radiopaque foreign body having a length of 10 mm in the left mandibular body (Fig. 1A). The authors planned elective surgery to remove the foreign body under general anesthesia in consideration of the absence of subjective symptoms, the long time that has passed since migration of the foreign body, and the

low risk of damage to other organs because the foreign body remained in the mandibular bone. A panoramic radiograph was obtained with a stent that enclosed the radiopaque material to determine the migration position (Fig. 1B), and a 3D model was created based on the preoperative CT image (Fig. 1C). They were used for making a surgical plan to minimize healthy bone damage. The authors reached the foreign body by elevating the mucoperiosteal flap and removing the alveolar crest bone of the right mandibular third molar region. Then, the foreign body was removed, and complete removal of the foreign body was confirmed by intraoperative x-ray examination. The foreign body was a piece of dental hand-piece bur, and it was thought that the bur migrated during third molar extraction (Fig. 1D). The postoperative course was uneventful.

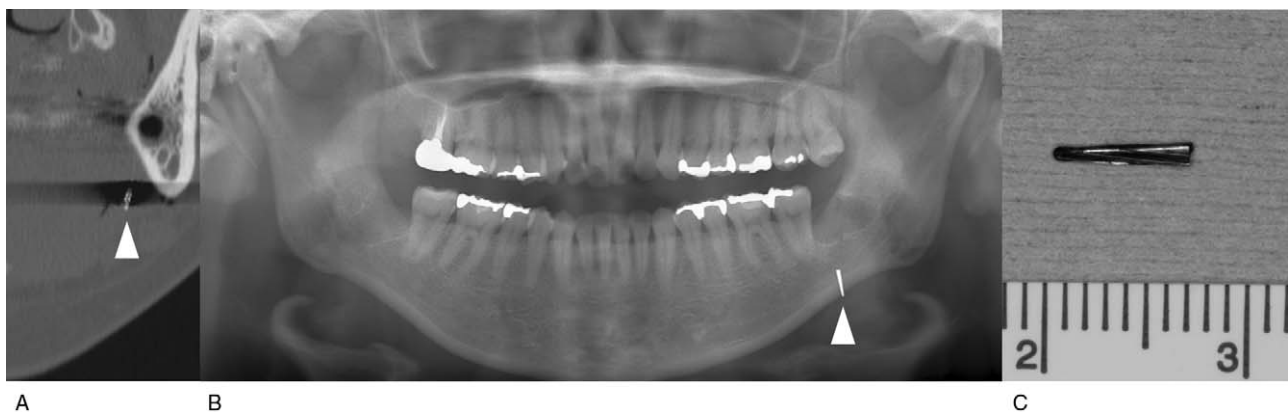
A 33-year-old woman visited a dental clinic for left mandibular third molar extraction. Because the dental hand-piece bur broke and migrated into the floor of mouth during tooth extraction, the patient presented to our department for removal of the fractured bur fragment on that day. Physical examination showed no remarkable symptoms. Intraoral examination showed an extraction wound of the mandibular left third molar, and the fractured bur fragment could not be confirmed. Preoperative CT examination revealed a straight radiopaque foreign body having a length of 7 mm beneath the mucous membrane of the mouth's floor (Fig. 2A, B). The authors performed emergency surgery to

Figure 2. Case 2. (A) Preoperative computed tomography. (B) Preoperative panoramic radiograph. (C) The foreign body.

remove the foreign body under local anesthesia in consideration of the risk of removal and damage to other organs, because the foreign body remained in the soft tissue. A careful search using a fiber light accompanied by suctioning and compression to the submandibular region contributed to the detection of the dental hand-piece bur. The foreign body was removed, and complete removal of the foreign body was confirmed by postoperative x-ray examination (Fig. 2C). The postoperative course was uneventful.
