# Polyethylene Liner Dissociation after Reverse Shoulder Arthroplasty Dislocation: a Case Series

Radiology Case. 2020 Aug; 14(8):14-23 :: DOI: 10.3941/jrcr.v14i8.3836

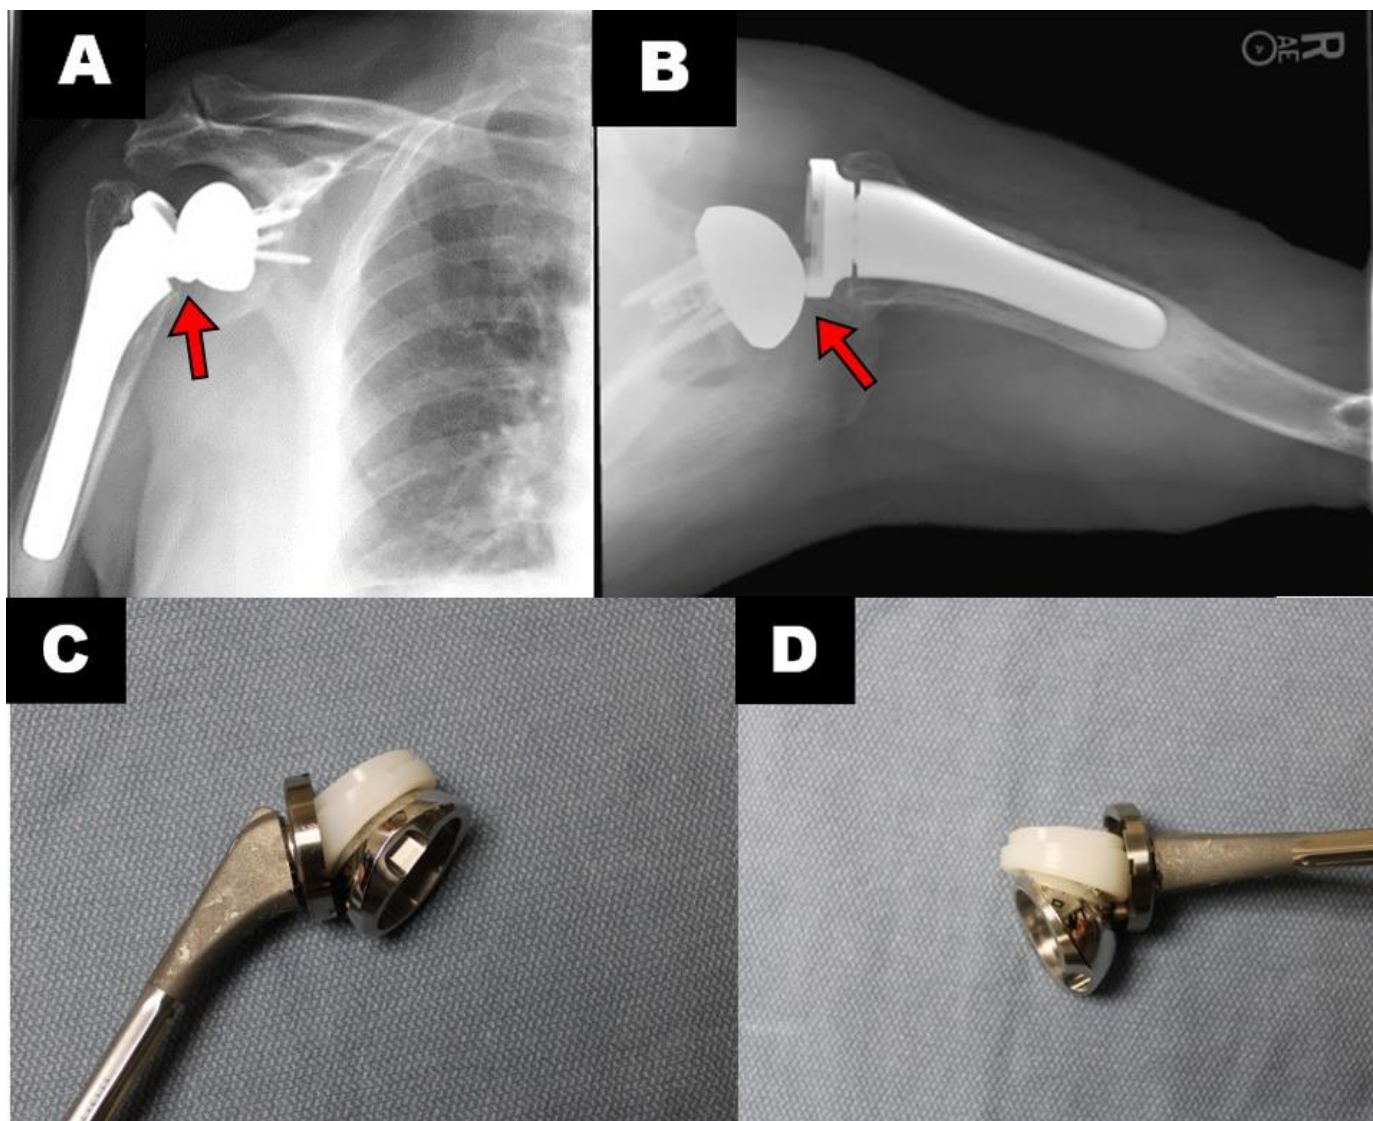
that the components might also be infected due to changes in the appearance of the incision scar. Plain radiographs and computed tomography (CT) images were concerning for dislocation, however the polyethylene was not appreciated. There was apparent loosening of the humeral stem, which was consistent with infection, so open treatment was planned.

The patient underwent operative exploration of the shoulder. Upon entering the shoulder joint, the polyethylene was found to be completely dissociated from the humeral tray. The patient was also found to have extensive loosening of the humeral component. An antibiotic spacer was then placed,

**Figure 1:** A 58-year-old male with reverse shoulder arthroplasty dislocation with polyethylene liner dissociation  
Findings/technique- Anteroposterior (A) and axillary lateral (B) radiographic views demonstrate dislocation with complete polyethylene liner dissociation with subluxation appearance (less than 100% displacement) compared to a full dislocation (arrow). This is only possible with the liner dissociation. Photographs of components demonstrating the positioning of the humeral stem, tray and polyethylene liner in relation to the glenosphere that corresponds with the previous radiographs (C & D).

and the patient was placed on appropriate antibiotic regimen. Intraoperative samples grew *Cutibacterium acnes* (*C. acnes*). The patient was treated definitively with the antibiotic spacer.

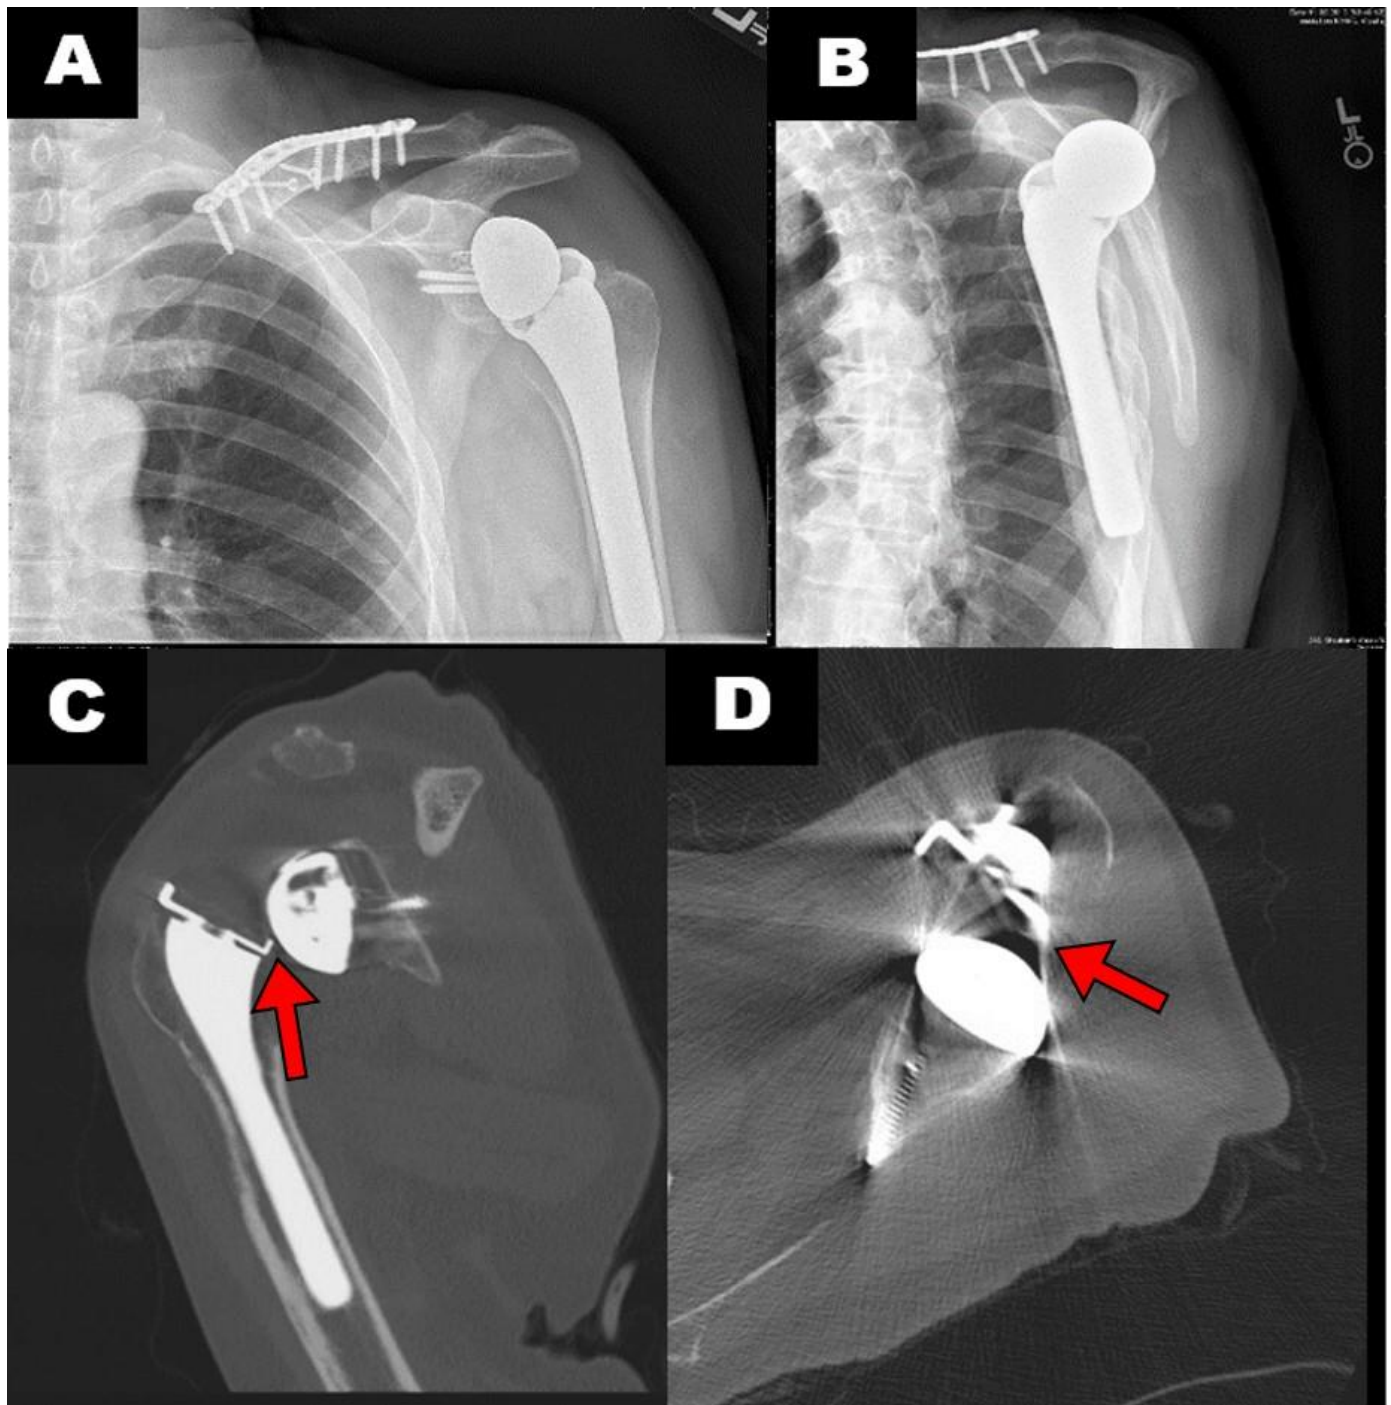
A 61-year-old male with Parkinson's disease was treated with a left RSA for rotator cuff arthropathy. The patient had an uncomplicated postoperative period. Approximately 8 months postoperatively, the patient had a dislocation event precipitated by his dog jerking on his leash. When seen in clinic, there was a palpable mass anteriorly with concern that it might be the humeral liner, and the patient noted exquisite pain. Images taken acutely at an outside emergency department were read as negative (Fig. 2, a-b). Our own review of the imaging was concerning for complete polyethylene dissociation, and a CT scan was obtained demonstrating subluxation of the components (Fig. 2, c-d). Therefore, open treatment was planned for presumed polyethylene liner dissociation.

**Figure 2:** A 61-year-old male with reverse shoulder arthroplasty dislocation with polyethylene liner dissociation  
Findings/technique - Anteroposterior (A) and scapular Y (B) radiographic views taken acutely in the emergency department and not felt to represent a dislocation. An axillary lateral view was not obtained. A CT scan was taken with representative coronal (C) and axial (D) cuts demonstrating the subluxated appearance (arrows) that is found with polyethylene dissociation.

The patient underwent revision reverse shoulder arthroplasty of the affected side. Intraoperatively the polyethylene was completely dissociated. There was no concern intraoperatively for infection. A larger glenosphere was implanted and a constrained liner was placed. Intraoperative cultures returned positive for *C. acnes*, and the patient was placed on antibiotic therapy. The patient was last seen 4 months out from his most recent surgery and had no further complications, was without pain, and denied any instability symptoms. His range-of-motion is 140 degrees in forward flexion and 45 degrees of external rotation with his elbow at his side.

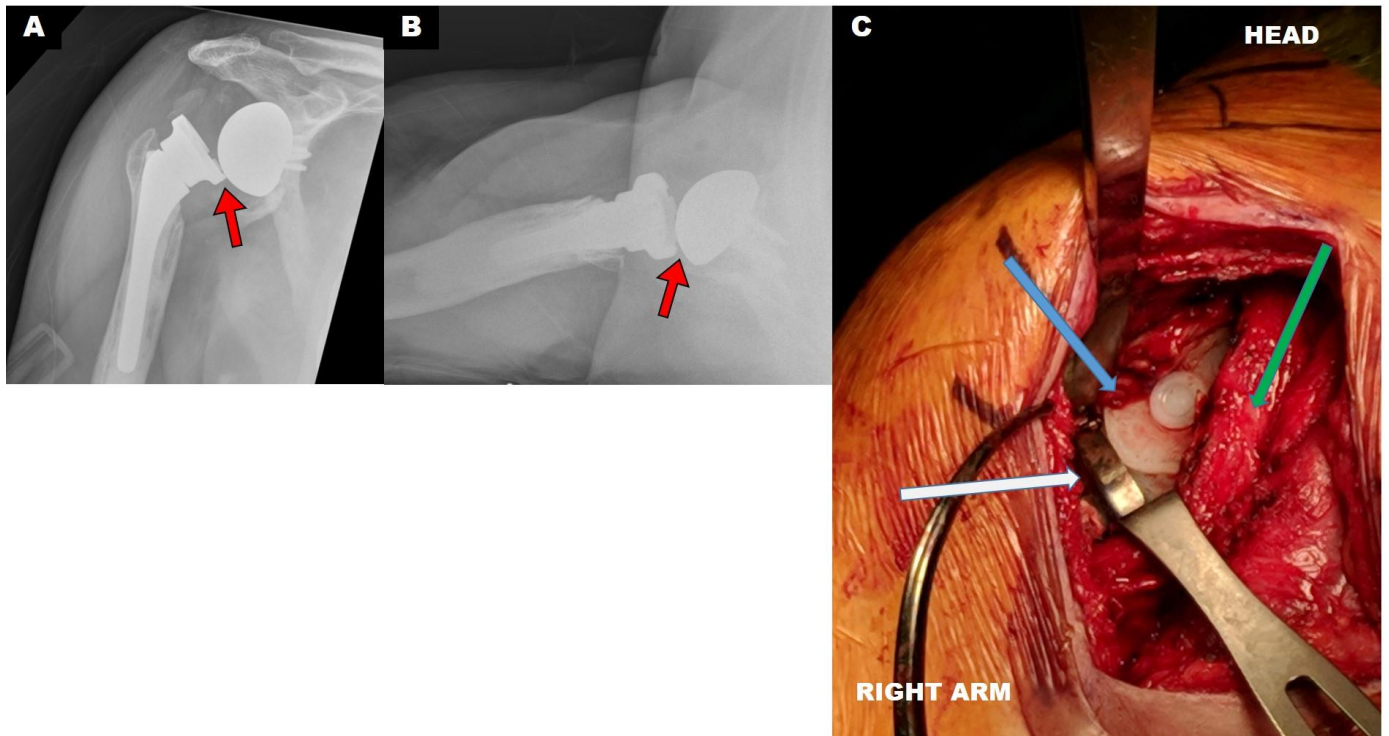
A 74-year-old male was treated with a right RSA for rotator cuff nine years prior to presentation at our facility. He had sustained multiple dislocations and infections in the past, which were treated with hardware explantations and placement of an antibiotic spacer as well as revision hardware implantation. His most recent surgery was a revision right RSA reimplantation after clearance of an infection eight months prior to presentation to our facility. He sustained a dislocation with complete polyethylene dissociation after a fall from ground level (Fig. 3, a-b), and open treatment was planned.

**Figure 3:** A 74-year-old male with reverse shoulder arthroplasty (RSA) dislocation with polyethylene liner dissociation  
Findings/Technique - Anteroposterior (A) and axillary lateral (B) radiographic views again demonstrating the subluxated appearance found with polyethylene dissociation (red arrow). This patient had previously received revision RSA for prior dislocations. Despite the relatively normal appearance of the axillary radiograph (which is obtained by placing the arm in abduction) the anteroposterior radiograph clearly demonstrates the subluxation consistent with complete polyethylene dissociation (red arrow). Upon entry into the shoulder joint during surgery, the completely dissociated polyethylene was visualized (C). The patient is in a beach chair position with a view into the deltopectoral approach to the shoulder. The humeral tray (white arrow), polyethylene (blue arrow), and subscapularis/glenohumeral capsule (green arrow) are visualized.

The patient underwent revision reverse shoulder arthroplasty of the affected side. Intraoperatively the polyethylene was completely dissociated (Fig. 3c). The previous components were well fixed and intraoperative frozen sections were negative for infection, so revision was undertaken. The glenosphere was retained, but a constrained polyethylene liner and a thicker humeral tray were used. The patient's intraoperative cultures also returned positive for *C. acnes* and the patient was placed on antibiotic therapy. His most recent follow-up was 4 months after surgery. At that

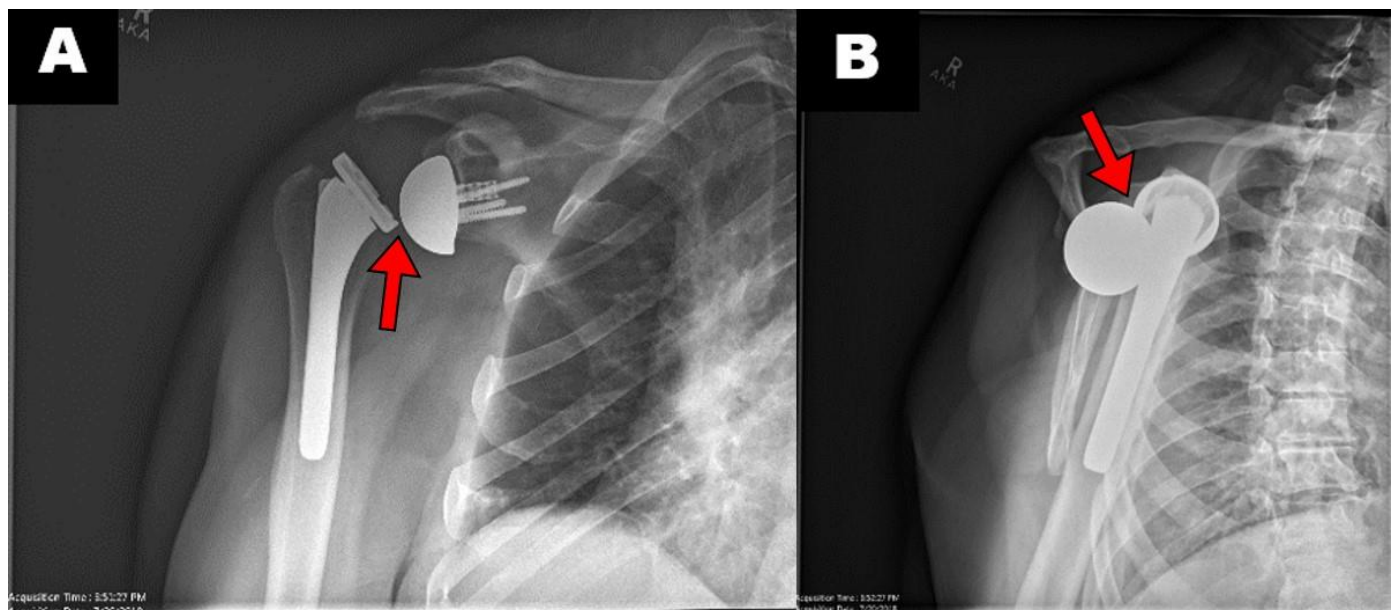
**Figure 4:** A 60-year-old male with reverse shoulder arthroplasty dislocation without polyethylene liner dissociation  
Findings/Technique - Anteroposterior (A) and scapular Y (B) radiographic views of first dislocation at outside hospital prior to reduction attempt (arrow). This is consistent with a complete dislocation without polyethylene dissociation based on near 100% displacement of the components.

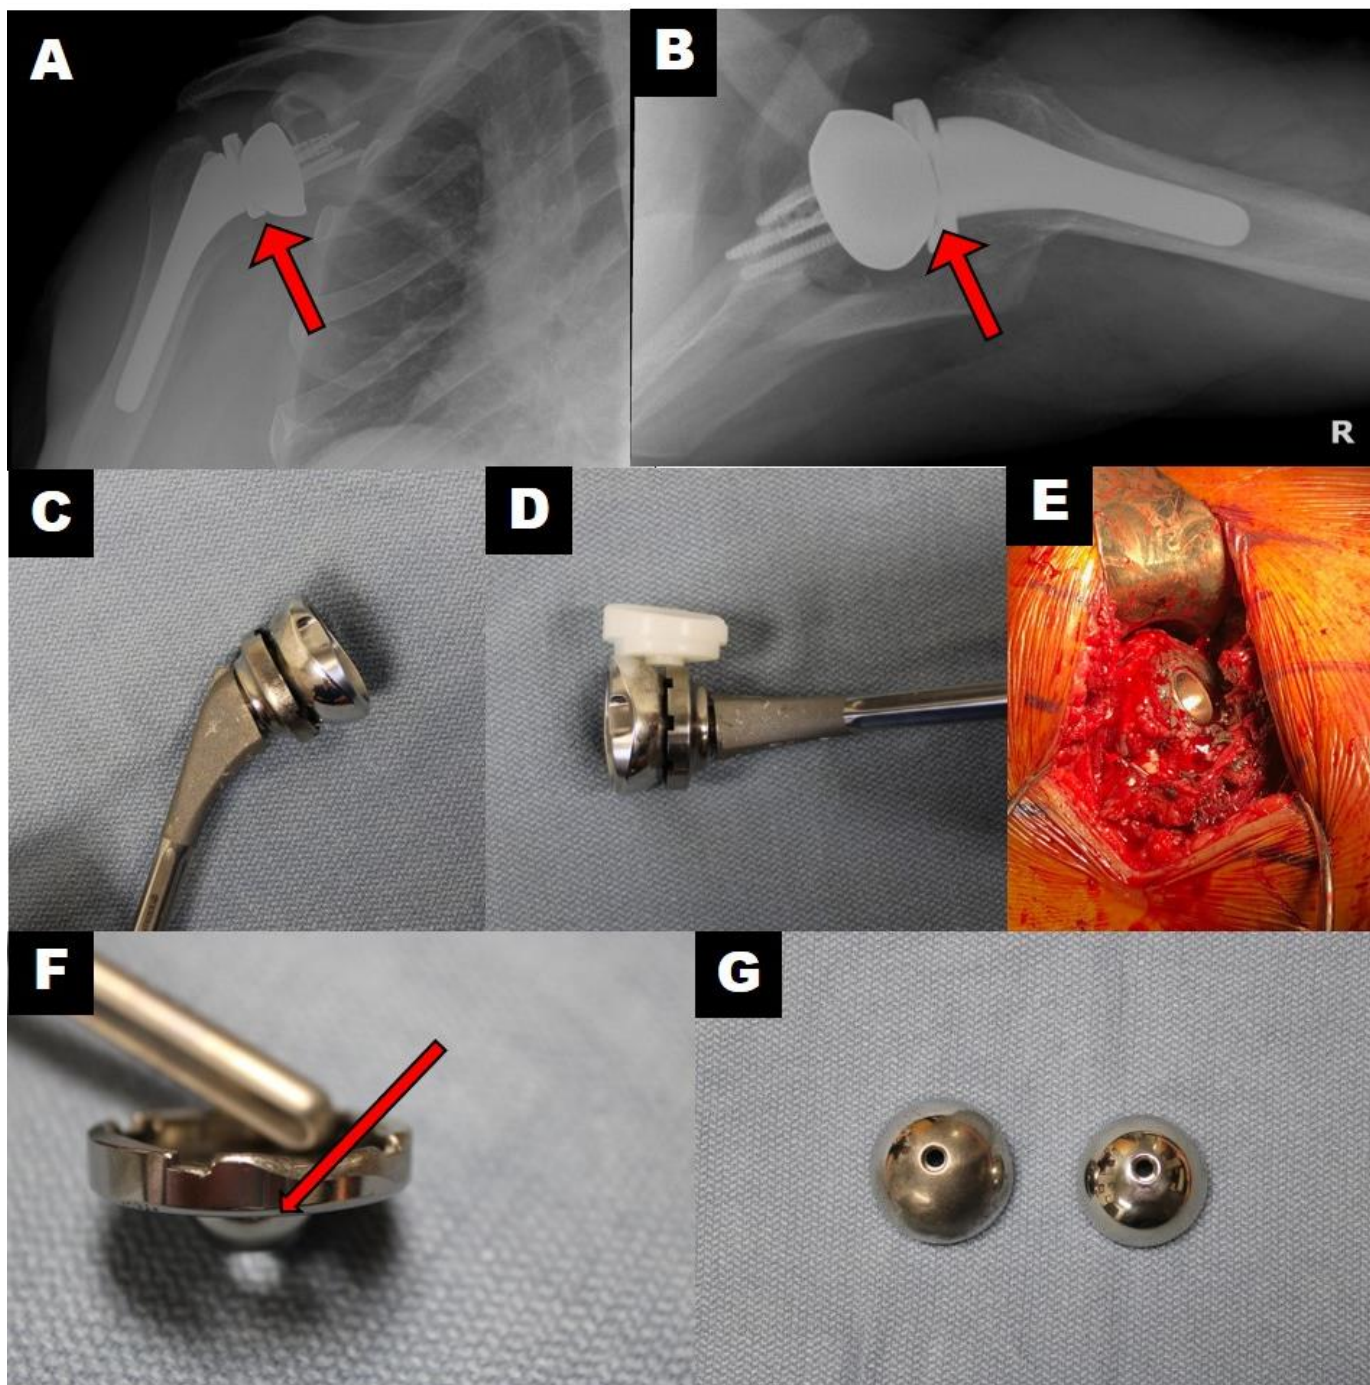
The patient underwent revision reverse shoulder arthroplasty. Upon entering the shoulder joint, the polyethylene was found to be dissociated from the humeral tray. The polyethylene exhibited significant wear. There was extensive metallosis present in the shoulder (Fig. 5e), and the glenosphere and metal humeral tray also demonstrated wear from the unintended metal-on-metal articulation (Fig. 5, f-g). Due to the wear, the components were replaced, and the polyethylene was upsized to increase stability. The patient's most recent follow-up was five months postoperatively, at which time he was doing well without further complication. His range of motion on exam was 130° forward flexion, abduction to 10°, external rotation of 30° with the elbow at the side and internal rotation to the level of his belt. He has smooth motion about the components with no crepitus, pain, or complaints of instability.

**Figure 5:** A 60-year-old male with reverse shoulder arthroplasty dislocation with polyethylene liner dissociation  
Findings/Technique - Anteroposterior (A) and axillary lateral (B) radiographic views of what was read as a concentric reduction. Further review of these radiographs demonstrate that the glenosphere is contacting the humeral tray (red arrows), which should not be possible if the polyethylene is in its proper location. Photographs taken in coronal (C) and axial (D) planes demonstrating the position of the components intraoperatively. Intraoperative photograph showing significant metallosis. Head is at the top of the picture and arm is at the bottom (E). Gross appearance of the patient's components (F) after hardware removal, noting the wear to the edge of the humeral tray (red arrow) as well as the burnishing of the patient's glenosphere (G, left) as compared to a new one (G, right).

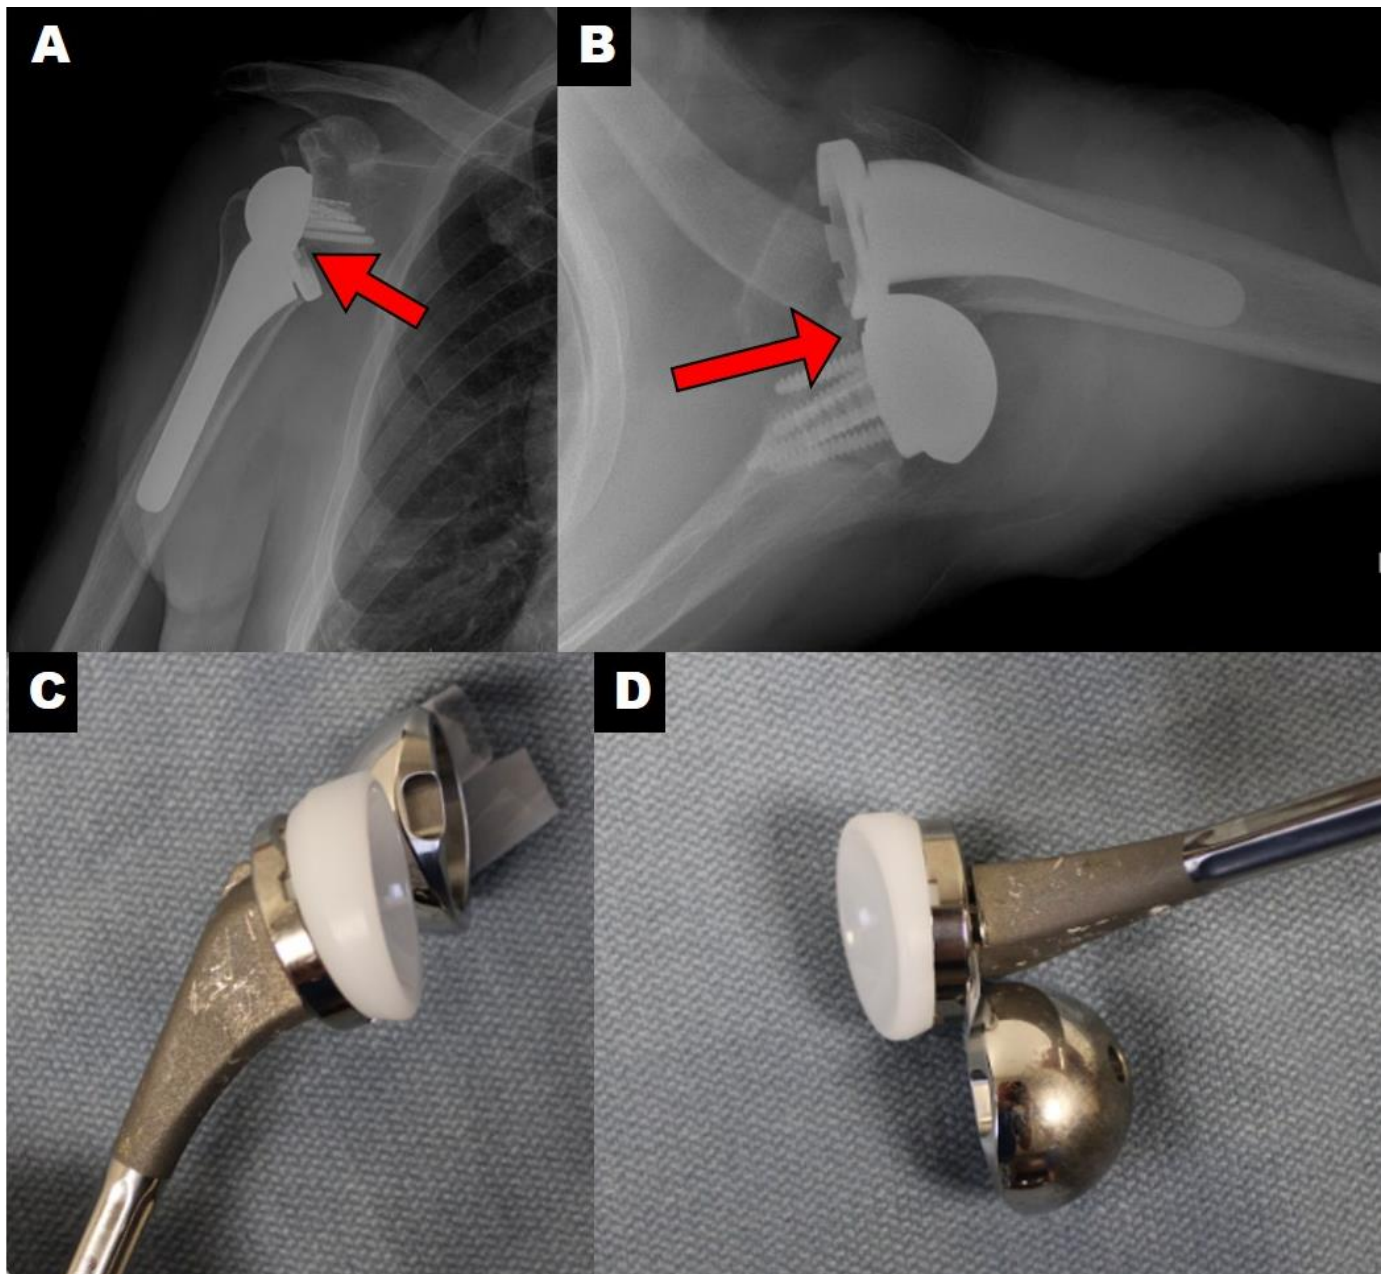
**Figure 6:** A 68-year-old male with reverse shoulder arthroplasty dislocation without polyethylene liner dissociation  
Technique - Anteroposterior (A) and axillary lateral (B) radiographic views demonstrating a complete dislocation in which the polyethylene liner remains attached to the humeral tray.  
Findings - The images show at least 100% displacement (arrow). Photographs of components demonstrating the positioning of the humeral stem, tray and polyethylene liner in relation to the glenosphere that corresponds with the previous radiographs (C & D).
