## Case report

# Inferior vena cava filter fracture and migration to the pulmonary artery

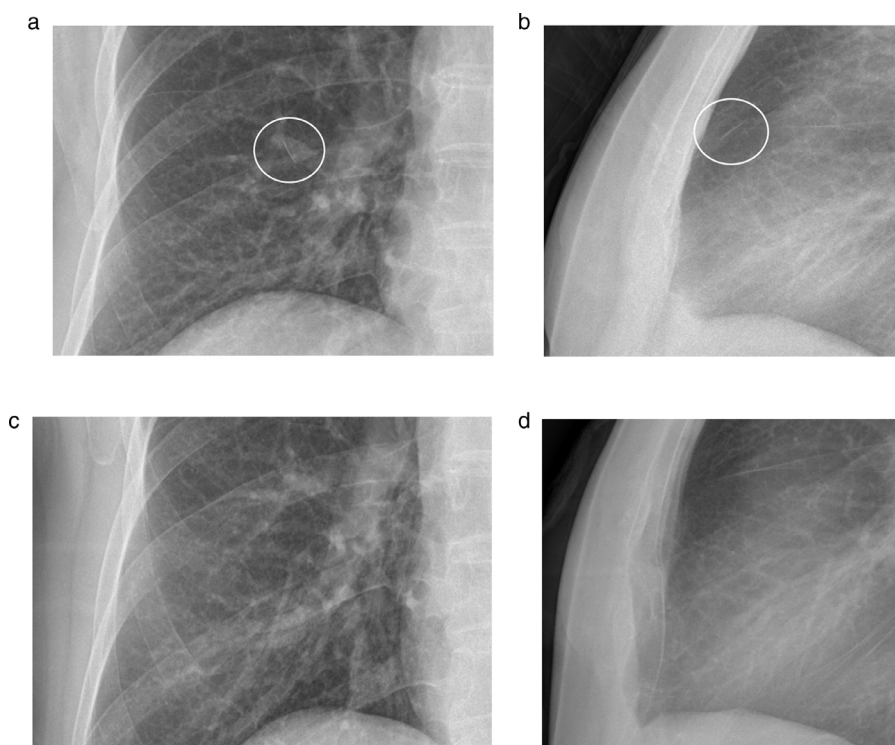
A 60-year-old woman with chest wall pain after slipping presented at our hospital. An initial plain chest radiograph showed no bony fracture in the thorax; however, a single linear radio-opaque density was detected in the right lung field (Fig. 1A and B).

**Fig. 1 – Plain chest PA (A) and lateral (B) radiographs 8 years after filter placement showing a single linear opacity in the right upper lung field (white circle). Plain chest PA (C) and lateral (D) radiographs 6 years after filter placement showing no abnormal finding in the same region.**

Six years after the placement of IVC filter, she presented our emergency department with headache. The plain chest radiograph showed no abnormal finding at that time (Fig. 1C and D). However, on this time, eight years after placement of the IVC filter, a plain chest radiograph showed a linear filter strut projecting over the right hemithorax. She underwent chest CT scan. An axial CT scan of the chest demonstrated a strut fracture in the IVC filter and a migrated fragment of the strut appearing as a bright radio-opaque structure within a branch of the right pulmonary artery (Fig. 2). On the abdominal radiograph, an irregularity or discontinuity of the IVC filter in the right upper quadrant of the abdomen (Fig. 3A) was detected. Three-dimensional reconstruction of the IVC filter demonstrates a more detailed structure of the fractured filter (Fig. 3B). And we add a picture show-

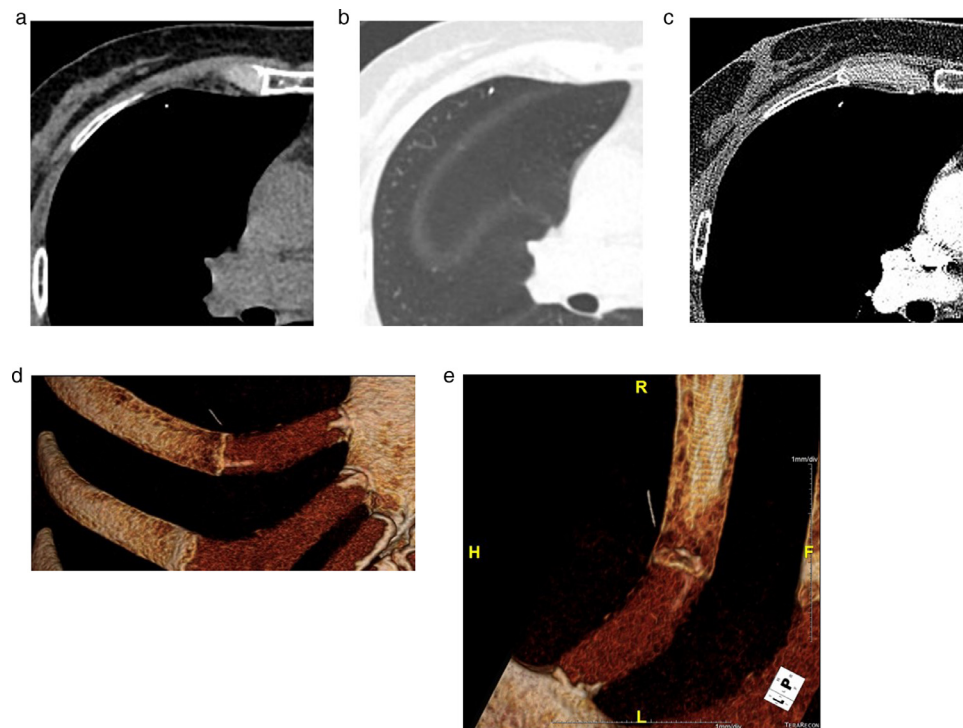
**Fig. 2** – Precontrast (A), lung window (B), and postcontrast (C) axial CT scans of the chest demonstrating the fractured and migrated IVC filter strut as a bright radiopaque structure within a right pulmonary artery branch. Volume rendering images (D,E) showing a linear radiopaque structure within a right pulmonary artery branch.

After this workup and conservative management, the patient was discharged without chest pain. No manipulation was attempted on the migrated strut and IVC filter and periodic follow-up was planned.

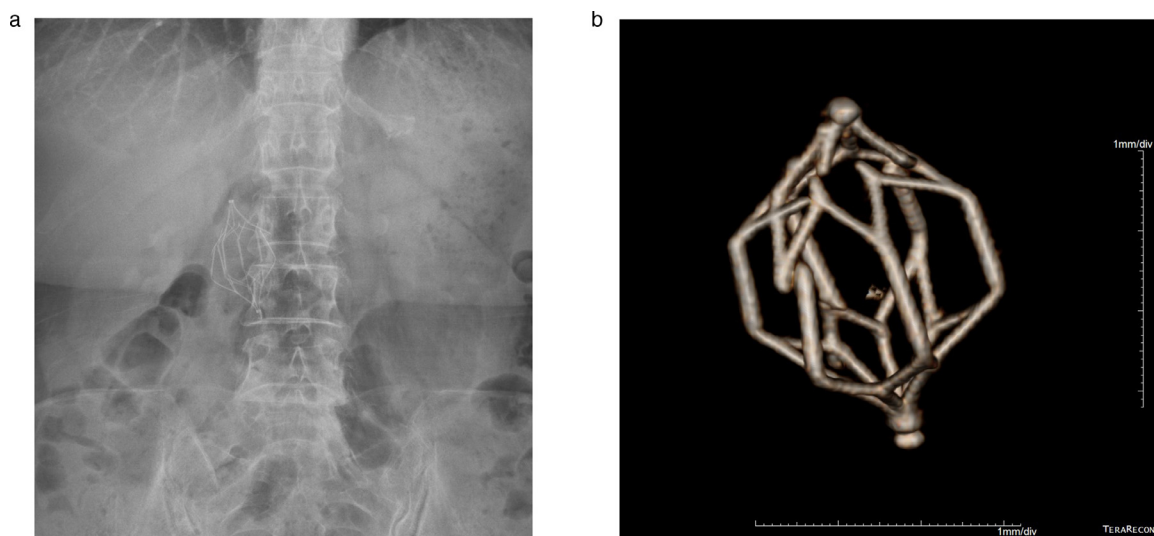
The fracture of filter is caused by metal fatigue. The risk factor of metal fatigue may be related to the tilt of the filter, which is result in continuous stress on the side struts of filter and causes flexion and structural fatigue. [2]

**Fig. 3** – Plain abdomen radiograph (A) and the 3D reconstructed image (B) showing the fractured OptEase IVC filter in the IVC.

Since migrated strut in the lung does not seem to cause clinical problems and surgical resection is the only way to remove it in this case, we decide to remain without removal. In the state of partial penetration of IVC filter into the IVC wall due to a long indwelling time and its radial force, and fracture discontinuity of IVC filter, it is difficult to remove the fractured filter percutaneously. And there is no functional problem of

fractured filter without entrapped thrombus, so it would be right to keep the status quo.
