Neurointervention 2021;16:171-174 https://doi.org/10.5469/neuroint.2020.00444

Electrothermal Coil Detachment Failure in Flow Diverter-Assisted Coiling of a Small Blister Aneurysm: Technical Considerations and Possible Solutions

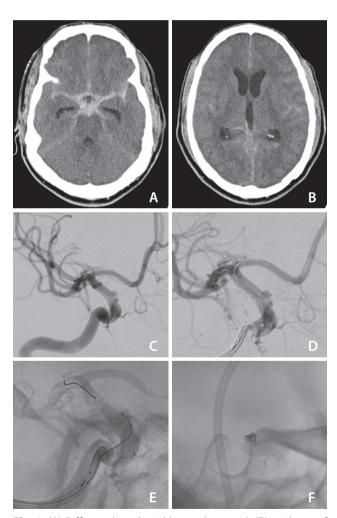
headache and confusion. Computed tomography (CT) confirmed extensive diffuse subarachnoid hemorrhage and moderate hydrocephalus (Fig. 1A, B). CT angiography suggested a small irregularity of the right internal carotid artery (ICA). Diagnostic cerebral angiography confirmed a tiny, wide-necked blister aneurysm, 1.6 mm deepx2.9 mm wide at the neck, arising from the ophthalmic segment of the right ICA (Fig. 1C).

At this point, we considered the position of the microcatheter, with its tip immediately adjacent to the flow diversion stent, meaning that the detachment zone was very likely in direct contact with the stent. We hypothesized that the high metal density in the flow diverter might be interfering with the electrothermal detachment of the coil. The coil was withdrawn a few millimeters into the microcatheter and detached immediately on the first attempt. The pusher wire was then advanced to push the tail of the coil into the aneurysm and successfully withdrawn. A second MicroPlex 10 HyperSoft coil (1.5 mmx3 cm) was deployed and detached in a similar fashion. The flow diverting stent was then fully deployed, and the coiling catheter was withdrawn (Fig. 1F).

Fig. 1. (A) Diffuse subarachnoid hemorrhage with (B) evidence of diffuse intraventricular extension of hemorrhage and early hydrocephalus. (C) Initial cerebral angiogram demonstrating the wide-necked right internal carotid artery aneurysm, after which (**D**) the Pipeline Embolization Device (Medtronic, Irvine, CA, USA) is seen partially deployed before (E) placing the microcatheter tip within the aneurysmal sac. Final result (F) after deployment of 2 coils and full deployment of the Pipeline Embolization Device.

An alternative explanation for the detachment failure could be compression or distortion of the detachment segment due to the high metal density of the stent strut. In this case, mechanically detachable coils might be susceptible to the same problem. It is also possible that heat dispersion away from the detachment zone was affecting the detachment mechanism. However, the solution would be the same in each case. This particular technical issue is most likely to arise in the setting of small, shallow aneurysms, where the tip of the jailed coiling catheter lies at the neck and immediately adjacent to the flow diverter. It may be circumvented by advancing the microcatheter tip away from the stent, if safe and feasible, or by positioning the detachment zone within the confines of the microcatheter. This technical issue and its solution have not been previously reported.

the detachment zone was made away from the stent, and the coil was then detached immediately and uneventfully using the same device.

In summary, flow diverter-assisted coiling is useful in the management of very small, shallow, or blister aneurysms. Failure of coil detachment may result from contact between the flow diverter and the coil detachment zone. Withdrawing the coil a very short distance insulates the detachment zone within the microcatheter, and detachment can successfully occur. Recognizing the reason for detachment failure in this situation facilitates resolution and avoids potential disastrous complications.
