Online SFRA for Reliability of Power Systems: Characterization of a Batch of Healthy and Damaged Induction Motors for Predictive Maintenance

Abstract: Asynchronous motors represent a large percentage of motors used in the electrical industry. Suitable predictive maintenance techniques are strongly required when these motors are critical in their operations. Continuous non-invasive monitoring techniques can be investigated to avoid the disconnection of the motors under test and service interruption. This paper proposes an innovative predictive monitoring system based on the online sweep frequency response analysis (SFRA) technique. The testing system applies variable frequency sinusoidal signals to the motors and then acquires and processes the applied and response signals in the frequency domain. In the literature, SFRA has been applied to power transformers and electric motors switched off and disconnected from the main grid. The approach described in this work is innovative. Coupling circuits allow for the injection and acquisition of the signals, while grids feed the motors. A comparison between the transfer functions (TFs) of healthy motors and those with slight damage was per

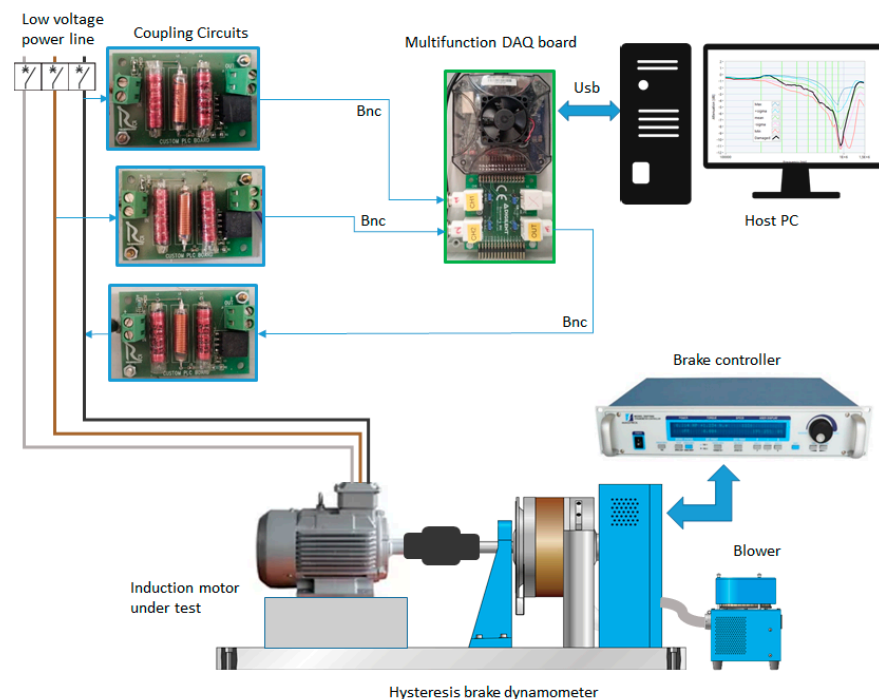
Figure 1. Block diagram of the experimental setup.

The measurement procedure is based on the following steps: (1) simultaneous acquisition of the input V_{in} (with reference to the motor under test) and the output V_{out} signals; (2) application of the Hanning window to both signals; (3) processing of the fast Fourier transform (FFT) of the V_{in} and measurement of the amplitude and frequency (bin position) of the test signal; and (4) FFT processing of the V_{out} and identification of the component with the same bin position as the V_{in} . As previously mentioned, with the test bench, we reproduced the actual operating conditions of the asynchronous motor, feeding it from the grid without an inverter or energy recovery system, in order to not introduce disturbances to the power supply line, to avoid altering the results of the test. The load was carried out using a Magtrol HD 815 hysteresis dynamometer equipped with a Magtrol TM 108 torque and speed transducer. Furthermore, the brake was controlled with a Magtrol DSP 6001 unit, which also acquired torque and speed rotation (Figures 1 and 2).

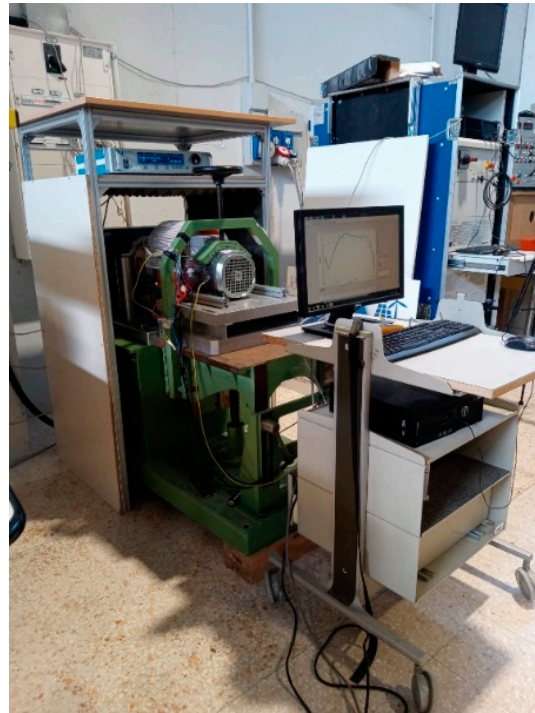
Figure 2. The testing bench.

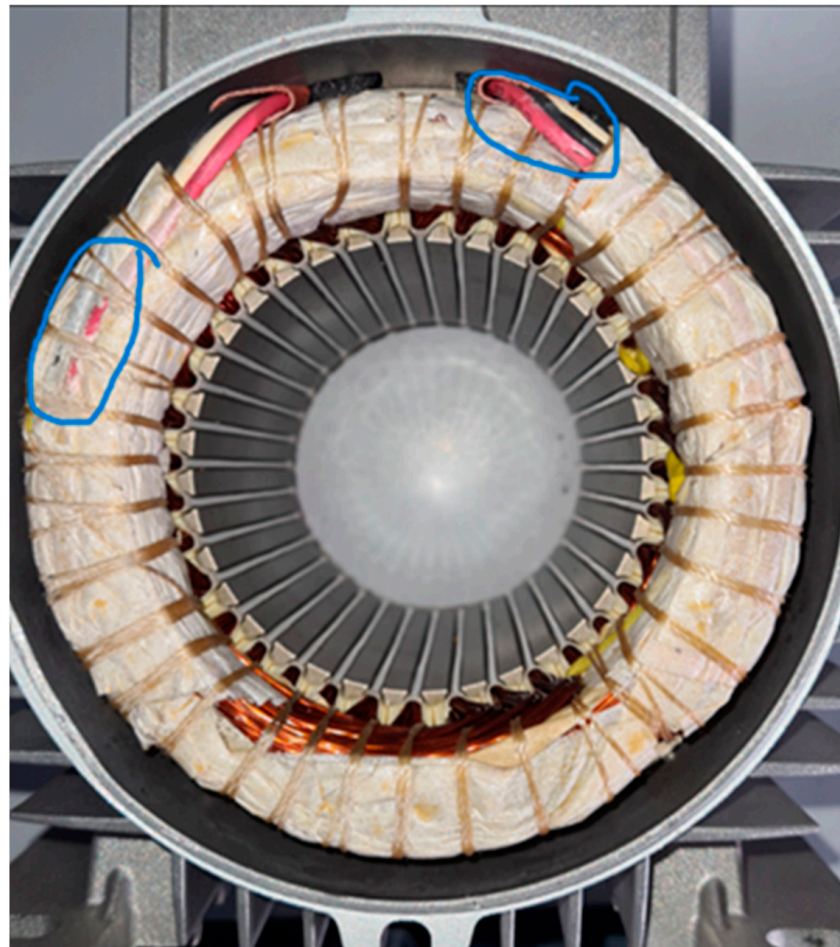
Figure 20. The stator of an induction motor after a fall from a height of 1 m.

Accidents can occur during and after the manufacture of a motor. For example, the stator could be subjected to shocks or falls, not seriously damaging the winding insulation. This type of event can be considered non-critical to the behavior of the motor. However, it can lead to insulation failures during service if the coil deformations are significant. The stator of one of the motors was dropped on the floor from a height of 1 m. The damage to the winding head is highlighted in Figure 20.

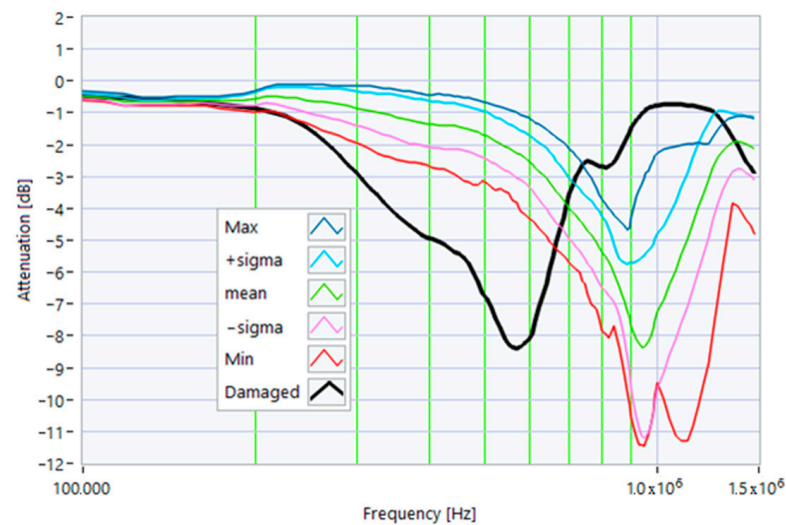
Figure 27. Comparison of the TF of a motor with shorting ring damage with the reference TFs.

From the analysis of the damaged motor TF of Figure 27, in the frequency range from 100 kHz to 1.5 MHz, it appears that 18.0% of the TF values exceeded the max TF envelope, while 61.36% were under the min TF envelope. Therefore, the correlation analysis confirms that this is a critical warning condition. The main peak was at a frequency of 568 kHz.
