Structural consequences of traumatising articular cartilage

N D BROOM

From the Department of Mechanical Engineering, University of Auckland, New Zealand

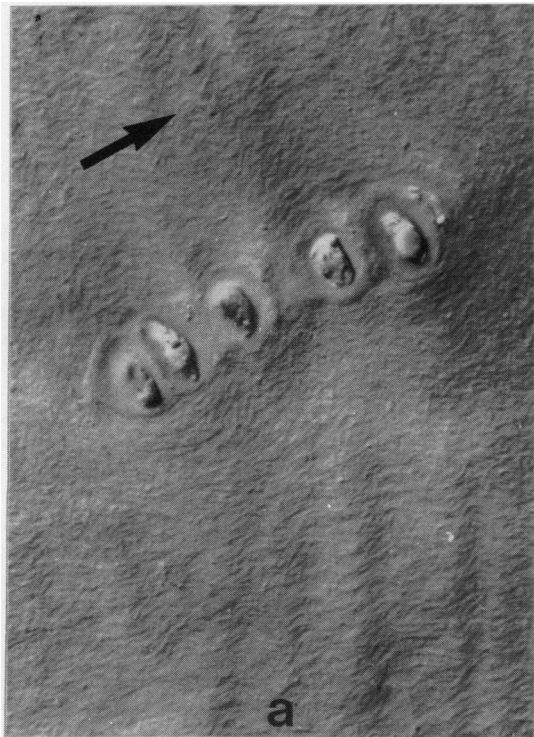
Fig. 3 Variety of matrix textures in middle and deep zones of traumatised tissue: (a) fine radial fibrous arrays with mild crimp in vicinity of chondrocyte column; (b) relatively coarse, crimped radial structure, adjacent to fissure extending from articular surface into deep matrix; (c) radial structure with acute crimp. Arrows indicate radial direction. (All DIC, $\times 590$).

In the most severely traumatised cartilage (see for example region C in Fig. 1) the middle and deep zones showed a significant reduction in optical density as compared with the less damaged or adjacent control regions. This increased matrix translucency was associated with a more acutely crimped radial structure (see Fig. 3c) and at times a distinct loss of coherency in the fibrous arrangement (Fig. 6).

short-range braced configuration most suited to resisting the swelling pressure of the hydrated proteoglycans could then revert to a low energy configuration namely a parallel radial arrangement: a prediction entirely confirmed in the traumatised articular cartilage (Fig. 3). The total length of each fibril previously accommodated within the repeatedly deflected segments of the zig zag configuration would now incorporate a degree of redundancy. This excess length could then be absorbed within the now parallel arrays by means of an in-phase collapse. Again this is consistent with the incorporation of a well defined waveform or crimp in the radial arrays observed in the traumatised cartilage. Further, with a breakdown in the interfibril connections fibrils will be increasingly separated by any additional swelling of the now less constrained proteoglycans (see Figs 9 and 11).

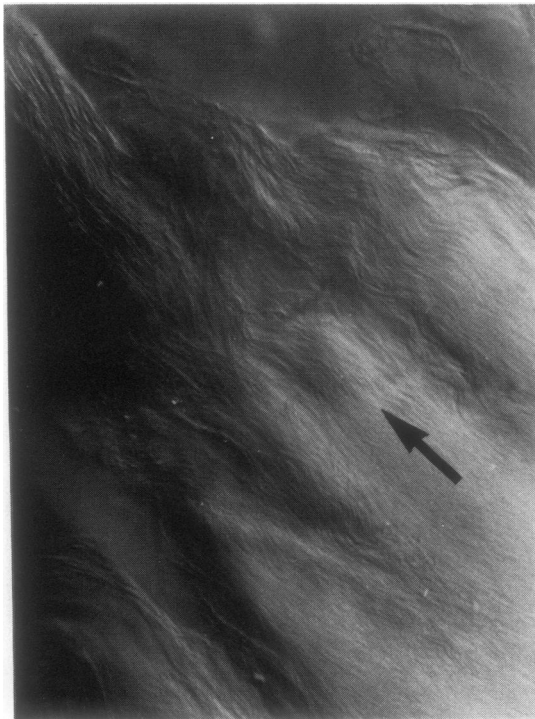
Fig. 4 Exposed mid-zone of traumatised tissue showing radial tufts consisting of fibrous aggregates. Arrow indicates radial direction. (DIC, $\times 212$).

Where the middle zone was exposed directly to the impacting surface it showed a series of radial tufts comprising loose aggregates of aligned and crimped fibres (Fig. 4). In regions where the original cartilage depth had been preserved but penetrated by deep radial clefts (as in region B in Fig. 1) the radial texture was assumed to be associated with a focus of stress acting at or near the roots of these clefts (Fig. 5). Further beyond the cleft root (shown in Fig. 5) the crimped fibrous texture is replaced by matrix which appears normal.

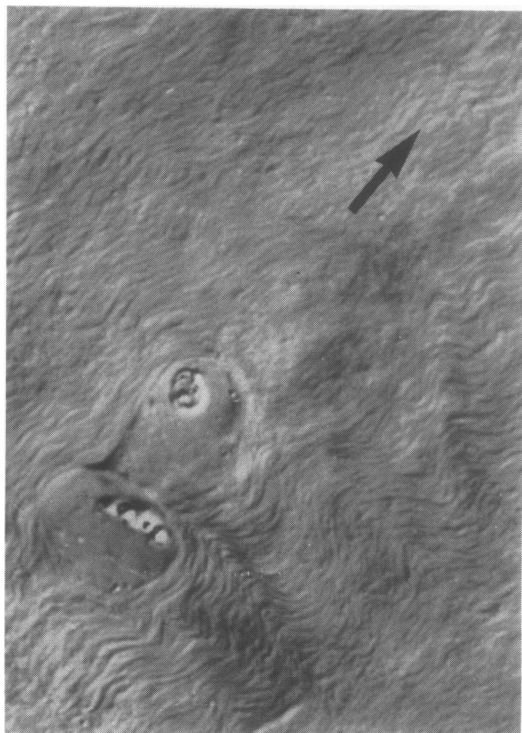
Fig. 13 *Crimped radial texture commonly observed in mid-zone of bovine tibial plateau articular cartilage. Arrow indicates radial direction. (DIC, $\times 590$).*

There are at least two areas where the results of this investigation may have relevance to the general problem of in-vivo cartilage degeneration. Firstly, there is a striking similarity between the crimped radial texture consistently induced in the traumatised cartilage and that of the softened cartilage obtained from the central weight-bearing region of the tibial plateaus of large mammals⁴—a region not covered by the meniscus and therefore in direct contact with the femoral condyle (Fig. 13). These matrix changes occurring in the human knee joint

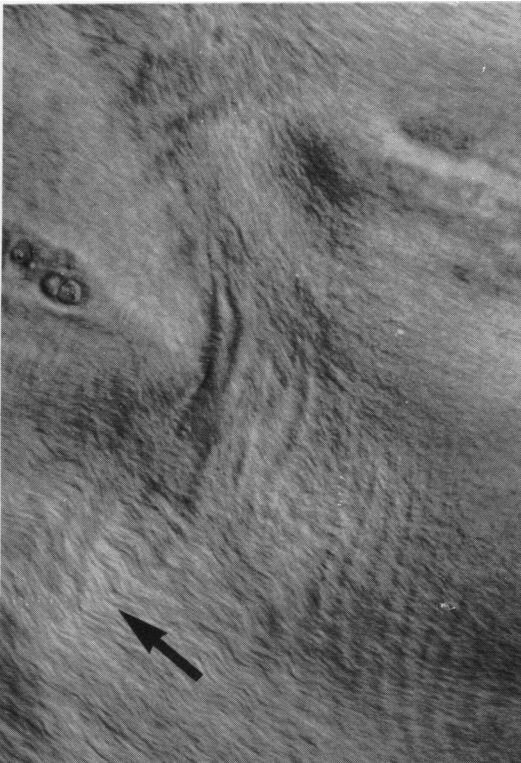
Fig. 14 Crimped radial texture commonly observed in mid-zone of osteoarthritic human femoral head articular cartilage. Arrow indicates radial direction. (DIC, $\times 590$).

frequently shows a similar crimped radial texture easily resolved at the light microscope levels⁶—Fig. 14 shows such an example. While it must be acknowledged that there is little agreement in the literature as to the primary factors which lead to the osteoarthritic breakdown of cartilage, there is a general acceptance that mechanical stress has a significant role in its development.^{21 22} Again it is conceivable that these strong radial arrays are a mechanically induced derivation of the original pseudorandom fibril architecture—this original arrangement being rendered more susceptible to repeated mechanical loading by other complex biological changes.
