# Test Method for Studying the Shrinkage Effect under Controlled Environmental Conditions for Concrete Reinforced with Coconut Fibres

**Abstract:** This study proposes a novel test method and corresponding procedure to evaluate how coconut fibres affect crack propagation rates resulting from plastic shrinkage during the accelerated drying of concrete slabs. The experiment employed concrete plate specimens, which were used to simulate slab structural elements with a surface dimension notably greater than their thickness. These slabs were reinforced with coconut fibre with 0.5%, 0.75%, and 1% fibre content. A wind tunnel was designed to simulate two significant climate parameters (wind speed and air temperature), which could impact the cracking behaviour of surface elements. The proposed wind tunnel allowed air temperature to be controlled alongside wind speed while monitoring moisture loss and the cracking propagation process. During testing, a photographic recording method was used to evaluate cracking behaviour, with the total crack length serving as a parameter to assess the impact of fibre content on the crack propagation of slab surfaces. Additionally, crack depth was measured

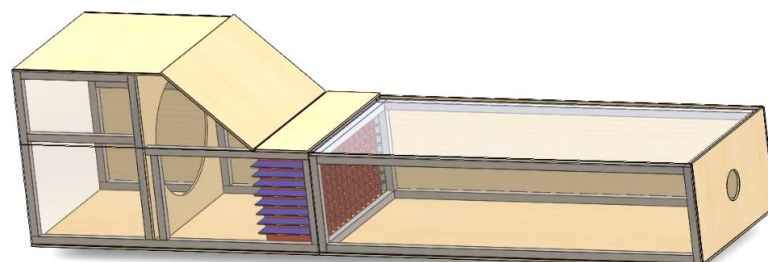
**Figure 1.** A 3D view of the proposed wind tunnel.

A similar model for the proposed wind tunnel was modelled in SolidWorks to check the proposed model and observe the wind flow inside the tunnel, and check the accuracy of the dimensions. All the components were designed to provide the best efficiency and performance. The feasibility and functionality of the proposed model were evaluated by analysing the fluid flow inside the tunnel. After several modelling and related analyses, the final design shown in Figure 1 was achieved.

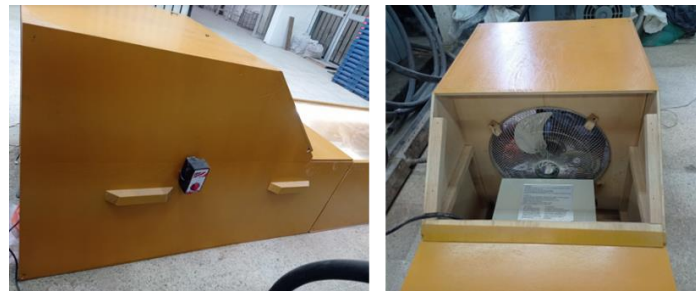
Figure 3 shows Block 1, where the spaces assigned to embed the fan and to place the heater for them to work together can be seen. It is worth mentioning that the fan had to lie behind the heater. This equipment location order was applied considering how the heat produced by the heater could harm the fan's operation. To create a uniform wind flow, a set of square channels was placed in front of the wind outlet (see Figure 2a,b).

**Figure 3.** Block 1.

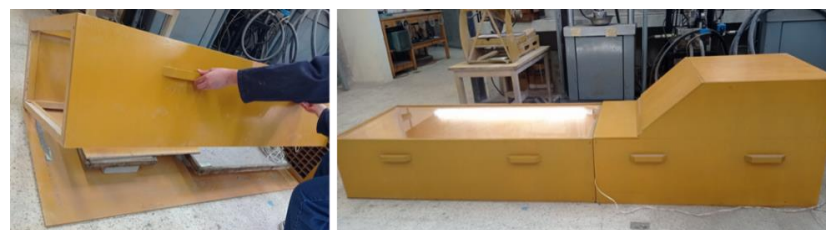
Figure 4 demonstrates Block 2, which is made up of two parts:

- A base that is fixed and firm, where the plate G mould, the anemometer, and the scale sit. It covers an area of 1600 mm × 700 mm.
- A mobile structure (lid) that facilitates placing the mixture inside moulds and avoids unnecessarily transferring plates to the base. This section is 400 mm high. It also allows a suitable distance between the camera and the plate to take images of the cracks that appear during tests.

**Figure 4.** Block 2.

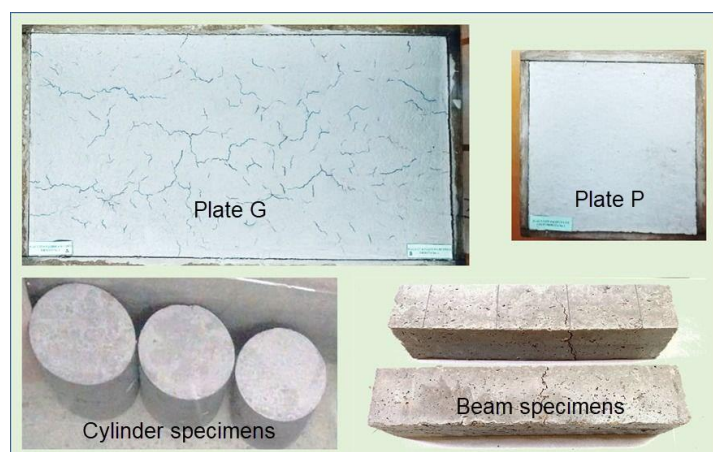
**Figure 5.** Type of test specimens used in the project.

As shown in Table 3, for each concrete type (different fibre doses), four types of specimens were made: the main slab specimen, G plates (75 × 40 × 2.5 cm); a small slab specimen to monitor the water evaporation rate, P plates (30 × 30 × 2.5 cm); concrete cylinder specimens (10 × 20 cm); and prismatic beam specimens (10 × 10 × 40 cm) to obtain flexural strength. Figure 5 shows the employed specimens corresponding to each type.

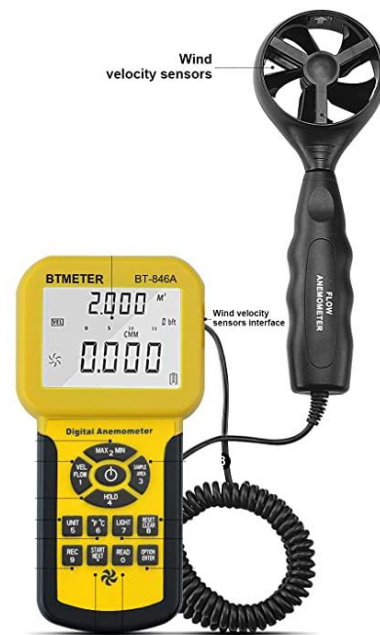
The anemometer (Figure 6) is a sensor that allows the temperature and wind speed produced inside the hot air chamber to be measured and recorded. When a fan is placed inside the wind tunnel, it is possible to adjust and change the wind speed to simulate different climate conditions. Therefore, it was necessary to include a sensor to monitor wind speed during the test process.

This equipment consists of a propeller that measures airflow, a handle with a temperature sensor, and a screen that collects information from the sensor. The wind speed range that this instrument can measure is 0.91–44.99 m/s, and temperatures could range from 0 °C to 59.99 °C.

**Figure 6.** Anemometer: temperature and wind speed sensor.

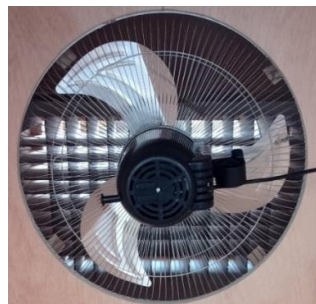
For the airflow to reach the plates' surfaces, it was necessary to use an electric fan (Figure 8) to push hot air, pass it through the grid (transforming the airflow into laminar air), and move it to the study area where the plates were. For this purpose, a 3-speed fan was used.

**Figure 8.** Oscillating 3-speed fan.

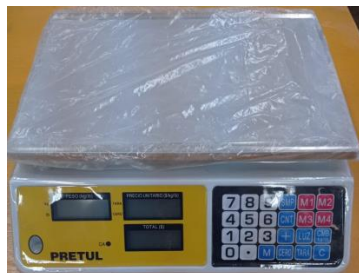
In order to determine moisture reduction on the concrete surface of the P plates, a digital weighing balance with a maximum capacity of 40 kg was used (Figure 9). With this weighing balance, any variation in concrete mass during the testing process was recorded (6 h). These data were recorded every 15 min. It is worth mentioning that to measure these data, a wooden mould was used to cast the P plates, which were placed on the balance.

**Figure 9.** Digital scale with a 40 kg weighing capacity.

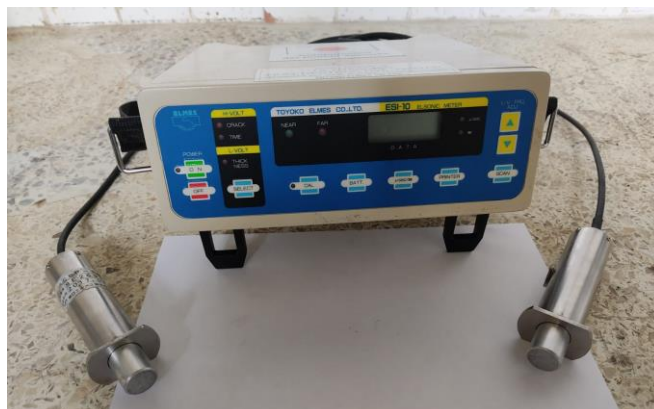
This device (Figure 10) helps to know the crack depth. This test was performed 24 h after manufacturing the G plates. This device generated longitudinal waves that went from an emitter to a receiver (transducers). These waves are not audible because their frequency is below 20 Hz (infrasonic waves), and they travel through concrete. This means that the test is non-destructive and can be applied at any time, provided that concrete is in a hardened state. This process is shown in further detail in Section 2.3.3.

**Figure 10.** Ultrasound equipment.

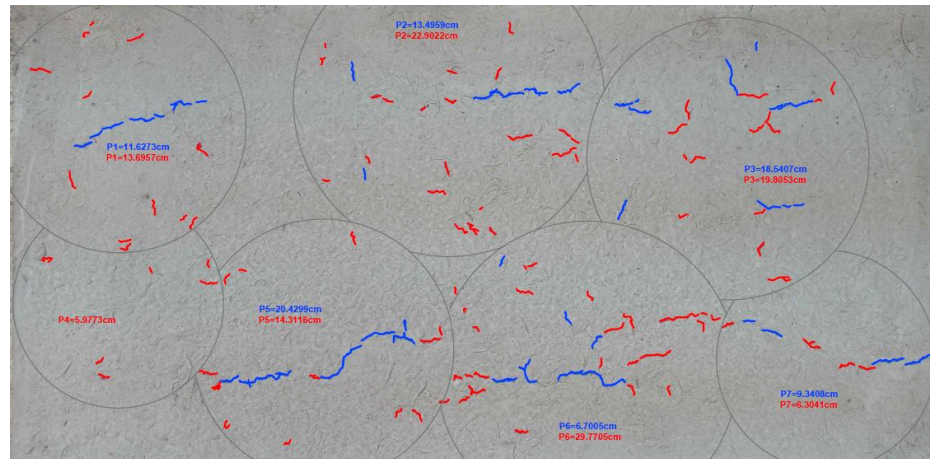
In order to determine the crack length in the G plates, it was necessary to distinguish the appearance of cracks in two groups. The cracks that formed during the 6 h testing were painted blue, while those that occurred outside the chamber, namely at 18 h of testing, were painted red (see Figure 11).

**Figure 11.** Distinguishing cracks on plates.

In order to simplify the measurement process, a picture was taken of the entire plate. It was scaled in AutoCAD and delimited by areas, as shown in Figure 11. Polylines were drawn to obtain the total crack length sum and, thus, to record the data for their respective analysis.

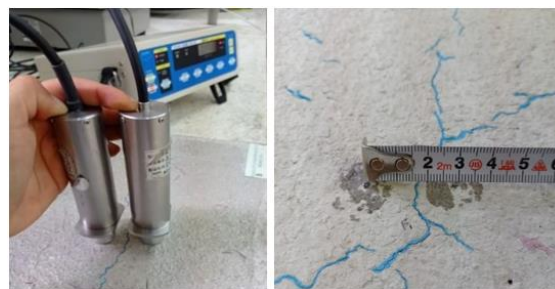
The crack depth measurement procedure was conducted by extending the distance between the ultrasound transmitting and receiving sensors on the crack, with which the position was determined from the equipment's lamp and buzzer (see Figure 12).

**Figure 12.** The crack depth measurement process using an ultrasound device.

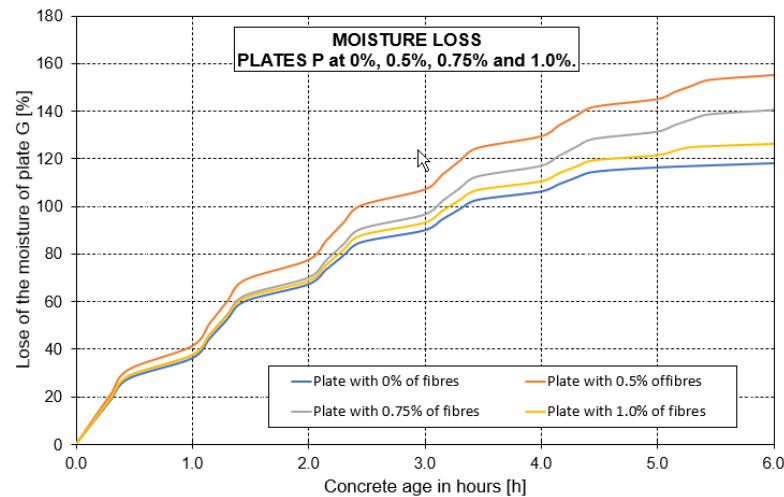
After the drying hours (due to the wind passing over the sample) had passed, the moisture loss in the P plates decreased. This caused concrete hardening and a visible surface drying state. Mass reduction (G plate mass) due to moisture loss was approximately 0.01 kg in the first hour until the temperature stabilised. After this period, mass reduction decreased from 0.02 to 0.025 kg (measured every 15 min.). Figure 14 shows the moisture loss rate during the test time for the P plates as percentages.

Figure 14. Moisture loss rate.

The specimens' moisture loss values were cumulatively presented, i.e., after 6 h of testing at 60 °C and at a wind speed of 1.34 m/s, where the specimens' maximum moisture percentage went from 125% to 165%. The highest moisture loss rate was for the specimen with 0.5% fibres.
