# Investigations on the Surface Integrity and Wear Mechanisms of TiAlYN-Coated Tools in Inconel 718 Milling Operations

**Keywords:** milling; Inconel 718; TiAlYN coatings; HiPIMS technique; tool wear mechanisms; surface integrity

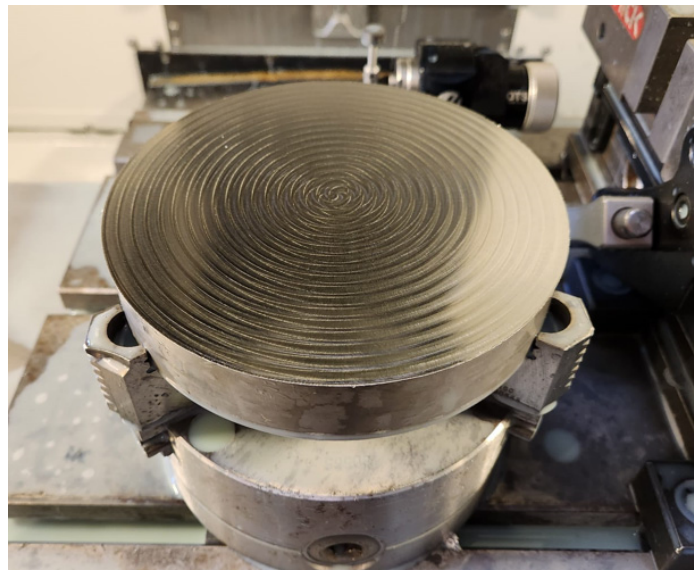
**Figure 1.** Workpiece material and its spiral marks.

Regarding the milling parameters, because the strategy chosen was a spiral to avoid wear-related phenomena, the radial depth of the cut was kept constant. Another parameter was the axial depth of the cut ( $a_p$ , or ADOC). This parameter was suggested by the cutting tool supplier, therefore, initially, values of 0.2 mm and 0.1 mm were applied. However, these values caused the tool to fail and break shortly after the initial plunge. Due to this, the value of 0.08 mm was defined for this parameter, which was kept constant for all tests, as finishing milling operations was the goal to simulate. In addition, as the tool  $\varnothing = 6$  mm, the value of the radial depth of cut ( $a_e$  or RDOC) was defined considering 75% of this value, i.e., 4.5 mm. This parameter also remained constant for all conditions tested. The parameters  $v_c$ ,  $f_z$ , and  $L_{cut}$  were varied, determined based on the provided substrate of the tool. Regarding  $f_z$ , the centre value (100%) was 0.0700 mm/tooth and varied by 25% for less and 50% for more. This parameter was varied as it is known to have a high impact on wear and influence the quality of the machined surface. For  $L_{cut}$ , values of 5 m and 15 m were selected, aiming to analyse the progression of wear throughout the machining of the workpiece. For  $v_c$ , values of 75, 100, and 125 m/min were used, with the purpose of comparing and analysing the influence of cutting speed on the resulting wear and surface integrity. All parameters and test conditions are shown in Table 5, and Figure 1 illustrates the workpiece with its corresponding spiral marks. To fix this workpiece, a self-centring bushing with three jaws, Bison 3575 (BISON-BIAL, Bliesk Podiaski, Poland), was used, and the tools were fixed with an ISO40 DIN69871 cone, an ER32 H70 collet holder, an ISO 7388-2 tie rod, and an ER DIN 6499 collet from the same manufacturer.

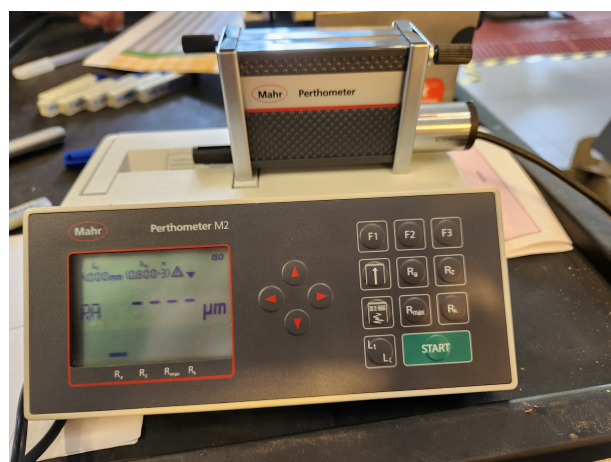
**Figure 2.** Mahr Perthometer M2 profilometer.

Regarding the roughness of the machined surface, this was measured using a Mahr Perthometer M2 profilometer (Mahr, Gottingen, Germany) (Figure 2). The test was carried out following DIN EN ISO 21920-3:2021 [57]. Each test was performed with a cut-off value ( $\lambda_c$ ) of 0.8 mm and a measurement length of 5.6 mm. Moreover, as errors may occur due to the acceleration and deceleration of the probe at the time of measurement, the first and last measurement segments of 0.8 mm were not considered. In addition, measurements were taken in the radial and tangential directions, and a minimum of five measurements were taken in different areas due to the possibility of variation in the values obtained in the centre and on the periphery of the workpiece. With these, the arithmetic average roughness value ( $R_a$ ) was determined.

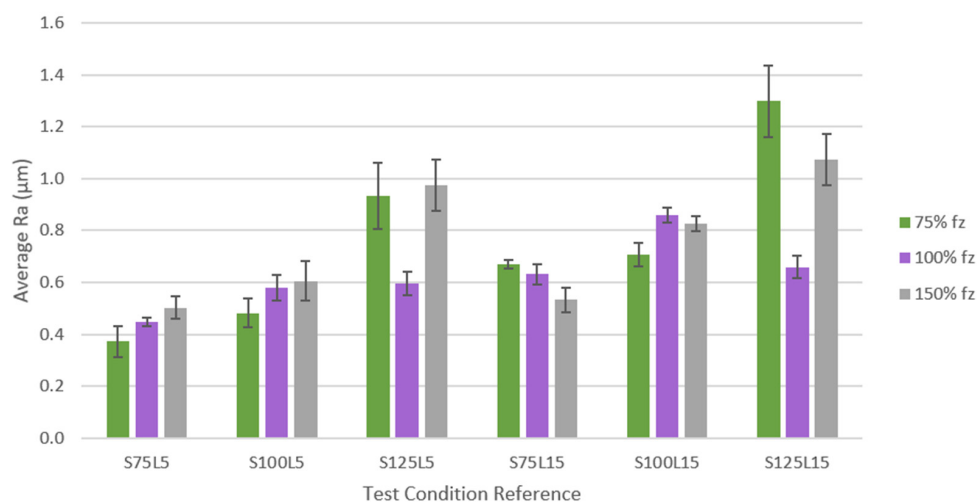
**Figure 3.** Comparison of SR values obtained for all conditions tested.

The influence of the  $f_z$  is not evident for the conditions tested at a  $v_c = 75$  m/min since for a  $L_{\text{cut}} = 5$  m, when the  $f_z$  increased, the roughness also increased. On the other hand, for a  $L_{\text{cut}} = 15$  m, when the  $f_z$  was increased, the SR decreased. Usually, for lower values of  $f_z$ , the quality of the machined surface is better, i.e., the roughness of the machined surface has lower values [60], meaning that the quality of the machined surface could be impaired with the increase in  $f_z$  [56]. However, for conditions with a  $L_{\text{cut}} = 15$  m, this scenario was not observed since there was an improvement in the surface quality obtained. This could have been generated by stabilising the wear behaviour on the tool's cutting edge, homogenising the wear effect on the edge.

Therefore, under the conditions tested at a  $v_c = 75$  m/min, the maximum value of  $R_a$  was obtained for the condition that used 75%  $f_z$  and a  $L_{\text{cut}} = 15$  m, i.e., for condition S75F75L15. The lowest  $R_a$  value was obtained for the condition with 75%  $f_z$  and a  $L_{\text{cut}} = 5$  m, corresponding to the S75F75L5 condition. Thus, it can be seen that for 75%  $f_z$ , when

In the same way as for the conditions tested at 75 m/min, under the conditions tested at 100 m/min, when the  $L_{\text{cut}}$  was increased, the roughness also increased, making this parameter's influence evident. Furthermore, for a  $L_{\text{cut}} = 5$  m, the same was observed as in the previous case: when the  $f_z$  increased, the roughness of the machined surface also increased. However, for a  $L_{\text{cut}} = 15$  m, when increasing the  $f_z$  from 75% to 100%, the roughness increased significantly, and when increasing the  $f_z$  to 150%, the roughness decreased slightly compared to 100%  $f_z$ . Therefore, by increasing the  $f_z$ , the roughness of the machined surface tends to be worse. Thus, it appears that this parameter greatly influences the roughness of the machined surface [61].

In the same way as in the conditions at 75 m/min and 100 m/min, in the case of using 125 m/min, when increasing the  $L_{\text{cut}}$  from 5 m to 15 m, the SR also increases. Regarding the  $f_z$ , there seems to be some instability in the process under conditions at 75% of this parameter, given the discrepancy in the values obtained. However, for 100% and 150% of this parameter, for both 5 m and 15 m, it is observed that when the parameter increases, the roughness also increases, and the quality of the machined surface decreases.

In general, it can be seen that average  $R_a$  values tend to increase for higher  $L_{\text{cut}}$  values, a trend that is registered for all conditions tested. In some conditions, this increase is more pronounced, as is the case in conditions S75F75, S100F100, and S125F75. On the other hand, this increase is slight in some conditions, for example, in conditions S75F150, S125F100, and S125F150.

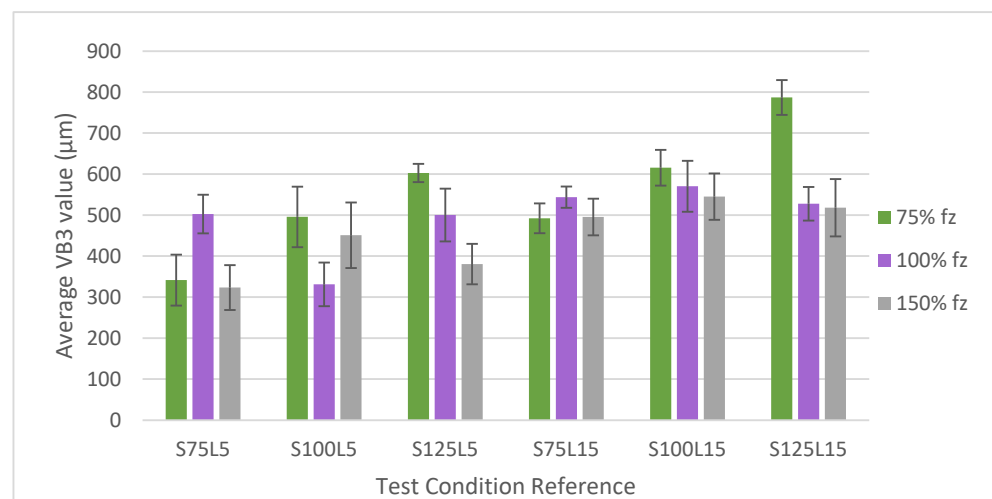
**Figure 4.** Comparison of VB3 values obtained for all conditions tested.

For conditions tested at a  $v_c = 75$  m/min, the influence of the  $L_{\text{cut}}$  is evidently clear when the  $L_{\text{cut}}$  increases from 5 m to 15 m. However, at 100%  $f_z$ , this increase was slightly higher. Regarding the influence of the variation in the  $f_z$  on the flank wear ( $VB$  as ISO 8688-2:1986 [58] of the tools, for a  $L_{\text{cut}} = 5$  m the lowest value obtained was for condition S75F150L5. Wear increased when increasing the  $f_z$  from 75% to 100% and decreased when increasing to 150%. In turn, the same trend was observed for the cases tested at a  $L_{\text{cut}} = 15$  m; increased wear from 75% to 100%  $f_z$ , and a reduction as the increase continued to 150%. At 100%  $f_z$ , and a  $L_{\text{cut}} = 15$  m, the maximum  $VB$  was observed. It was also noted that the condition of a  $L_{\text{cut}} = 5$  m and 100%  $f_z$  presented greater wear than conditions with a  $L_{\text{cut}} = 15$  m and 150%  $f_z$ .

For conditions tested at 100 m/min, the same situation as in the previous case is observed regarding the  $L_{\text{cut}}$ . When increasing from 5 m to 15 m, the resulting  $VB3$  is higher. This is due to the properties of Inconel 718, such as the thermomechanical tool load, which generates high abrasive damage [65]. However, no clear influence of the  $f_z$  parameter is observed. For a  $L_{\text{cut}} = 5$  m, when increasing from 75% to 100%  $f_z$ , the  $VB3$  decreases, and when increasing it to 150%, the  $VB3$  increases, but with a lower value than in the first condition (F75L5). On the other hand, for a  $L_{\text{cut}} = 15$  m, when the  $f_z$  is increased, the  $VB3$  decreases in all  $f_z$  conditions.

Under the conditions tested at 125 m/min, the influence of  $L_{\text{cut}}$  was also observed. In all conditions,  $VB3$  increased when  $L_{\text{cut}}$  increased. This is due to the properties of Inconel 718, which causes abrasive damage and can consequently lead to tool chipping [65]. However, for 100% of the  $f_z$ , this increase was lessened. Furthermore, the conditions with 75%  $f_z$  presented the highest  $VB3$ , higher for 15 m than the  $L_{\text{cut}} = 5$  m.

As for the  $v_c$  used in each condition, it can be observed that when this parameter is increased in conditions with 75%  $f_z$ , VB3 also increases. For conditions at 100%  $f_z$ , a clear trend cannot be identified. Regarding a  $L_{cut} = 5$  m and 100%  $f_z$  conditions, wear decreases when increasing from 75 m/min to 100 m/min and increases when increasing to 125 m/min. However, in the last condition, the VB3 is similar to the first condition. In turn, for 150%  $f_z$ , wear increases when increasing the  $v_c$  from 75 m/min to 100 m/min and decreases when increasing to 125 m/min at both  $L_{cut}$  values.

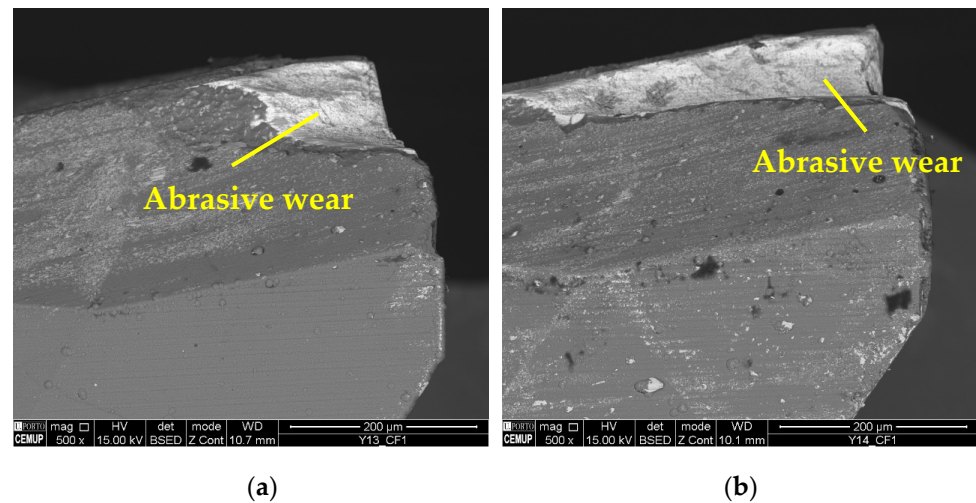
**Figure 6.** Abrasive wear: (a) clearance face (CF1) of S75F75L5 at 500× magnification and (b) clearance face (CF1) of S75F75L15 at 500× magnification.

As for the wear mechanism, it can be said that for 75 m/min conditions, mainly abrasion wear and adhesive wear were observed, both on the substrate and on the coating. In addition, in some conditions, delamination and cracking of the coating occurred. Mechanical mechanisms such as abrasion and adhesion are common in terms of the wear suffered by cutting tools in the milling process [73]. Figure 6 illustrates the abrasive wear that occurred on the substrate of the cutting tool under the S75F75L5 and S75F75L15 conditions, where, for 15 m, the wear is more developed. Abrasive wear was detected for all the tests, and was more significant and more intense for the  $L_{cut} = 15$  m.

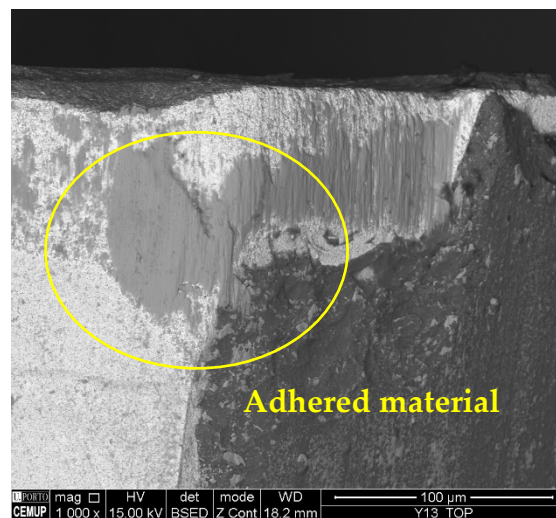
**Figure 7.** Adhered material: top view of S75F75L5 at 1000× magnification.

As for the presence of adhered material, it was found in all conditions and in great quantities. This is an expected result, since Inconel 718 usually tends to adhere to cutting tools [74]. Figure 7 illustrates the presence of adhered material on the top view of the S75F75L5 condition.

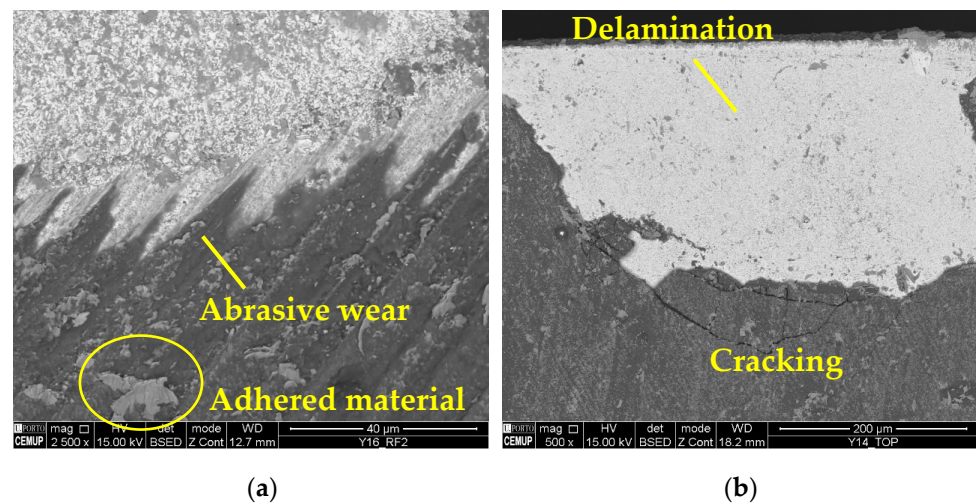
**Figure 8.** Coating wear mechanisms: (a) abrasive wear and adhered material in the RF2 of the S75F100L15 condition at 2500 $\times$  magnification and (b) delamination and cracking in the top view of the S75F75L15 condition at 500 $\times$  magnification.

The wear mechanisms identified in the coating were abrasive, workpiece material adhesion, delamination, and cracks. Abrasive and adhesive wear were observed at a lower intensity on the tool substrate. Material adhesion causes more abrasion and can lead to coating delamination [59]. Figure 6 illustrates the wear mechanisms identified in the coating. In Figure 8a, abrasive wear and adhered material can be observed in the S75F100L15 condition, and in Figure 8b, delamination and cracking can be seen in a cutting tool tested in the S75F75L15 condition. Furthermore, it can be stated that the wear mechanisms identified in the cutting tool's coating were more intense under the conditions tested at the  $L_{cut} = 15$  m.

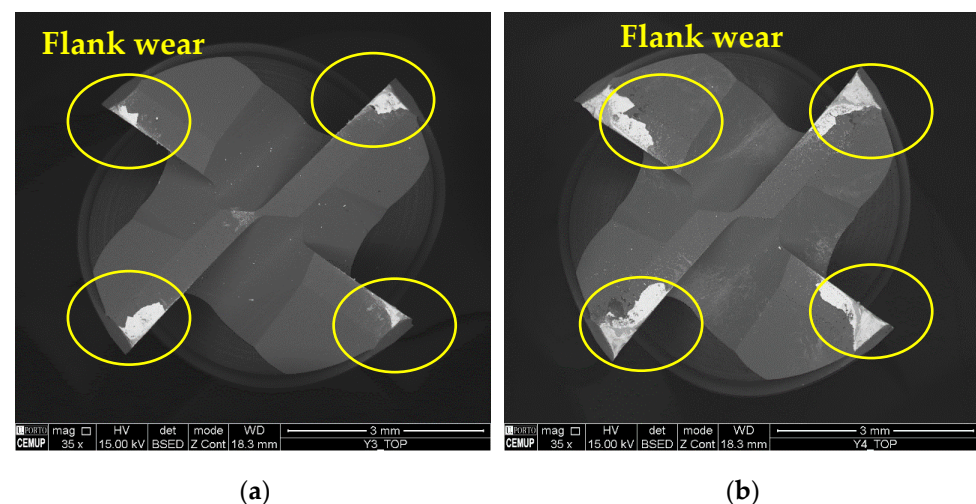
**Figure 9.** Top view of the tools tested at a  $v_c$  of 100 m/min at 35 $\times$  magnification: (a) S100F100L5 and (b) S100F100L15.

Figure 9 illustrates the top view of the S100F100L5 and S100F100L15 conditions, where it is possible to observe the influence of the  $L_{cut}$  on the machining in these conditions.

As mentioned, the impact of the  $L_{cut}$  seems to significantly increase the resulting wear, as can be seen from the measurements carried out and clearly seen in the images obtained.

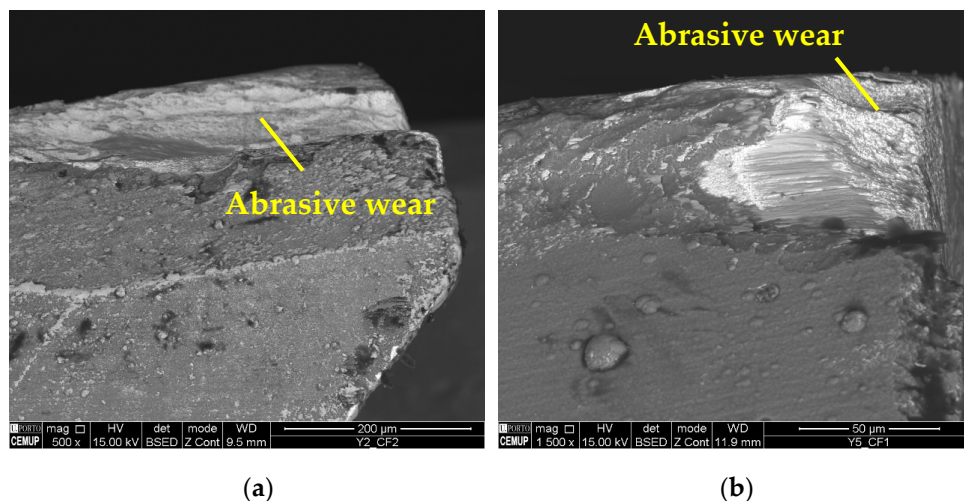
**Figure 10.** Abrasive wear: (a) clearance face (CF2) of S100F75L15 at 500× magnification and (b) clearance face (CF1) of S100F150L5 at 1500× magnification.

The predominant wear mechanisms on the tool substrate and coating were abrasion and material adhesion, the latter being more intense than in the cases tested at 75 m/min. It is seen that Inconel 718 commonly adheres to cutting tools [74]. The abrasive wear was more intense on the clearance face of the tools, as shown in Figure 10, and this type of wear is frequent when machining this alloy [76].

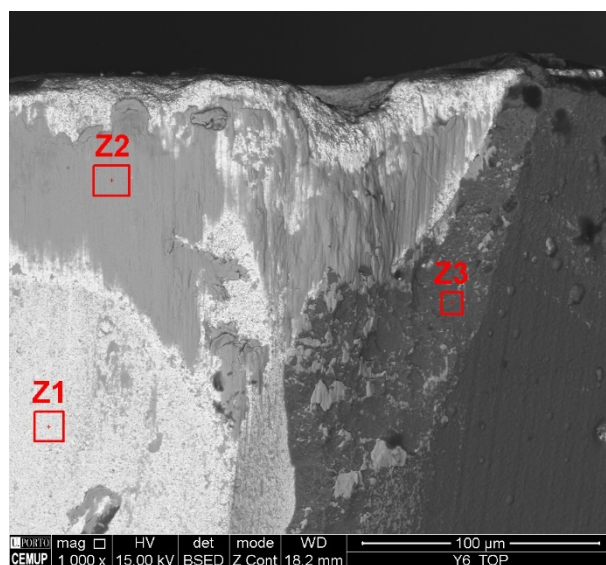
**Figure 11.** Condition S100F150L15 indicates material adhesion and has three zones for EDS analysis.

Figure 11 illustrates the adhesion of the material to the tool substrate under the S100F150L15 condition, and three zones in which the analysis was carried out. This wear was registered on the tools' flank, edges, and rake face. In this case, EDS analysis was performed to confirm that it was Inconel 718, according to the chemical composition resulting from the analysis. Figure 12 illustrates the results of the EDS analysis for the three corresponding zones.

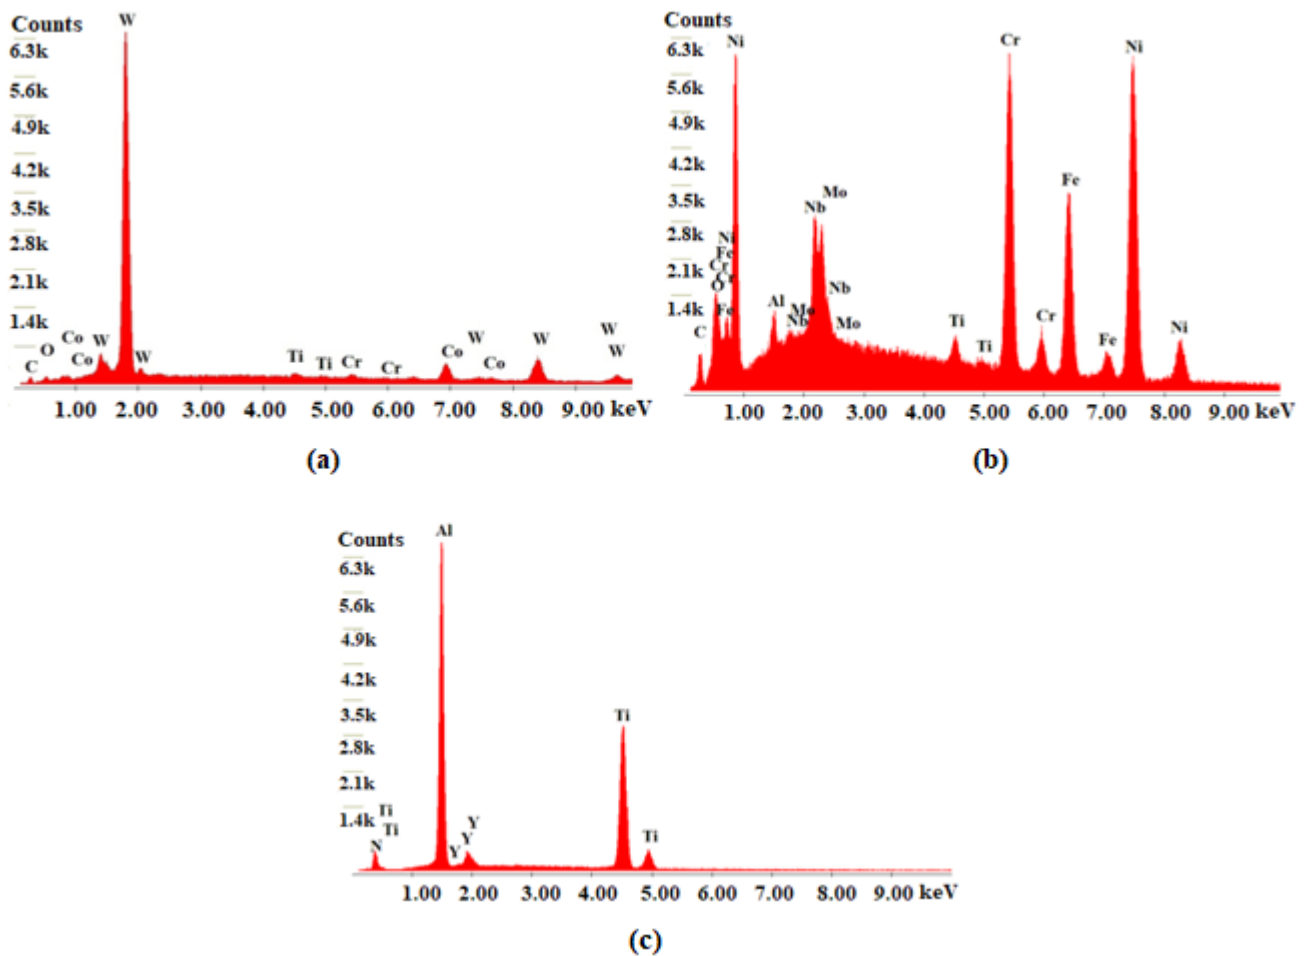
**Figure 12.** EDS spectra analysis of the three zones of S100F150L15: (a) Z1—tool substrate, (b) Z2—adhered machined material, and (c) Z3—coating.

According to the EDS analysis, zone 1, rich in tungsten, refers to the tool substrate; zone 2, in turn, is rich in Ni and with other elements present that are part of the composition of Inconel 718, indicating that it is machined material that is adhered to the substrate of the tool; and zone 3, indicating the constituent elements of the coating. Therefore, the coherence of the results obtained, based on the chemical composition of the areas indicated in the image, can be observed.

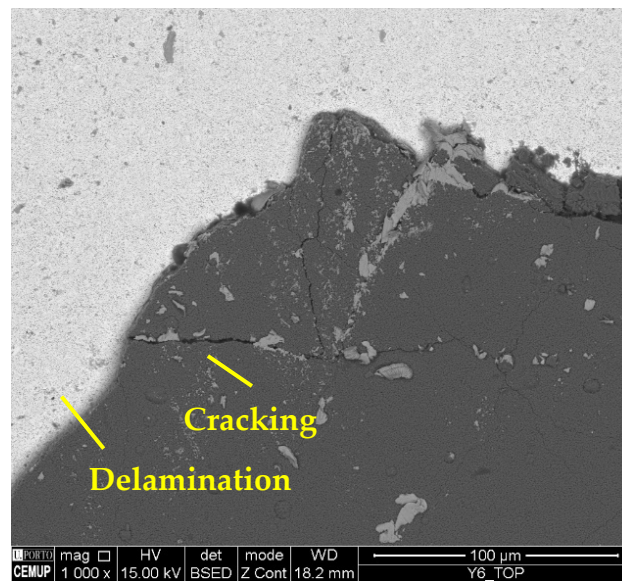
Figure 13. Delamination and cracking in the top view of S100F150L15 at 1000× magnification.

Regarding the wear mechanisms identified in the coating, delamination, chipping, and cracking can also be observed in addition to material adhesion and abrasion. Figure 13 illustrates cracking and delamination identified on the coating, and Figure 14 the chipping and delamination as well. This chipping may negatively affect process performance [77] due to the change in the cutting tool's geometry [78]. Another aspect is related to cracking propagation. Some authors, such as Zhang et al. [79] and Shuai et al. [80], suggest that the presence of an interlayer could provide high strength to the coating, and that, with this, the resistance to crack propagation increases. Furthermore, thinner layers significantly increase the resistance to crack propagation and protect the coating from delamination, improving its adhesion [81,82].

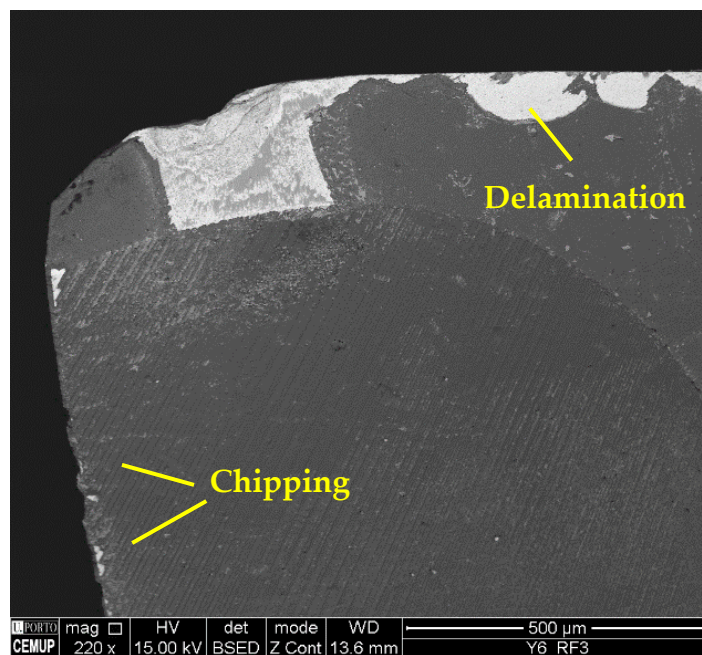
Figure 14. Delamination and chipping in RF3 of S100F150L15 at 220× magnification.

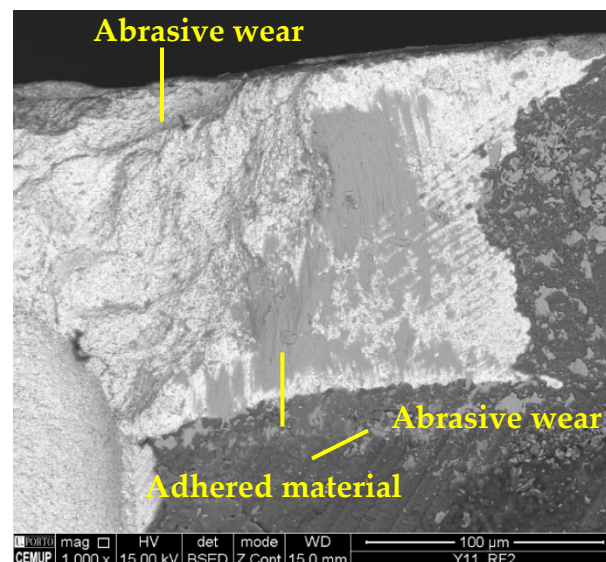
**Figure 16.** Wear mechanisms in condition S125F150L5: abrasive and adhesive wear on the tool substrate and coating.

As in previous cases, the main wear mechanisms observed were abrasion and adhesion. However, under these conditions, the wear was higher and more expressive, with the beginning of the development of a BUE under the conditions tested at a  $L_{cut} = 15$  m. The beginning of the development of a BUE indicates a large amount of adhered material, which tends to generate severe wear [83], as this mechanism increases abrasive wear and, consequently, leads to the occurrence of the delamination of the coating. Figure 16 illustrates the abrasive wear and material adhesion, both on the coating and the tool substrate, and Figure 17 illustrates the beginning of BUE development.

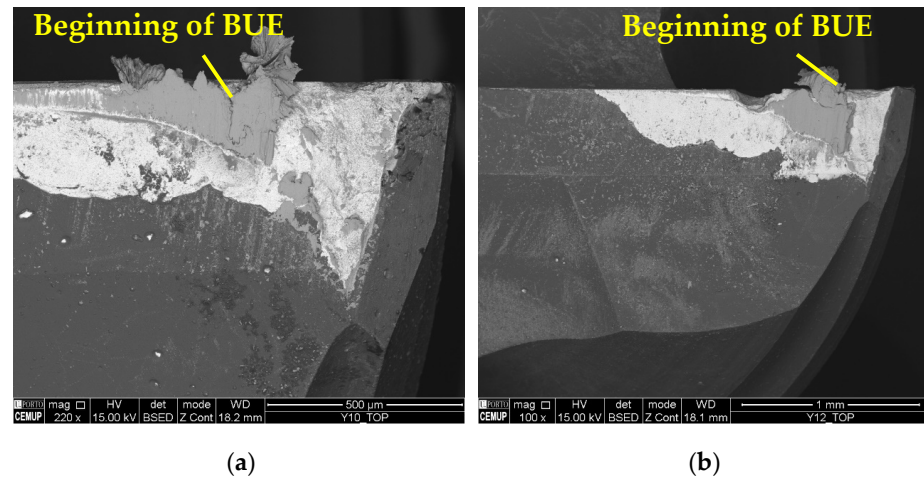
**Figure 17.** Beginning of BUE development: (a) top view of S125F100L15 with 220× magnification and (b) top view of S125F150L15 with 100× magnification.

It should be noted that the BUE is more common at a lower  $v_c$ , and changes the tool's geometry, which can accelerate TW [59]. The machining of Inconel 718 can be reasonably aggressive on cutting tools, promoting high levels of wear [76]. Furthermore, cracking, chipping, and delamination were observed in the coating. The formation of chips impairs the performance of the machining process, as this type of wear changes the geometry of the cutting tools, which causes the chip generation mechanisms to be modified, and consequently, the quality of the product obtained is lower [84]. Figure 18 illustrates the

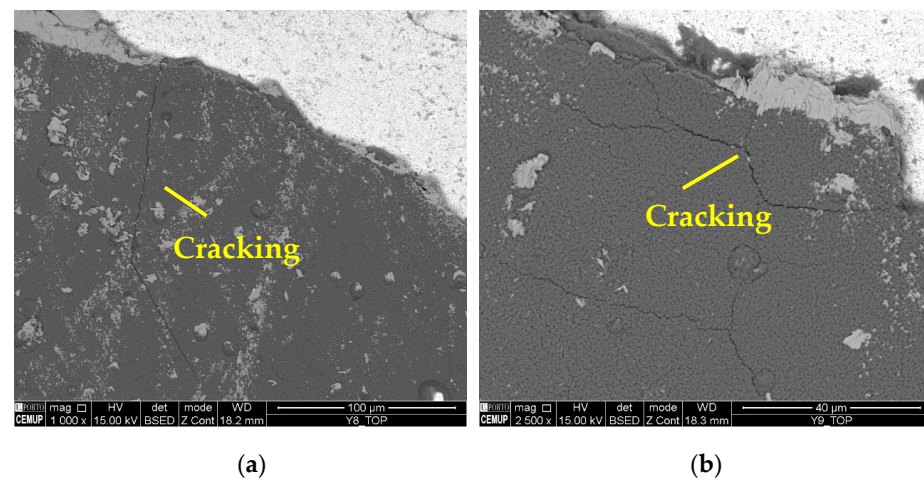
**Figure 18.** Cracking in the coating: (a) top view of S125F75L15 at 1000× magnification and (b) top view of S125F100L5 at 2500× magnification.

cracks in the coating seen under the S125F75L15 and S125F100L5 conditions, and Figure 19 illustrates chipping (S125F100L5) and delamination (S125F150L5).

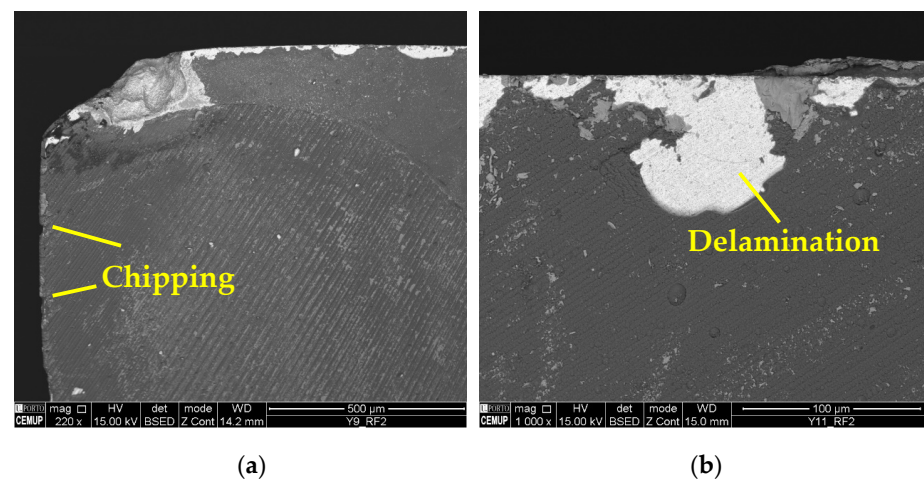
**Figure 19.** Coating wear mechanisms: (a) chipping in RF2 of S125F100L5 condition at 220× magnification and (b) delamination in RF2 of S125F150L5 condition at 1000× magnification.
