Development of a High-Sensitivity Millimeter-Wave Radar Imaging System for Non-Destructive Testing

Hironaru Murakami ^{1,*}

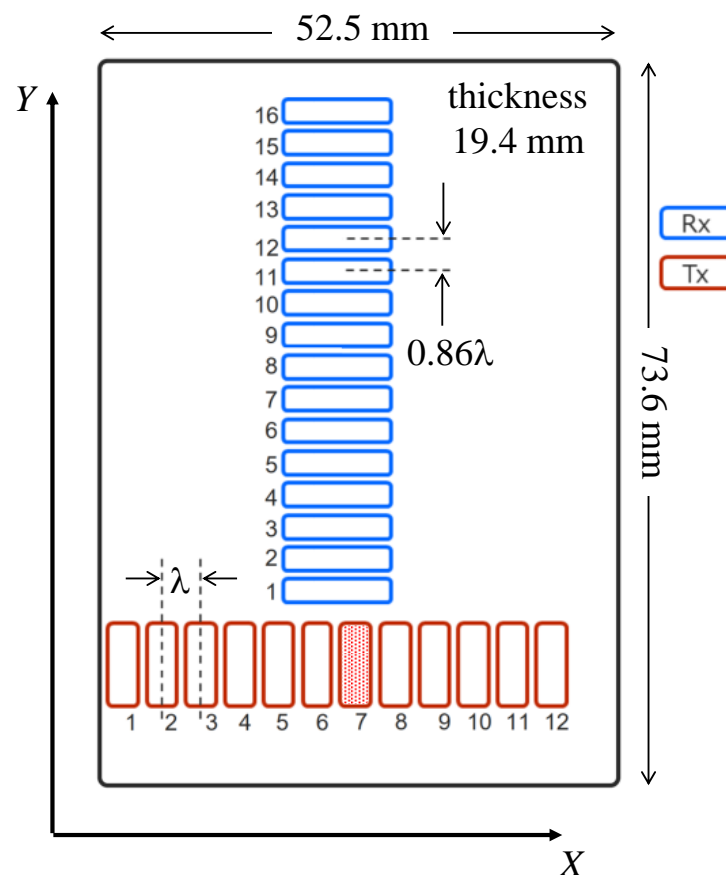
Figure 1. A 2-dimensional orthogonal arrangement of antenna elements of the array prepared for the present study. In the present experiments, only the seventh transmit antenna (Tx7) was used. Where $\lambda = 3.80$ mm.

To explore the possibility of MM-wave imaging for NDT, the transmission characteristics of MM-wave against various materials that would attenuate MM waves should be investigated. For this purpose, an MM-wave array antenna module with high absolute gains of the transmit and receive antennas was prepared for the present studies. Specifically, a two-dimensional orthogonal array antenna sensor was fabricated by TAIYO YUDEN CO., LTD. (Japan). The array pattern of the transmit and receive antennas is shown in Figure 1, which consists of twelve transmit antennas (Tx) with a spacing of λ ($=3.80$ mm) and sixteen receive antennas (Rx) with a spacing of 0.86λ ($=3.25$ mm) in an antenna unit of 52.5 mm \times 73.6 mm \times 19.4 mm, in an orthogonal array pattern of MIMO antenna structure. Although these antennas are arranged in such a narrow pitch, they have excellent side-lobe suppression and can control directivity over a wide bandwidth. In addition, there is very low signal transmission loss between these Tx and Rx antenna elements and the radar chips using the technology developed by Aoki et al. [16]. For the MM-wave radar chips, four cascaded chips (AWR2243 marketed by Texas Instruments [17]), which are FMCW transceivers in the 76.5 GHz to 81 GHz band, are installed on this antenna unit. The element statistics of the MM-wave array antenna module are shown in Table 1.

Since there is very little interference between the sixteen Rx antennas, even though the Rx spacing is very small, 16 rows of data in the Y-axis direction can be acquired in a single scan along the X-axis. However, for high-resolution imaging in the Y-axis direction, the X-axis scanner was shifted by 0.5Δ ($\Delta = 0.86 \lambda$: 3.25 mm) in the Y-axis direction and scanned again along the X-axis before the X-axis scanner was shifted by 15.5Δ in the Y-axis direction (see Figure 2a).

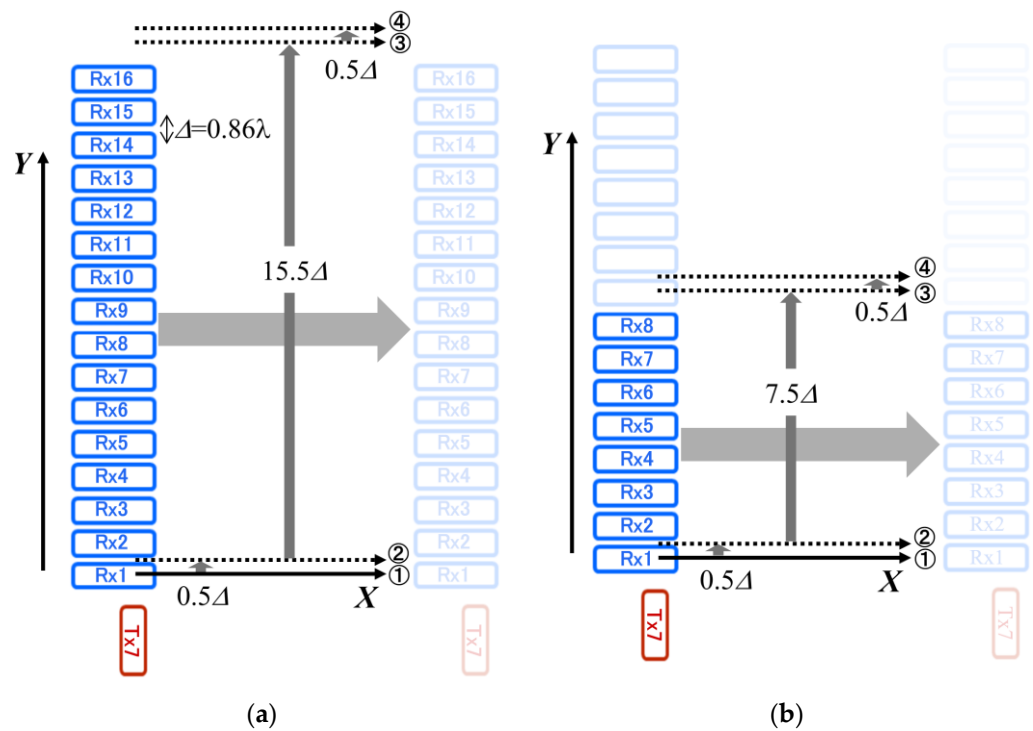
Figure 2. X-Y scanning method for antenna elements of the array. (a) Diagram of X-Y scanning using all Rx antennas from Rx1 to Rx16. (b) Diagram of X-Y scanning using eight Rx antennas from Rx1 to Rx8. Here, $\Delta = 0.86 \lambda$ is the distance between adjacent receive antennas.

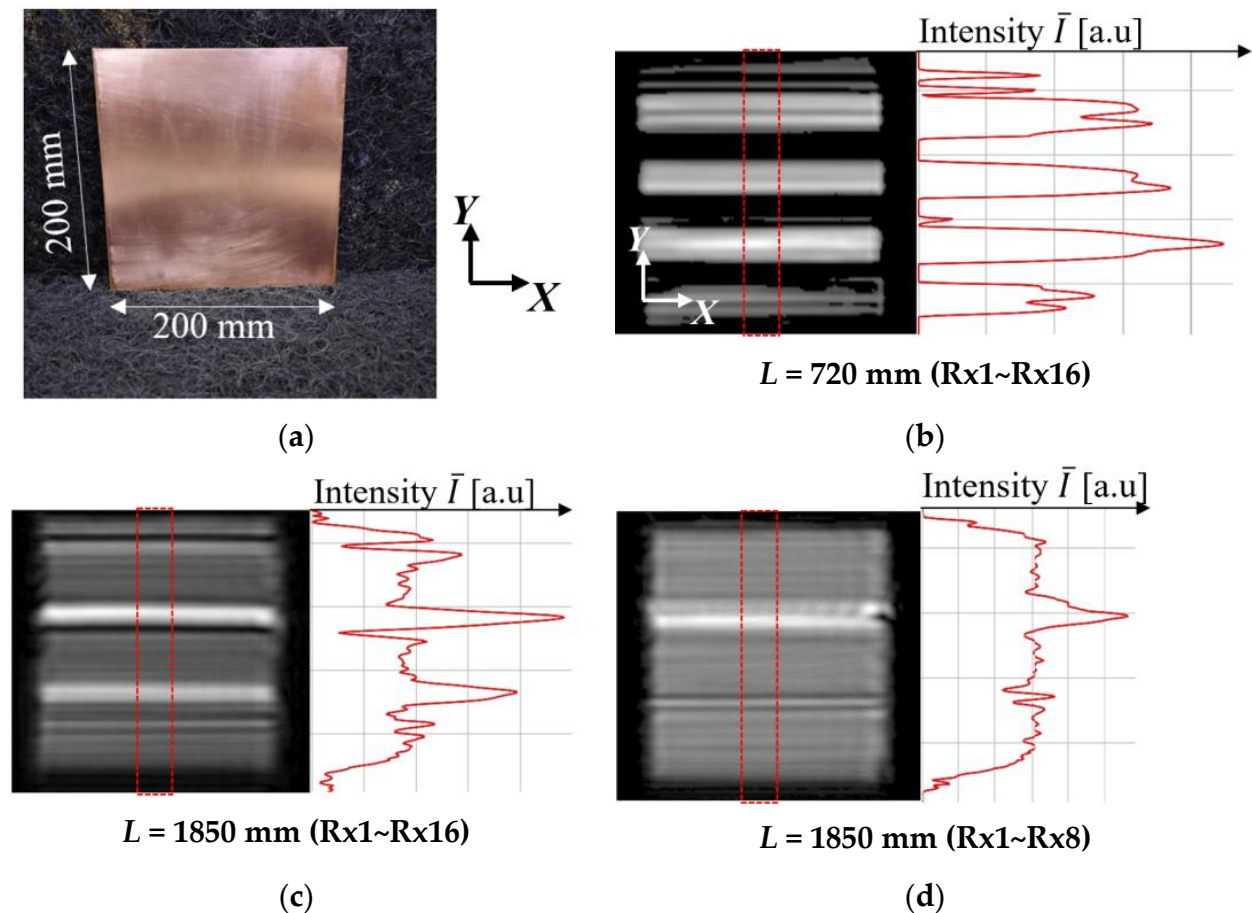
Figure 3. Influences of the distance L to the target and the number of receive antennas (Rx) used in the MM-wave image observations. (a) The 200 mm \times 200 mm flat copper plate for the measurements. (b) Condition of $L = 720$ mm with all receive antennas from Rx1 to Rx16. The left and the right figures show the observed MM-wave image and the distribution along the Y-axis of the averaged signal intensity \bar{I} within the red dotted rectangle inserted in the MM-wave image, respectively. (c) Result in the condition of $L = 1850$ mm with all receive antennas from Rx1 to Rx16. (d) Result in the condition of $L = 1850$ mm with 8 receive antennas from Rx1 to Rx8.

To investigate this point, we compared the MM-wave images of a copper plate placed at different distances. The results are shown in Figure 3. Figure 3a shows a 200 mm \times 200 mm copper plate used for this MM-wave imaging. This copper plate was placed in front of the constructed SIMO-SAR imaging system at different distances of $L = 720$ mm and $L = 1850$ mm in the measurements. The left sides of Figure 3b,c shows the MM-wave images observed when the copper plate was placed at $L = 720$ mm and $L = 1850$ mm, respectively. The right sides of Figure 3a,b shows the Y-axis profile of the averaged intensity \bar{I} values within the red dotted rectangles inserted in the MM-wave images. The intensity (I) corresponds to the MM-wave power received by the receive antenna. All receive antennas of Rx1~Rx16 were used in the measurements. Here, the difference in the MM-wave images between Figure 3b,c clearly shows that the difference in the distance L from the transmit antenna Tx7 causes a significant difference in the signal intensities received by the Rx1~Rx16 antennas when observed at a short distance of $L = 720$ mm. In particular, the profile in Figure 3b shows apparent areas where the reflection signal from the target can hardly be received.

Another interesting result is that although the observation with system-A was made by placing the concrete blocks at a very close distance of $L_A = 780$ mm from the radar module, no significant difference in signal intensities appeared, as shown in the MM-wave images of a copper plate. Although a periodic dark and light wide stripe structure is observed approximately equal to the total length of the array of eight receiving antennas ($8\Delta = 26$ mm), the signal is not extremely weak, as shown in Figure 3b,c. This is because

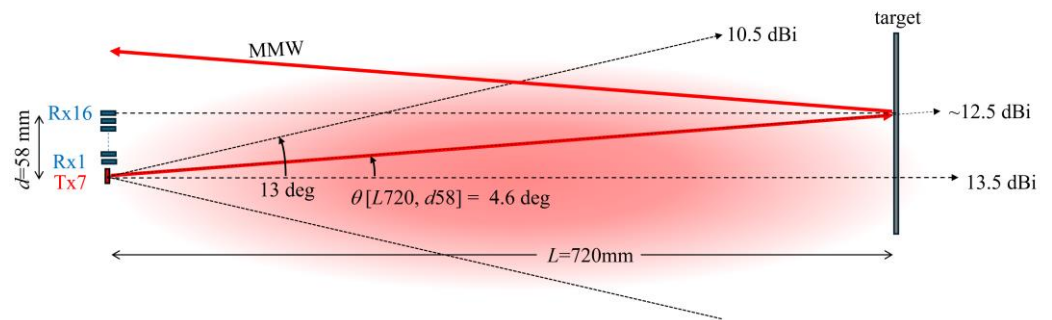
Figure 4. Estimation of MM-wave irradiation power on a target at a distance of $L = 720$ mm from the Tx antenna to the target. 4.1. Optimization of MM-wave imaging measurements.

The result obtained at $L = 720$ mm can be well explained by considering the situation as shown in Figure 4. When the distance $L = 720$ mm, the elevation angle $\theta[L720, d57]$ from Tx7 of the point on the target located in front of Rx16 (distance d between Tx7 and Rx16: 58 mm), which is the farthest from Tx7, is 4.6 degrees. Considering the beamwidth given in Table 1, the MM-wave power at the point on the target in front of Rx16 would be about 1 dB less than the absolute gain of 13.5 dB. In addition, MM waves are reflected from flat metal surfaces of copper plate with a reflection angle nearly equal to the angle of incidence. Therefore, it is expected that MM waves will hardly be received by the Rx16 antenna. Increasing the distance L improves this situation somewhat, but there should be still a significant difference in the received signal intensity between Rx1 and Rx16, as shown in Figure 3c. Based on these results, we decided to use only Rx1 to Rx8 antennas as the receive antennas in the present study, according to the diagram of the X-Y scanning diagram, as shown in Figure 2b. Figure 3d shows the result of the measurement with the number of antennas reduced while the distance L remains at 1820 mm. It can be seen that the change in the signal intensity is considerably improved. In addition, in the present study, the measurements were performed with distant targets as far as possible.

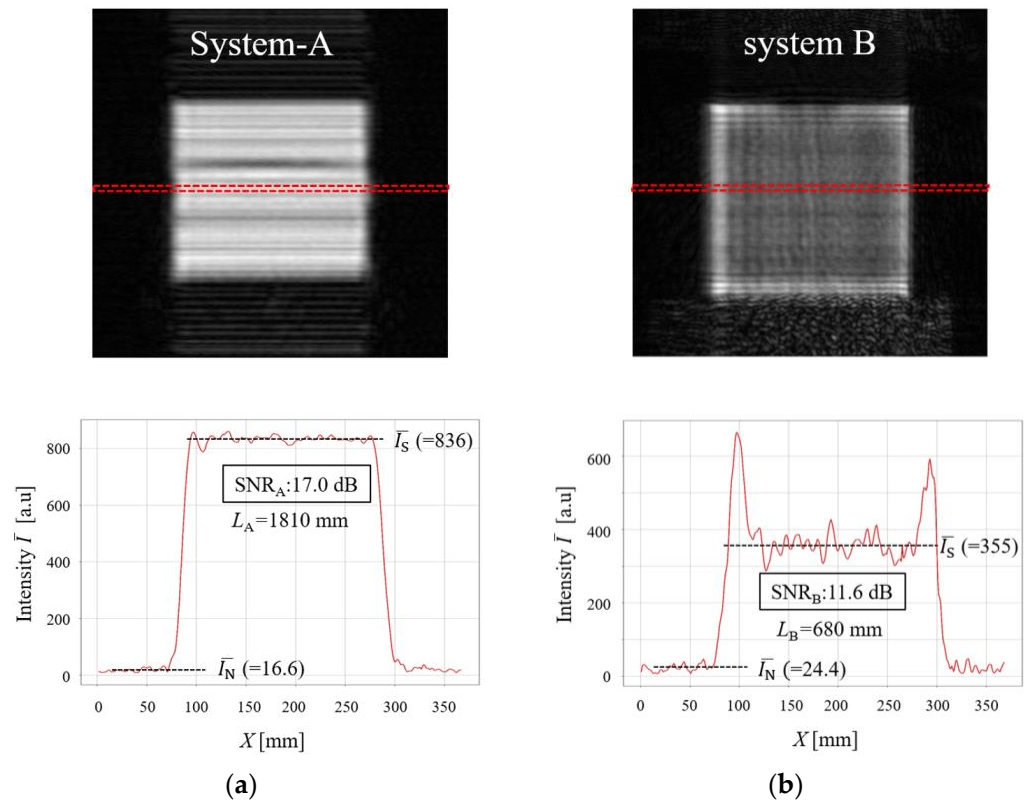
Figure 5. Comparison of SNR in the MM-wave images observed by (a) present SIMO-SAR imaging system (system-A) at $L_A = 1810$ mm and (b) previously constructed MIMO-SAR system using an IWR1443BOOST EVM (system-B) at $L_B = 680$ mm. The top figures show the MM-wave images, while the bottom figures show the profiles of the averaged signal intensity \bar{I} along the X-axis direction in the area indicated by the red dashed rectangle inserted in the MM-wave image.

Assume that the results of Figure 5 were obtained under the same condition of radar scattering cross section σ and the wavelength λ and that the difference in SNR values is considered to be given by the ratio of the maximum received power of each radar module of system-A and system-B. Therefore, the difference in the SNR value of 5.4 dB would be expressed by using the receive powers of P_{RA} and P_{RB} and the emission peak powers of P_{TA} and P_{TB} for system-A and system-B, respectively, as follows:

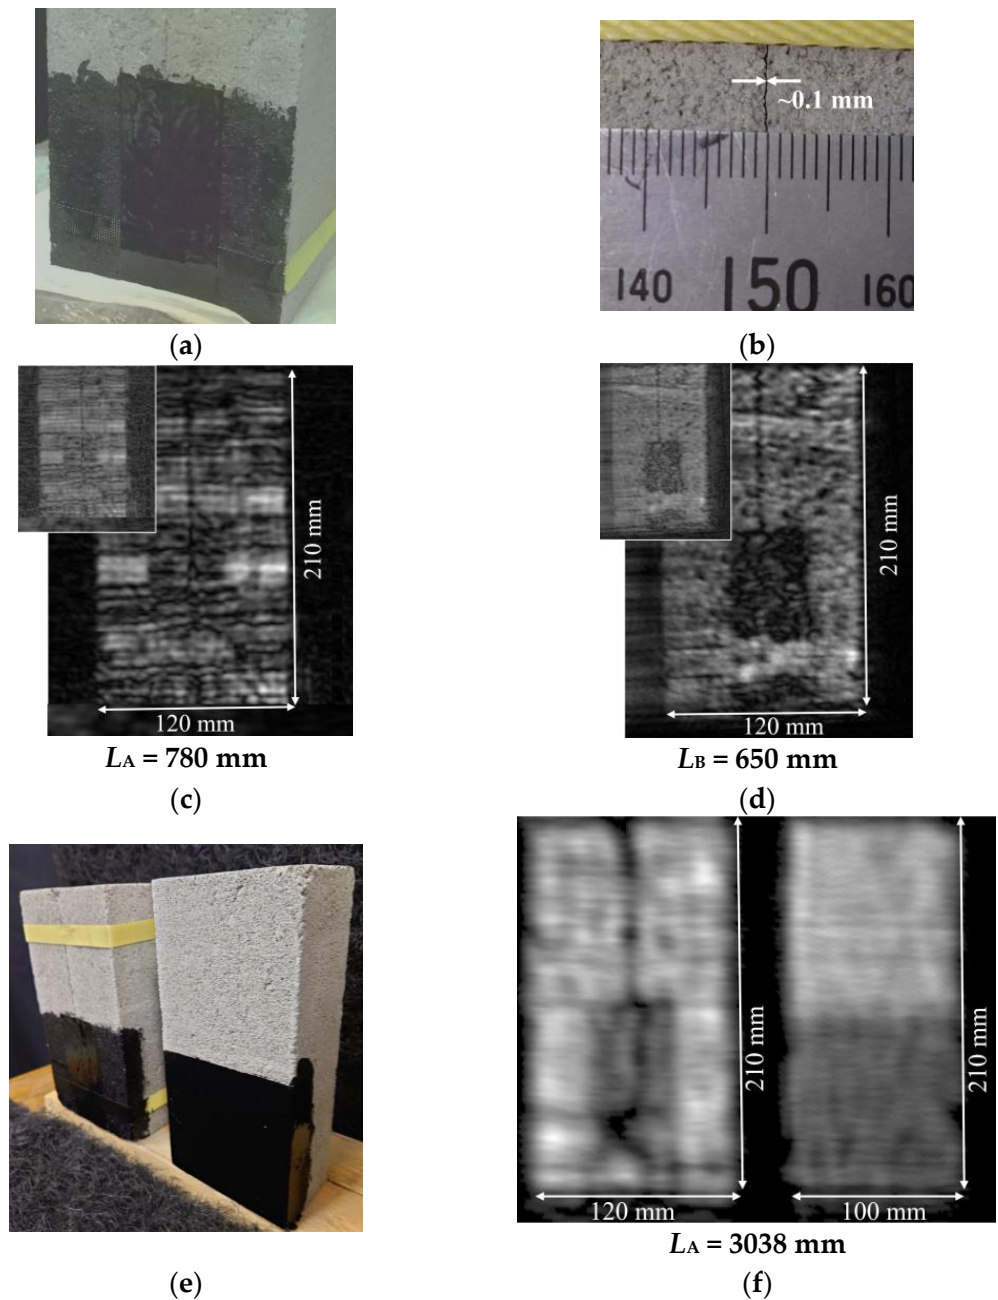
Figure 6. Comparison of MM-wave images of concrete blocks with GFR tape and black acrylic paint over the cracks. (a) Strongly bonded concrete blocks for observation. The contrast of the raw image is adjusted to show the position of the GFR tape under black acrylic paint. (b) Magnified view of the cracked area. It can be seen that the crack is about 0.1 mm wide. (c) MM-wave image observed at the target distance of $L_A = 780 \text{ mm}$ using system-A. (d) MM-wave image observed at the target distance of $L_B = 650 \text{ mm}$ using system-B. (e) Concrete blocks with (left) and without (right) cracks, thickly coated with acrylic paint over GFR tape. These were placed at a distance of $L_A = 3038 \text{ mm}$ from the radar module. (f) MM-wave images of concrete blocks with (left) or without (right) cracks.

Based on the results of the preliminary experiments, the potential of the present imaging system for NDT inspection was investigated. First, a comparison study with system-B was conducted to detect the cracks between concrete blocks under glass fiber-reinforced (GFR) tape and a coat of black acrylic paint. The results of this experiment are shown in Figure 6a through Figure 6d. As shown in Figure 6a, two concrete blocks were firmly bonded together, and GFR tape and a coat of black acrylic paint were applied over a portion of the cracks to hide the crack areas. Figure 6b is a magnified photograph taken to show the width of the cracks. As can be seen from this photograph, the width of the crack is approximately 0.1 mm. Figure 6c shows the MM-wave image observed with system-A. It can be seen that the cracks are visible in the image below the GFR-taped areas. On the other hand, Figure 6d shows the result with system-B. In this case, the coating paint itself is transparent, but the GFR tape is not sufficiently transparent and the cracks in the underlying concrete are not visible.

The detection of cracks caused on the surface of concrete infrastructure facilities is one of the most important issues in NDT, and as shown in Figure 6c,d, we can observe the cracks on the exposed surface areas of concrete blocks. On the surface of the concrete blocks, which does not have a smooth surface like a copper plate, the incident MM waves are scattered uniformly in all directions and reflected with some intensity (backscattering) in the direction of incidence. As a result, unlike objects with smooth surfaces, an overall dark image is observed. However, in the areas with cracks, since the incident MM waves are scattered more strongly and irregularly, the intensity of refracted MM waves returning in the directions of the receive antennas would be much smaller, which would be reflected as darker lines in the MM-wave image.

On the other hand, in the area with GFR tape and black acrylic paint on the surface, we could see cracks hidden under these coverings only with the present system-A with high sensitivity. Incidentally, the contrast in the raw photographic data was adjusted so that the viewer could see where the GFR tape was applied in Figure 6a. From these two MM-wave images, there is almost no change in the received signal intensity for the black acrylic paint, but the signal intensities are weaker in the areas of the GFR tape, confirming that absorption by the GFR tape has occurred. To be sure, contrast-adjusted photographs are shown in the upper left corner of Figure 6c,d. Here, the contrast has been adjusted to show the crack structure most clearly. As can be seen from this photograph in Figure 6c, the MM wave image observed using system-B did not show the crack structure hidden under the GFR tape, no matter what adjustments were made.

The validity of such an idea is evident from the crack images in the MM-wave images in Figure 6c,f. Comparing the crack images in Figure 6c,f, it is obvious that the image in Figure 6c shows a finer crack structure. However, in terms of signal intensity and contrast of these images, the signal intensity is higher, and the presence of cracks can be observed more clearly in Figure 6f, even though the measurement distance is about four times longer. At a distance of $L = 3038$ mm, the elevation angle from the transmit antenna Tx7 to the point in front of the receive antenna Rx8 on the concrete surface is only 0.6 degrees. Thus, it can be seen that both transmission and reception are carried out using a signal of almost maximum gain. This indicates that the newly developed radar module with high directivity and high gain is very useful for non-destructive, non-contact, and safer remote inspection of concrete structures at risk of collapse due to aging or natural disasters. Furthermore, it can be seen that in this type of non-destructive testing using MM waves, it is necessary to develop a compact system with signal strength rather than resolution, i.e., high SNR.

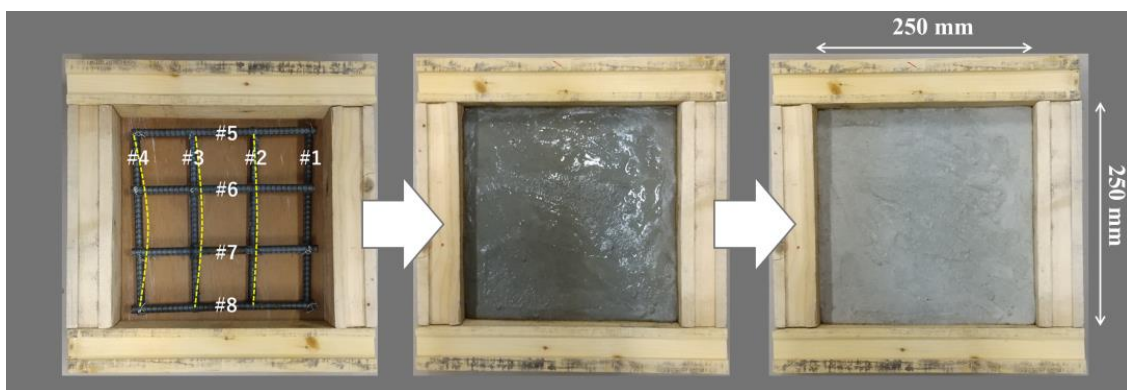
Figure 7. Reinforced concrete slab to investigate MM-wave transmission characteristics into concrete.

To evaluate the performance of MM-wave transmission to concrete, a reinforced concrete (RC) slab with a steel frame of D13 ($\phi 12.7$ mm) was prepared, as shown in Figure 7. It is difficult to see here, but steel frames #1 and #5~#8 are straight, and the other steel frames #2~#4 are bent near the center. The amount of bending increases from #2 to #4. The assembled steel frames were placed in wooden frames and poured with concrete, and this RC slab was removed and measured after the concrete had sufficiently dried and hardened.

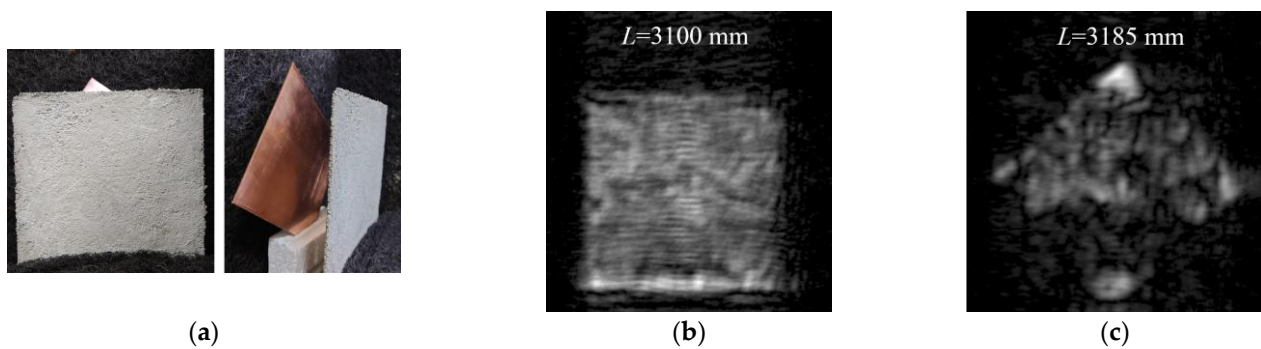
Figure 9. (a) Photographs of the thin concrete slab of 3.7 mm thickness placed at $L = 3100$ mm and the copper plate placed at $L = 3185$ mm behind it. (b) MM-wave image at position $L = 3100$ mm on the concrete surface and (c) MM-wave image at position $L = 3185$ mm on the copper plate surface.

While all MM-wave images presented so far have been single reflection images of the target, the SAR imaging technique using FMCW radar converts the obtained IF signal into a range FFT signal, so that a 2D cross-sectional image (2D slice image) can be obtained at any distance in front of the MM-wave radar module [13]. Therefore, if there is some target of interest behind an object through which MM waves can penetrate, the reflection image of the target can also be observed. Therefore, as shown in Figure 9a, a thin concrete slab

with a thickness of 3.7 mm was prepared and placed at $L = 3100$ mm in front of the radar module, and a copper plate was placed at $L = 3185$ mm behind it, and the transmission performance of MM waves through concrete was investigated by observing the reflection image of the copper plate. Figure 9b shows the MM-wave image of the concrete surface at $L = 3100$ mm, and Figure 9c shows the MM-wave image at $L = 3185$ mm corresponding to the surface of the copper plate behind the concrete slab. As can be seen from Figure 9a, the uppermost part of the copper plate protrudes from the concrete slab and is exposed, so Figure 9c shows that the signal intensity in this exposed area is considerably higher than in other areas. Therefore, the attenuation distance of the concrete was calculated by comparing the received signal intensity from the uppermost part of the copper plate and the hidden part behind the concrete in this experiment.

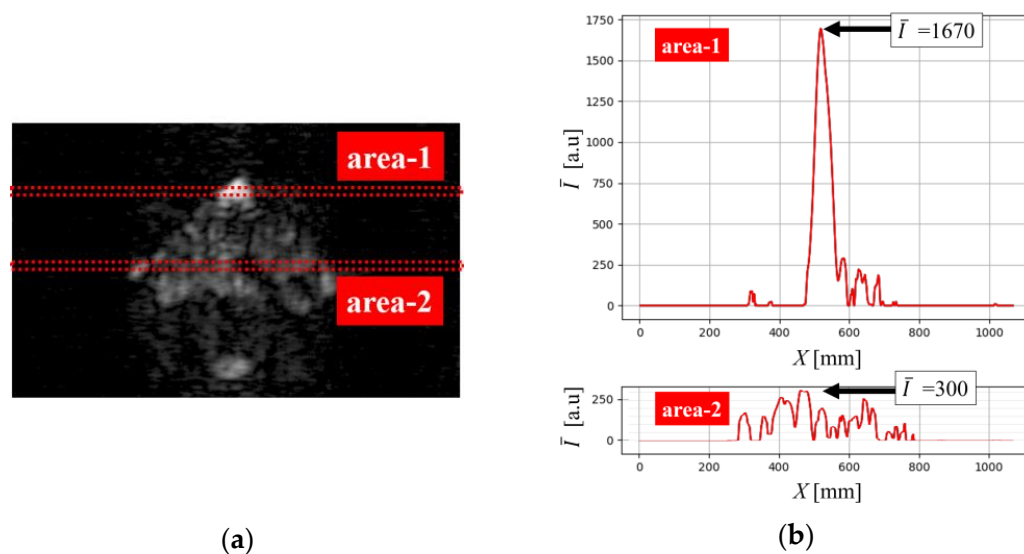
Figure 10. (a) area-1 and area-2 for comparing averaged signal intensity \bar{I} in the MM-wave image. (b) Distribution of the averaged intensity \bar{I} along the X-axis in area-1 and area-2.

To compare the signal intensities from both parts, the averaged signal intensities along the X-axis direction in area-1 and area-2 in Figure 10a were used. The distribution of the averaged intensity \bar{I} in area-1 and area-2 are shown in Figure 10b. The maximum averaged signal intensity in the area-1 (\bar{I}_{Cu}) was about 1670. On the other hand, that in area-2 (\bar{I}_{exp}) is about 300. We will use these values to determine the experimental attenuation distance Λ_{exp} in the prepared concrete slab. In determining the attenuation distance Λ_{exp} , let the reflectance R of MM waves on the concrete surface be 0.22 and the reflectance of MM waves on the copper plate surface be R_{Cu} . When the signal intensity transmitted from the Tx7 is I_0 , the received signal intensity \bar{I}_{Cu} reflected directly from the copper plate can be expressed as follows:
