Article

Characterisation and Application of Bio-Inspired Hybrid Composite Sensors for Detecting Barely Visible Damage under Out-of-Plane Loadings

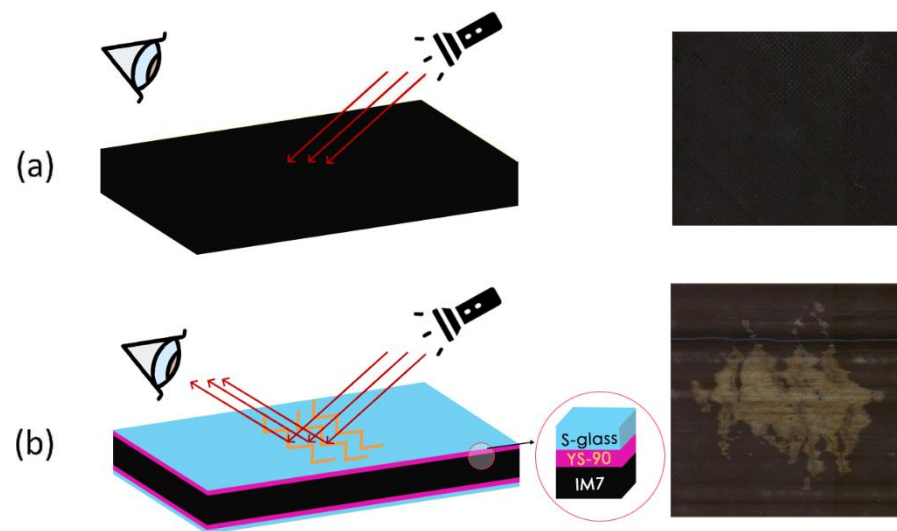
Figure 1. Schematic of (a) a reference specimen and (b) a sensor-integrated specimen, showcasing the sensor's working principle and configuration (left). The images on the right show the post-low-velocity impact surface of the specimens, highlighting the mechanochromic function in the sensor-integrated sample.

visible colour change occurs when subjected to strains surpassing a predefined threshold. As the sensor is applied onto the surface of the structure, it experiences similar strains as the underlying material. It comprises a carbon sensing layer and an outermost glass layer. As shown in Figure 1, a *reference* specimen (without a sensor) absorbs the light after being subjected to an impact load, indicating a dark appearance. In the *sensor* specimen, on the other hand, after the impact, when the strain goes beyond the failure strain of the carbon sensing ply, the carbon ply develops multiple fractures, reflecting the light from the damaged glass/carbon interface around the fractures in the carbon layer, making the damage visible.

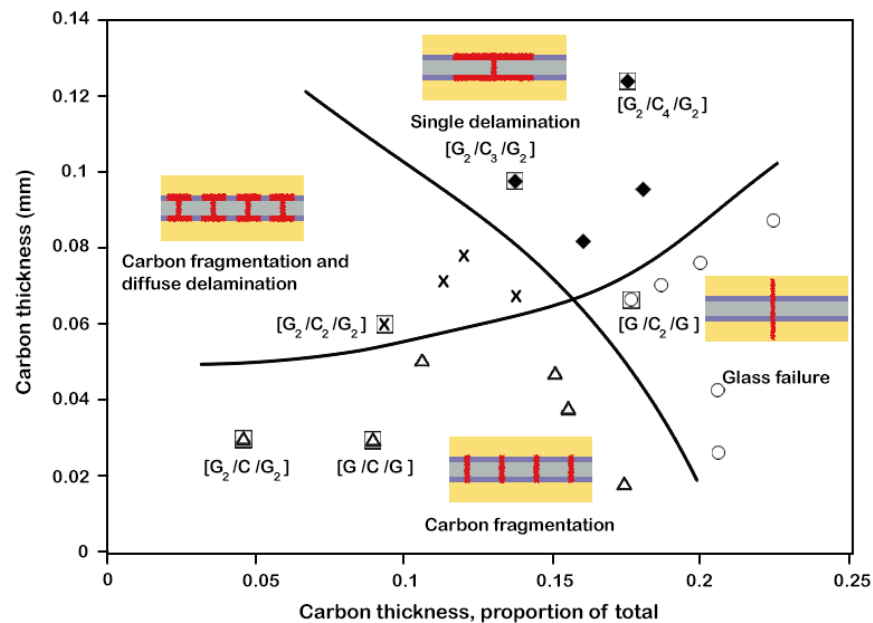
Figure 2. Categorisation of different damage modes as a function of absolute and relative thickness of carbon layers (reprinted with permission from Ref [23]).

The sensor can be integrated by either co-curing or retrofitting by bonding onto finished parts. Depending on the curing temperature of the sensor and substrate prepreg materials, the co-curing itself can also be done through either a one-step or a two-step curing procedure. By co-curing, the sensor acts as a structural sensing layer, while by retrofitting, it acts as a discrete sensor on the structure. It should be noted that the thickness of the sensing material must be thin enough to exhibit failure with fragmentation and dispersed delamination. This was studied in detail in work by Jalalvand et al. [23], where a damage mode map was developed using numerical damage analysis of hybrid glass/carbon composites with different thicknesses of the carbon layer (see Figure 2).

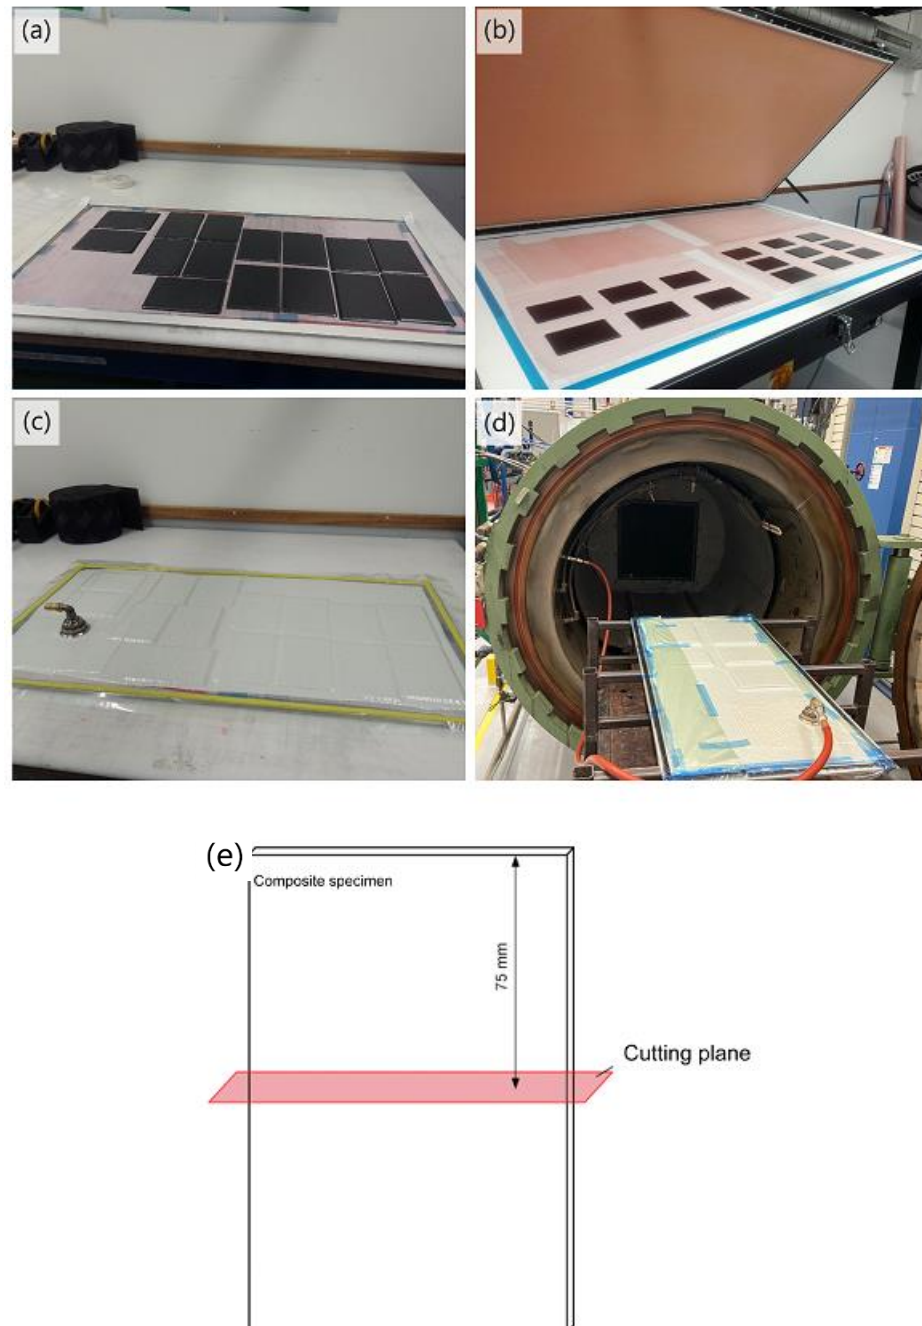
Figure 3. Manufacturing process: (a) cutting the prepregs into standard specimen size and stacking the layers, (b) applying pressure after stacking every four layers to ensure there is no air or bubbles, (c) completing the vacuum-bag lay-up, (d) curing at autoclave under desired temperature and pressure, (e) cutting plane for examining the cross-section of the impacted specimen.

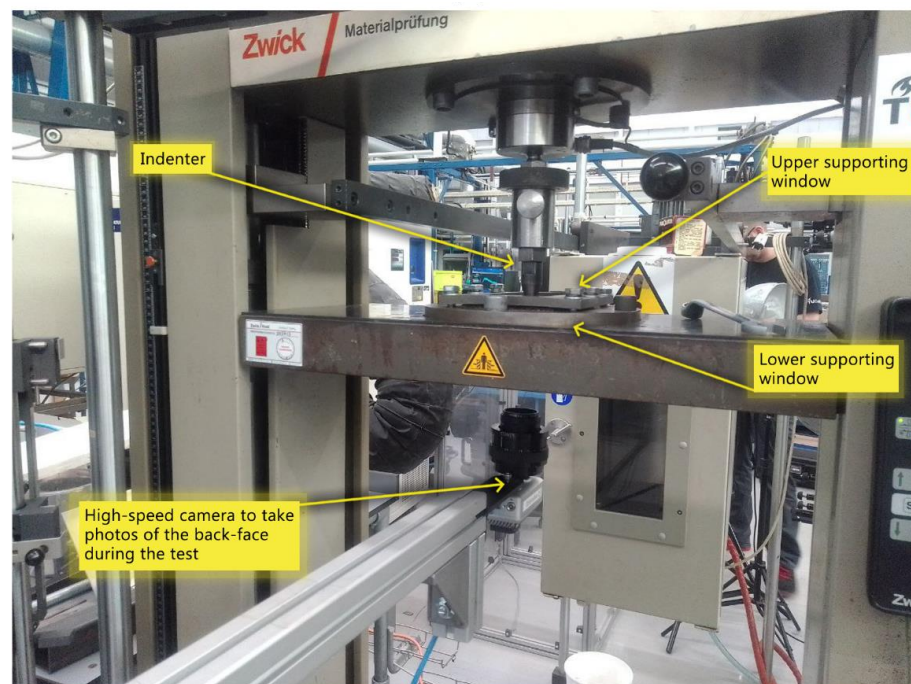
Figure 4. Indentation test setup.

The out-of-plane indentations were applied vertically on the front surfaces of the specimens at a constant indentation rate of 2 mm/min using a steel hemispherical indenter with a diameter of 16 mm, in accordance with the ASTM D7136-07 standard for drop weight impact damage resistance on FRP composites, ensuring the indentation test results match drop weight impact testing as closely as possible. The dynamic and rate effects of the laminate were considered to be minimal at this loading rate [21]. The specimen was positioned centrally over a 75 mm × 125 mm supporting window and was clamped in position, ensuring that the clamping base and the specimen were central to the indenter. Experiments were continued until a significant drop in force was observed, and the force did not continue to rise after the drop. This is the termination load drop, marked by an audible cracking sound. All tests (indentation and impact) were performed at room temperature. As shown in Figure 4, and a camera was placed beneath the supporting window to capture the initiation and propagation of the damage as well as sensor activation. The camera was set to take a photo every one second, collecting an image-based dataset during the whole test time.

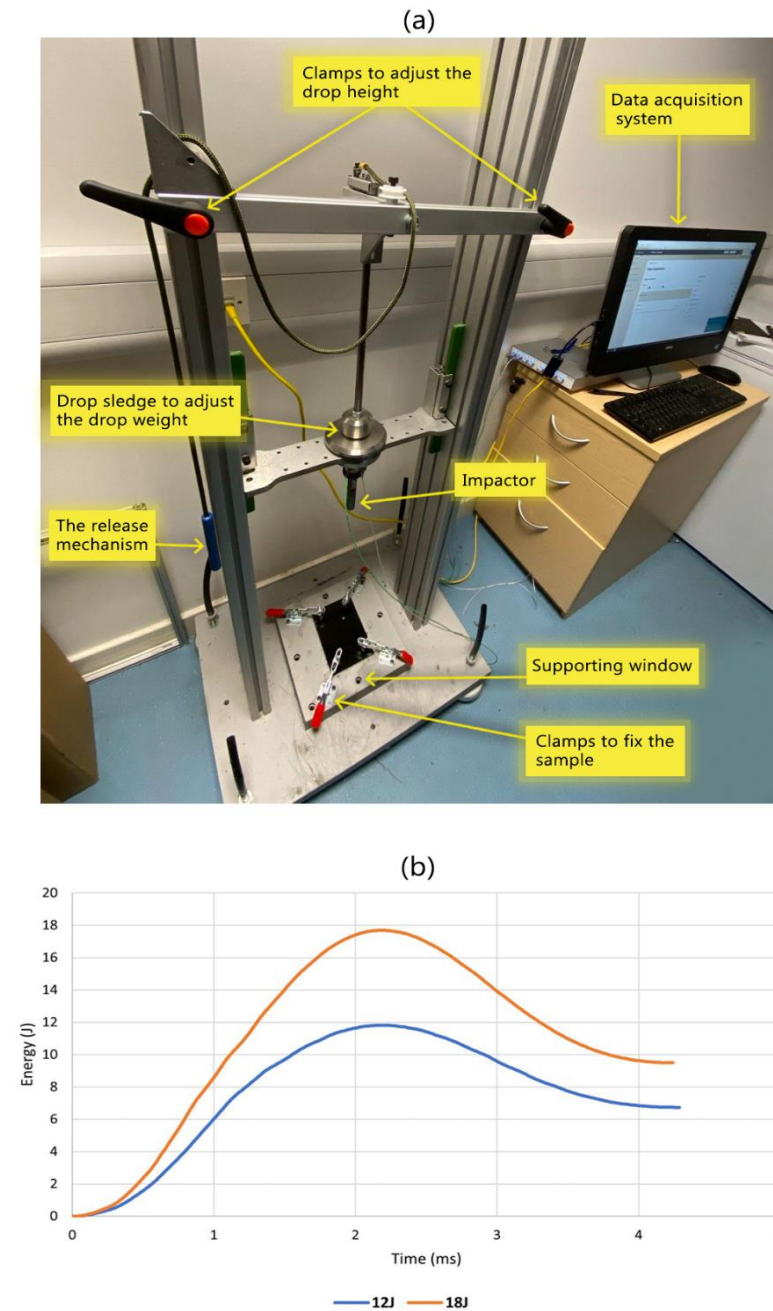
Figure 5. Impact test setup: (a) different parts of the custom-designed drop tower apparatus; (b) calculated impact energy at 12J and 18J impact tests from force–time results. Peak values are seen to match the corresponding test energy, demonstrating an effective setup.

Based on the indentation results, three impact energy levels were considered (12J, 18J, and 27J) and carried out according to the ASTM D7136 standard [21]. The drop mass was chosen to ensure the lowest drop energy of 12J would not require a drop height of less than 300 mm, ensuring test standards were met. As a result, the drop mass was recorded to be 3.94 kg, including all components on the dropping sledge (see Figure 5a). A Kistler

9333 load cell, which is capable of recording impact forces of up to 50 kN, was used. The maximum data sampling rate for the load cell is 62,500 samples per second. This rate was chosen as impact durations were expected to be less than 10 ms; therefore, it was desirable for sampling to be as high as possible to ensure good resolution in the results. A lowpass filter embedded within the data acquisition software was used to ensure the results had minimal noise. This was a Butterworth filter, and the cut-off frequency was set to 3000 Hz. This frequency was chosen by performing multiple drop tests with different filter frequencies. The frequency was chosen so that the section of the curve indicating elastic rebound was smooth with minimal noise, yet the oscillatory areas resulting from specimen damage remained visible.

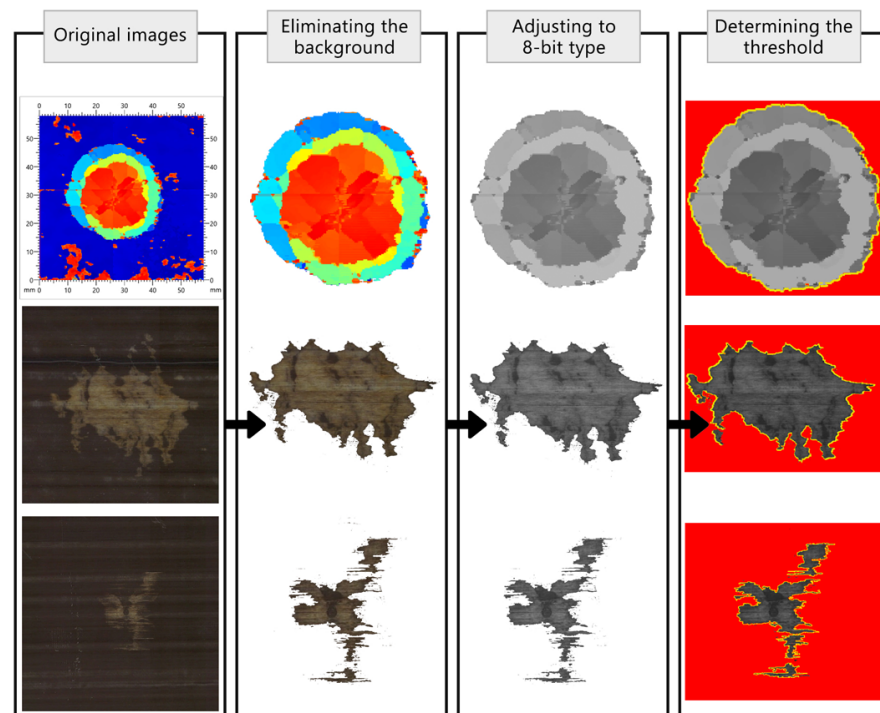
Figure 6. The image processing method to measure the C-scanned area and sensor-activated areas.

Following the collection of image-based data from the front face, back face, and C-scan of the samples impacted at various energies, image processing was performed using ImageJ software to measure the sensor-activated area on the surface as well as the C-scanned area. This analysis aimed to establish a correlation between surface and internal damage. The image processing procedure involved utilising Adobe Photoshop software (version 25.6) to eliminate the background, followed by adjusting the image type to 8-bit using ImageJ software. Subsequently, the threshold was determined, and the area was measured using the Region of Interest manager toolbox. This process is illustrated in Figure 6.

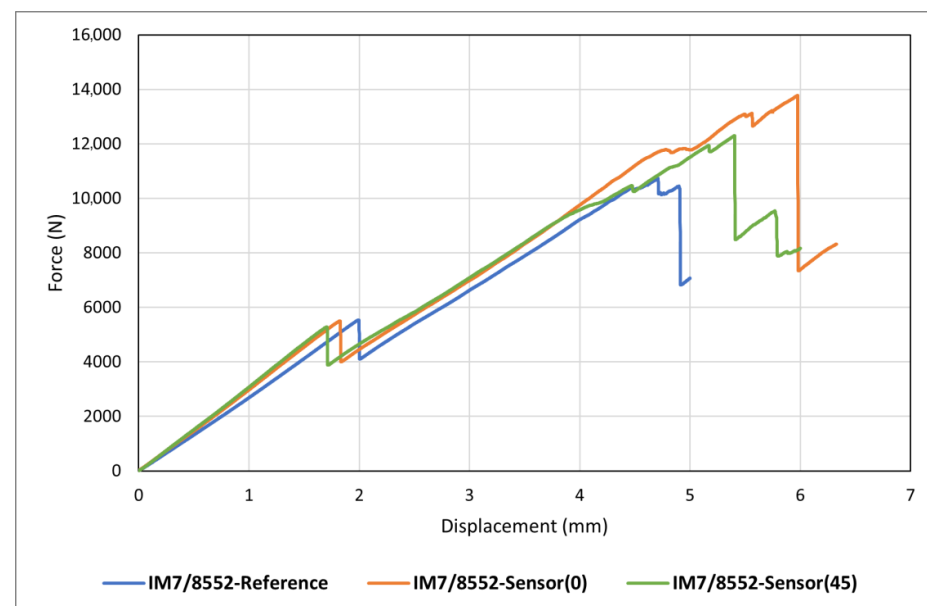
Figure 7. Static indentation results of all tested samples.

Figure 7 shows the results of *reference* and *sensor* samples tested under static indentation loading. It is seen that all curves follow the same general pattern (global behaviour), featuring a linear behaviour until a noticeable load drop, followed by a non-linear behaviour with a lower slope that reaches a second, more significant load drop, and then multiple smaller drops. This pattern has also been seen in static indentation testing of quasi-isotropic CFRPs by other researchers [16,19,21,31,32]. The graphs presented in this figure show the high repeatability and accuracy of both the test setup and the obtained results.

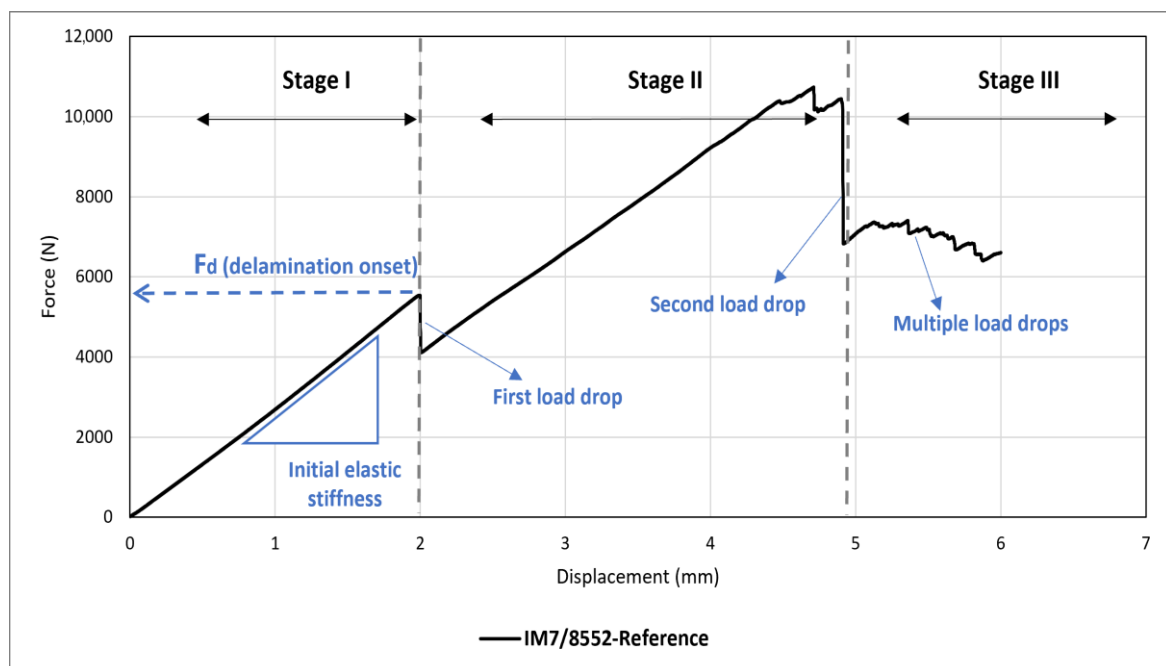
Figure 8. Different stages of damage initiation and propagation in a laminated quasi-isotropic CFRP composite under quasi-static indentation.

To further investigate global behaviour, the results of the first sample (IM7/8552-Reference) is chosen and shown in Figure 8. Three primary stages are evident from this figure. The first stage starts from the beginning of the test until a load drop occurs at displacement and force of approximately 2 mm and 6000 N, respectively. This initial phase represents the elastic region, characterised by a linear load–displacement response. The primary damage mechanism in this stage is matrix cracking, with the load drop marking the onset of delamination [21,33]. This delamination onset was distinctly identifiable during testing by an audible sound. The associated critical load at this point is shown by F_d , which is of great interest in this work. After the first load drop, a nearly linear response is seen until a second significant drop occurs at displacement and force of approximately 5 mm and 10,000 N, indicating more severe damage in the form of fibre failure. Alongside the load drop, this type of damage was identifiable by a distinct sound during testing. The minor load drops in the second stage, between the first and second significant load drops, are mainly associated with delamination propagation. Furthermore, the magnitude of the second load drop surpasses that of the first, indicating more severe damage to the specimen (see Table 2). Generally, damage in CFRPs is not visible until this point, and it only becomes visible on the surface after fibre failure happens. The third stage, initiated after the second load drop, signifies that the sample has incurred significant damage and cannot withstand further loading. Consequently, multiple small drops occur until the sample undergoes complete failure. Given that the objective of this research is to develop sensors capable of enhancing visual inspection of BVID, the emphasis will be on the first two stages. Accordingly, all subsequent low-velocity impact tests are designed to induce damage within these two regions.

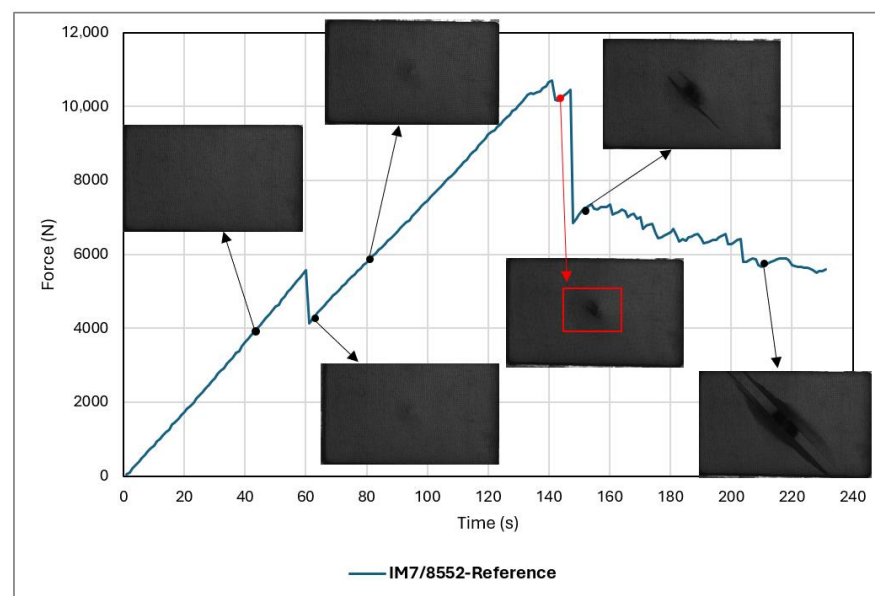
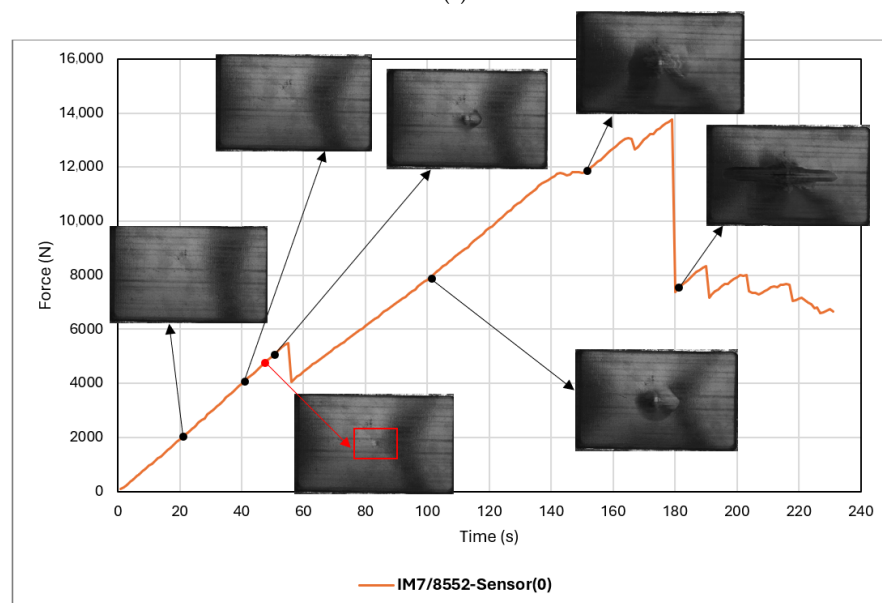
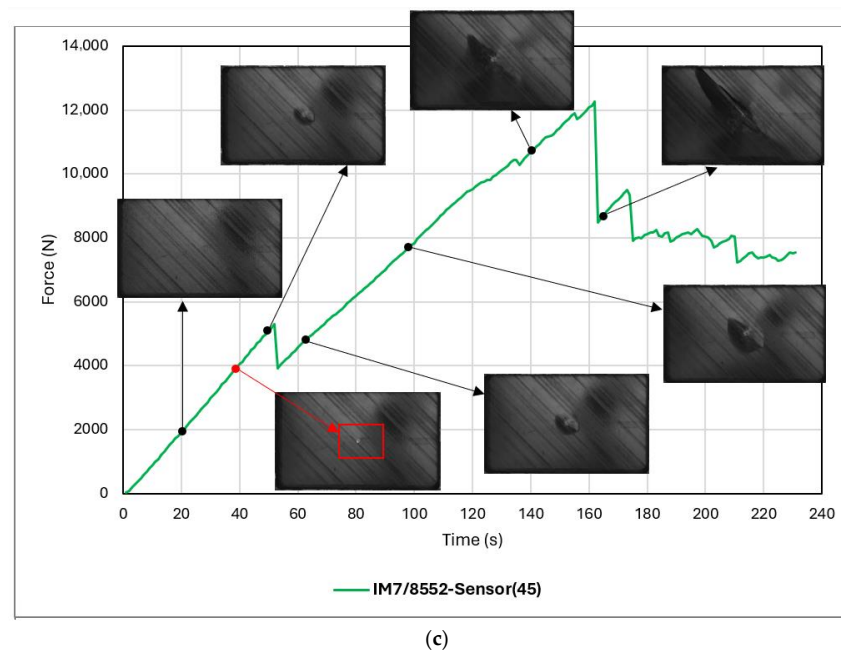
Figure 9. Visual inspection and sensor activation during static indentation experiment: (a) IM7/8552-Reference, (b) IM7/8552-Sensor(0), (c) IM7/8552-Sensor(45).

This section presents the visual inspection results, focusing on sensor activation and damage detection performance. For the scale, images of the back face cover the whole sample size (100 mm × 150 mm). As shown in Figure 9, damage on the back face remains imperceptible until just before fibre failure occurs at the second load drop, around forces of approximately 10,000 N. The initial point of visible damage is denoted by red colouring on the graph. This is where the structure has undergone significant damage and poses a very low residual structural integrity. However, across both two graphs associated with *sensor* samples, it is evident that the sensor on the back face activates before the first load drop at forces below 5000 N (highlighted by red colouring). This observation highlights the sensor's ability to detect damages as subtle as matrix cracks, given that its activation precedes the initial load drop, thereby rendering it a viable early warning tool for BVID detection and avoiding delamination.

In Figure 9b,c the sensor on the back face activates before the first load drop, with the activated area expanding as the force increases. Upon analysing images captured during the indentation test of *sensor* samples, it was observed that the visible damage pattern on the surface enlarges up to a certain point, that is, where delamination has already happened, but fibre failure is yet to occur. However, beyond this point, the activated area exhibits minimal change despite increasing force. This suggests that in terms of detecting damage “levels” (rather than damage “existence”), the sensor is well suited for identifying low-energy damage types such as matrix cracks and delamination. This is evidenced by the lack of significant alterations in the appearance of the samples (size and shape of damage pattern) beyond a certain force threshold. Nonetheless, the sensor can also be utilised for “visualising” and “detecting” higher-energy damage types. Furthermore, a comparison between Figure 9b,c reveals sensor activation at a lower force for the sample with a sensing layer orientation of 45° . This suggests that the activation force threshold could be influenced by altering the fibre direction of the sensing layer.

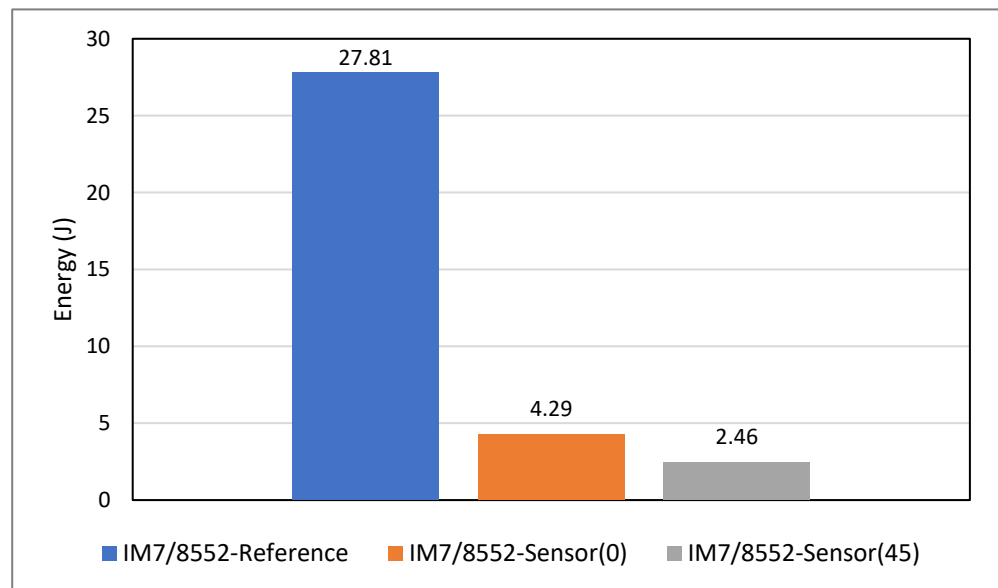
Figure 10. Threshold energies for visually detectable damage.

Figure 10 represents a comparison of threshold energies for detecting damage across all tested samples, highlighting the performance of the sensor in visualising damage on the back face at very low energies. It is observed that while damage on the back face of the IM7/8552-Reference sample is not visible until over 27J, it becomes visible in *sensor* samples at energies as low as less than 5J.

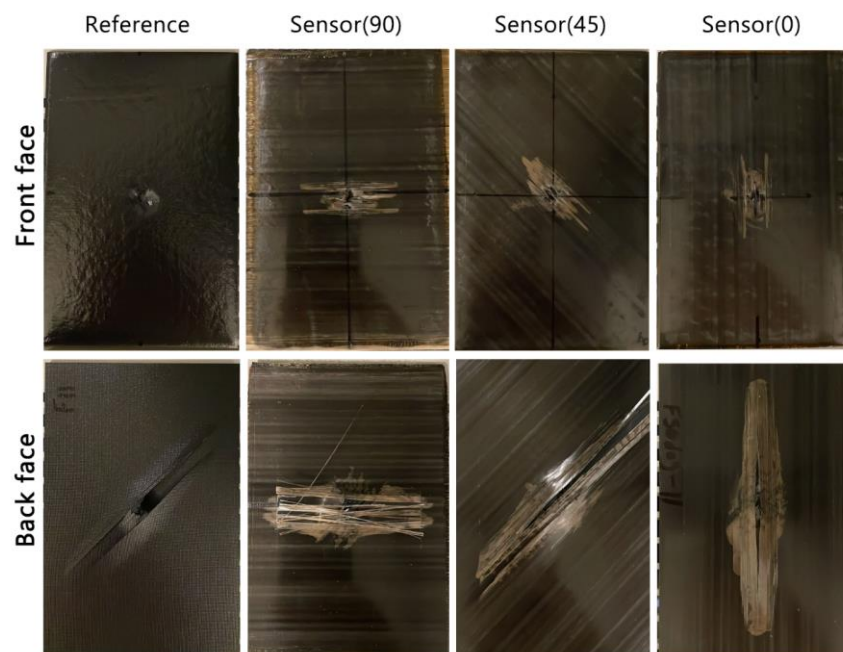
Figure 11. Post-experiment visual inspection.

The post-experiment inspection images are displayed in Figure 11. Note that in addition to the samples discussed previously, this figure includes visual inspection images of an IM7/8552-Sensor(90) sample. This test was conducted initially, and its force–displacement graph was not included in the preceding sections. Its purpose here is to illustrate a comparison of visual damage patterns at various degrees.

Various modes of composite failure are observed in these samples, stemming from indentation tests continuing until significant load drops are observed. Noticeable damage is evident on the front face of the *reference* sample. A recessed area is evident, where the indenter made contact with the specimen. Additionally, a series of small, stepped lines indicate cracks propagating in the upper carbon layer. On the back face, there is significant evidence of damage, particularly fibre failure at the centre of the image directly under the indenter, running parallel to the fibre direction. On the front face of *sensor* samples,

light-coloured patches parallel to the sensor fibre direction indicate sensor activation. On the back faces, the significant light patch directly under the contact area of the indenter demonstrates good sensor activation. Above and below the activated patches, the sensor activation appears striped; this indicates the strain due to the tension on the back face has exceeded the strain to failure of the carbon sensing layer. This result was seen when sensor-integrated specimens were tested in tension by Czél and Wisnom [13]. Overall, the visual damage pattern is larger on the back face than the front face. The findings here suggest that incorporating sensors can lead to notable improvements in visual inspection by revealing visible damage patterns on both the top and back surfaces. Additionally, it enhances the load-bearing capacity, offering flexibility in design to meet the specific requirements of each application. This adaptability can be achieved by adjusting sensor-related parameters, such as the fibre orientation of the sensing layer, to suit desired outcomes.

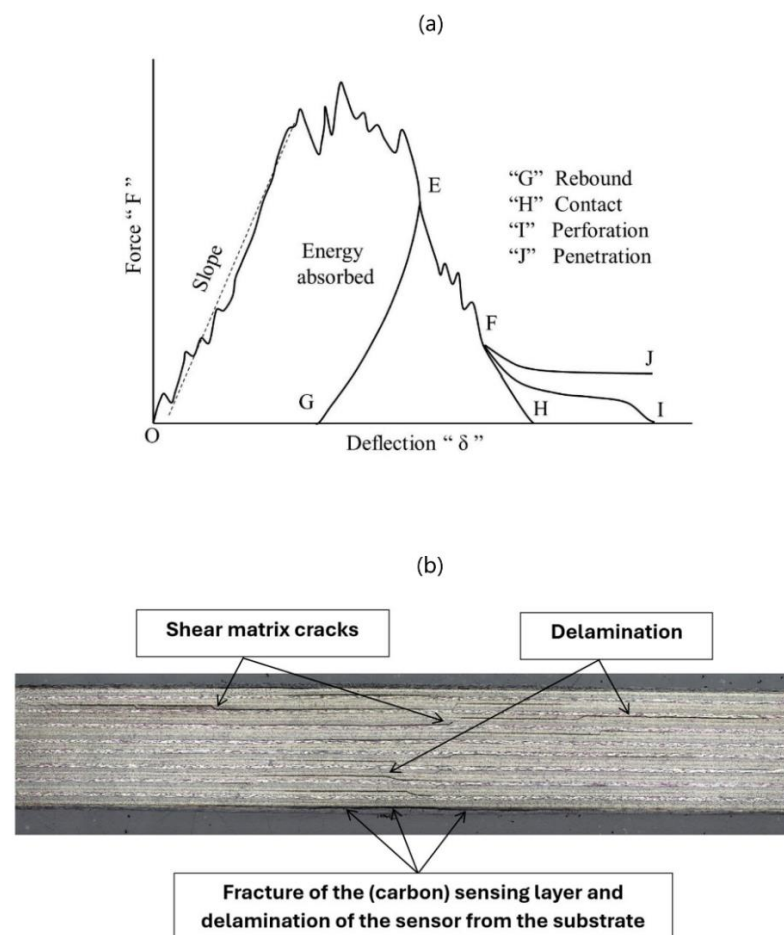
Figure 12. (a) Different damage scenarios with respect to permanent deflection (indentation) [38]. (b) The microscopy image depicts impact-induced damage at 12J, captured from the cross-section of the *sensor* specimen, demonstrating internal damage mechanisms, such as shear matrix cracks and delamination. Additionally, the fracture of the carbon sensing layer and delamination of the sensor from the substrate are evident, both at the point of impact on the front and back faces.

Shah et al. [38] reviewed impact resistance and damage tolerance of FRP composites, summarising different damage scenarios with respect to permanent deflection (indentation) of the composite, including permanent indentation with rebounding of the impactor without perforation, with perforation and the penetration of the impactor (see Figure 12a). BVID can be defined using various metrics or standards. In accordance with general guidelines, permanent indentations ranging from 0.3 mm to 0.5 mm suggest the presence of BVID, while indentations of 2 mm or perforations of 20 mm indicate minor visible impact damage. As indicated in [16], the impact energy required to induce BVID was estimated to be 40% higher than the critical energy level derived from the indentation test, owing to strain-rate sensitivity. Nevertheless, other studies have presented diverse correlations between the critical energy level in quasi-static indentation and low-velocity impact tests [27–29,33,39–45]. This will be studied in more detail in Section 5.3 of this study. Hence, to guarantee the force is sufficient to induce delamination, 12J was considered as the minimum impact energy in this chapter. Additionally, for investigating impact behaviour at higher energy levels, 18J and 27J, were considered as the second and third impact energies for examination. Indentation results showed that for the IM7/8552-Reference sample, the energy required to induce fibre failure slightly exceeds 27J (see Table 2). Hence, this value was selected as the upper limit to study in this research. At these energies, samples undergo delamination; nonetheless, there is no perforation or penetration. This is indicated by a similar trend observed in the graphs obtained from the tests (see Figure 13) to the situation “G” depicted in Figure 12a. Furthermore, microscopy images of the cross-section of impacted samples confirm delamination occurring at the minimum considered impact energy (12J) (see Figure 12b). For the scale, the image shows the central 5 cm throughout the width. Nevertheless, surface damage is either invisible or barely visible on both impacted and non-impacted surfaces when viewed from a distance of 40 cm at a viewing angle of 0°, thus classifying the damage as BVID. Moreover, the measured dent depth data from the Alicona 3D profilometer averaged around 0.5 mm, showing minimal deviation across different groups. This confirms that for all samples, the dent depth aligns with the specified BVID range outlined in the aerospace sector [9]. Every individual impact coupon test underwent two repetitions to verify repeatability.

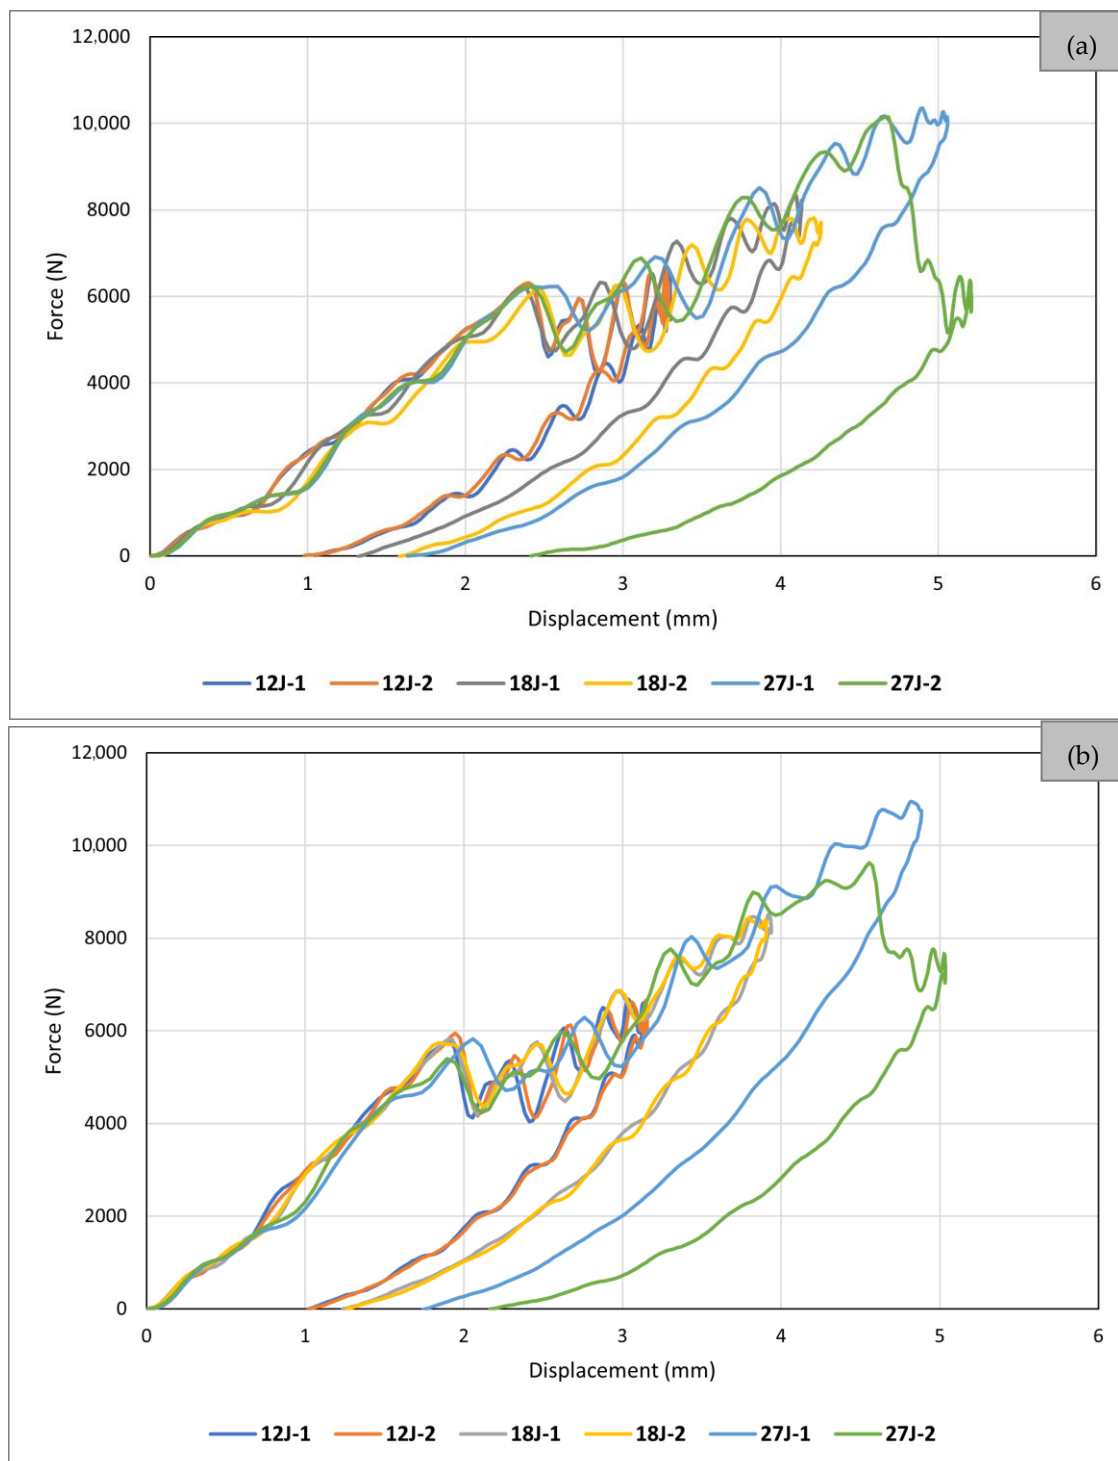
Figure 13. Low-velocity impact test results: (a) *reference*; (b) *sensor*.

The results of all impact tests are shown in Figure 13. It indicates that at impact energies of 12J and 18J, both *reference* and *sensor* samples exhibit excellent repeatability, as evidenced by the close alignment of the graphs. However, some discrepancies arise at the impact energy of 27J, particularly noticeable when approaching the maximum force and displacement. Notably, this trend persists in both *reference* and *sensor* samples at the 27J energy level. This can be attributed to two potential factors. Firstly, the influence of boundary conditions may become more pronounced as the impact energy increases.

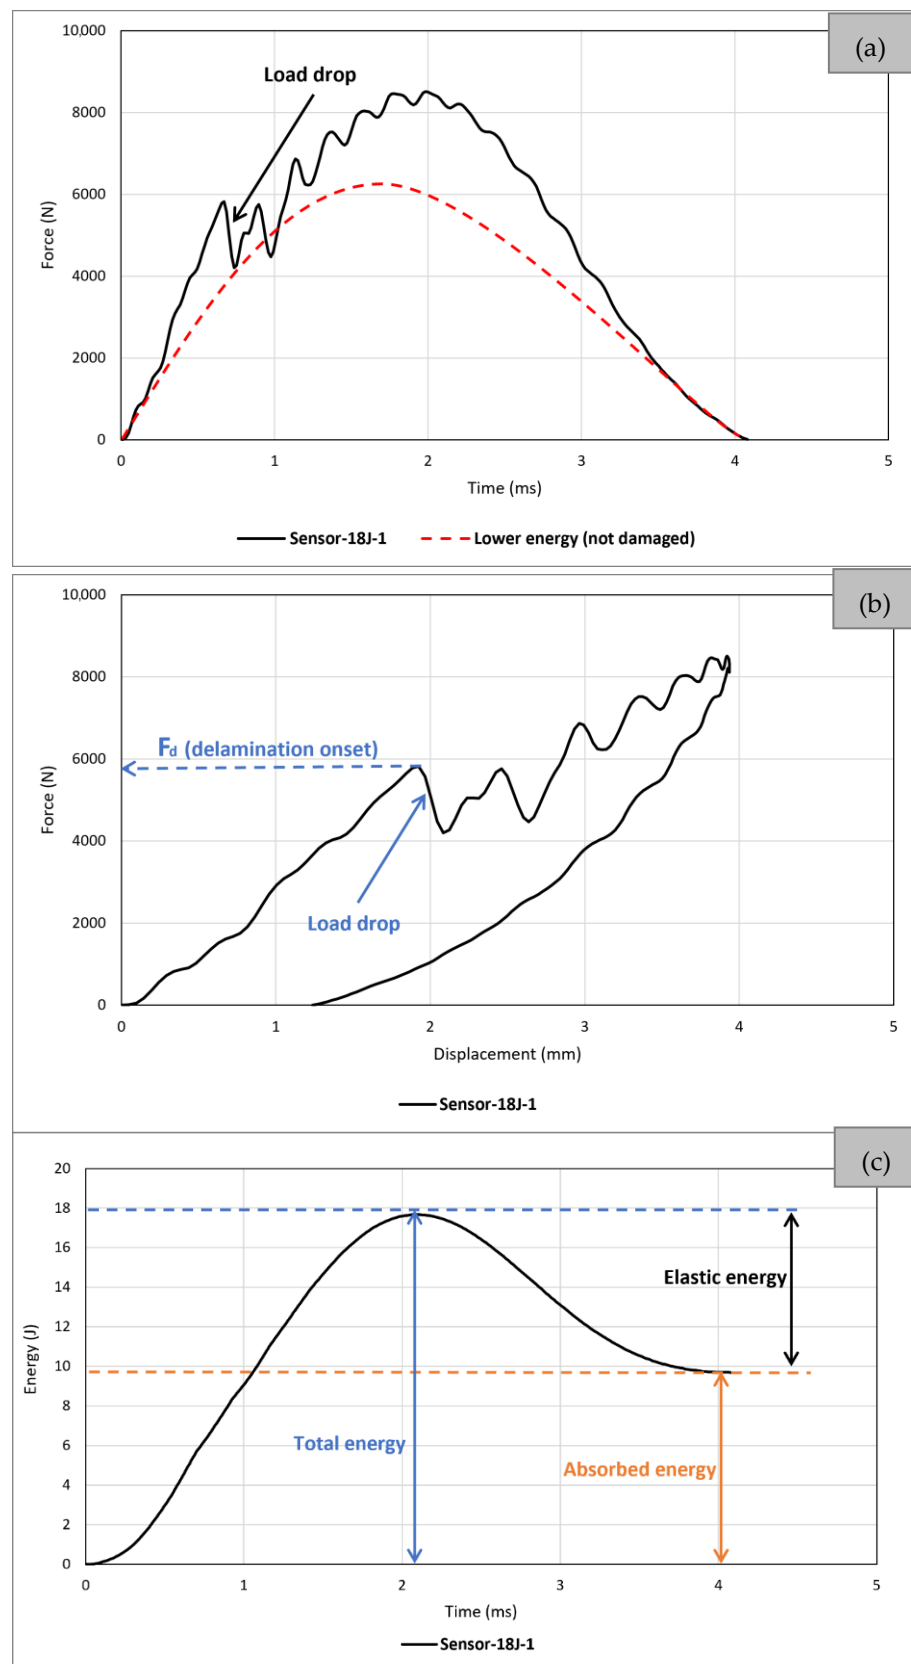
Figure 14. Typical low-velocity impact test results: (a) force–time, (b) force–displacement, (c) energy–time.

To comprehensively analyse the global behaviour of a CFRP under the impact, the force–time, force–displacement, and absorbed energy–time graphs of the *sensor* sample (18J-1) are depicted in Figure 14. In Figure 14a, the force–time results, directly recorded and obtained from the data acquisition system during the impact test, are illustrated. The graph can be divided into two distinct phases. The first half commences with the initial contact between the impactor and the specimen and extends until the velocity of the impactor reaches zero, indicating the point at which the impactor is about to rebound. Notably, a significant load drop associated with delamination is observable during this phase. A red

graph corresponding to a hypothetical lower impact energy that does not cause any damage is also included, demonstrating no significant drop in load. The second half portrays the rebound process, concluding at the moment when the impactor completely separates from the sample. As damage is primarily incurred during the first half, multiple drops are evident in the graph, while the second half displays a smoother and less fluctuating trend. Figure 14b illustrates the force–displacement history, calculated from the force–time results. The graph exhibits an initial almost linear response from 0 to nearly 6000 N. Minor load drops in this region may be attributed to matrix cracking. Then, a sudden drop in load is observed, signifying the onset of delamination. Subsequently, intermittent minor drops occur until reaching a maximum force of slightly over 8000 N. Following this, once the impactor has fully transferred its energy to the specimen, there occurs a redirection of elastic energy stored within the specimen back to the impactor, inducing a rebound phenomenon. This transition is graphically represented by a gradual reduction in both force and deformation. The plot of the unloading curve passes under the loading section of the plot; this encloses an area that corresponds to the total absorbed impact energy. This energy is absorbed through both the dynamic response of the specimen and through damage mechanisms. The change in gradient and the enclosed area indicate that damage has occurred for this impact energy. Nevertheless, the enclosed nature of the graph means that there is no penetration or structural failure [38], which supports findings from both indentation and visual inspection. Figure 14c shows the energy–time history that can be divided into two parts: (a) elastic energy and (b) absorbed energy. The curve exhibits a progressive increase during loading, reaches a peak, decreases during unloading, and ultimately levels off at a constant value. The latter signifies the total energy permanently absorbed through damage mechanisms by the composite specimen at the end of the impact event. The peak of the curve corresponds to the respective impact energy (18J here).

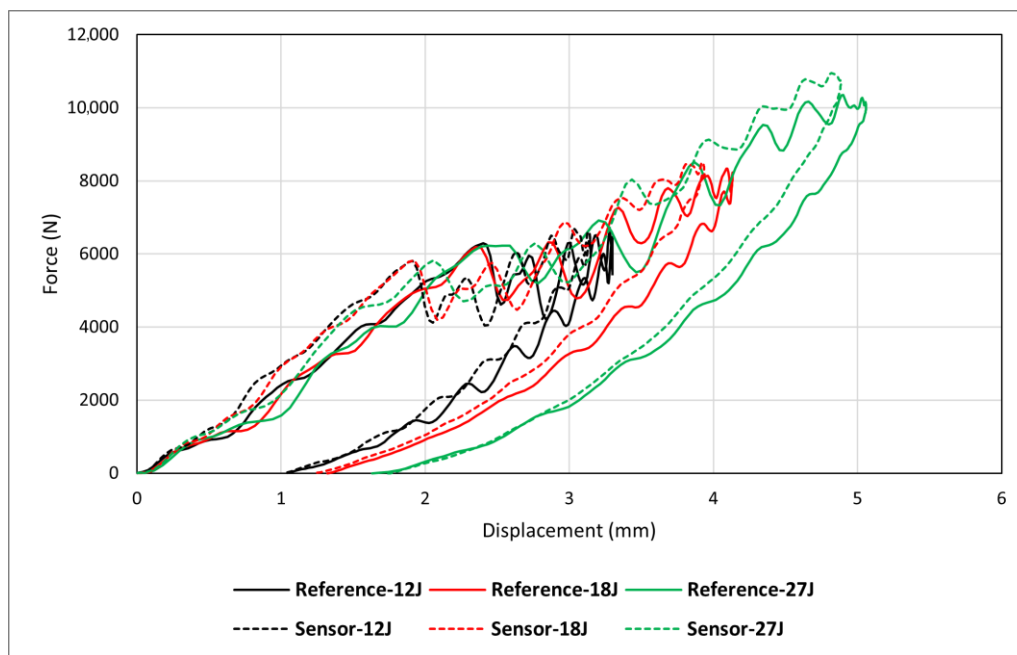
Figure 15. Influence of adding sensors at different impact energies.

The assessment of composite materials' impact resistance typically involves examining aspects such as impact energy absorption, resistance to damage (specifically, the extent of damage following a non-penetrating impact), and tolerance to damage (residual properties after non-penetrating impact) [46]. This research focuses on energy absorption and resistance to damage. Accordingly, it is essential to understand the influence of sensor incorporation on the mechanical properties of the substrate structure and minimise this effect to achieve a reliable self-sensing system. Figure 15 compares two groups of samples, *reference* and *sensor*, at three different impact energies, and important information obtained from the graph is presented in Table 3. The results demonstrate a higher maximum force at a relatively lower maximum displacement for *sensor* samples compared to *reference* ones, meaning that adding sensors slightly increased the rigidity and structural stiffness. Considering the maximum force, for example, the results suggest that adding sensors could increase the maximum force by approximately 1% at 12J energy, 2% at 18J energy, and 6% at 27J energy, indicating that the effect of adding sensors on impact behaviour appears to be more significant at higher impact energies. Overall, no significant difference can be seen between the two types of specimens, indicating the addition of sensors has little influence on the maximum force generated by the specimen, though it does slightly increase the energy absorption, suggesting the sensor may slightly enhance impact resistance in terms of the energy absorption capacity (see Figure 16). The post-impact visual inspection revealed that these drop energies had activated the sensor, meaning that energy was absorbed by damage within the sensing layer, which could be a possible reason for the increased energy absorption in *sensor* specimens. Overall, results suggest that within the BVID range, the sensor does not change mechanical properties significantly while improving the load-bearing capabilities (energy absorption) of the entire structure. This aligns well with the indentation test results.

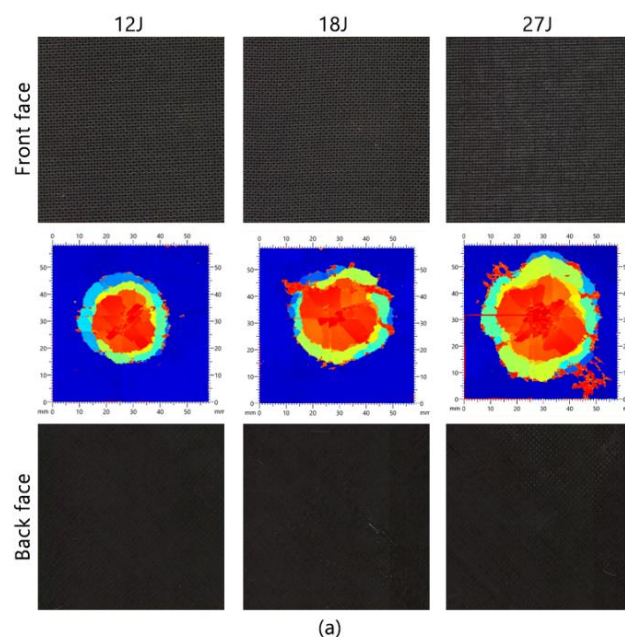
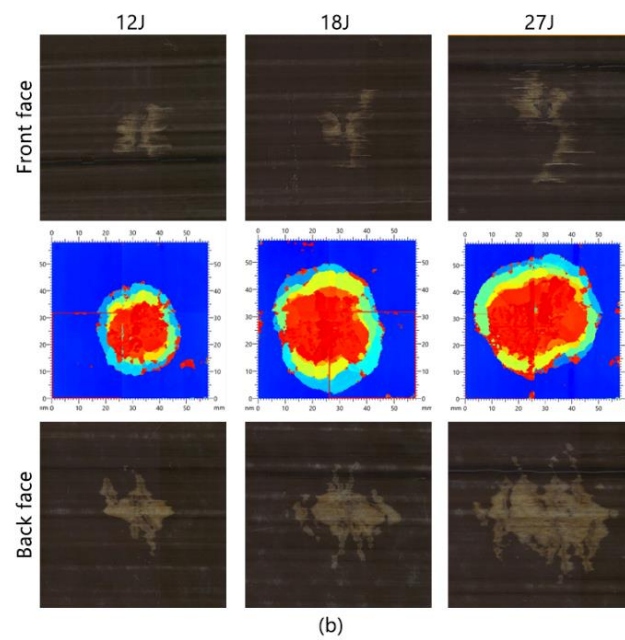
Figure 17. Ultrasonic C-scan and visual inspection results: (a) reference; (b) sensor.

No visible signs of impact damage on the back face are apparent in any of the three energies investigated in the *reference* samples. However, upon closer scrutiny of the 27J sample, a subtle indentation is discernible in the region directly affected by the impactor on the front face, suggesting internal damage within the specimen, indicative of BVID. This becomes more apparent upon physical examination. Ultrasonic examination, on the other hand, reveals evidence of internal delamination damage across all three energy levels, with the extent of damage increasing proportionally with energy input (see Figure 17a). In contrast to the *reference* samples, the visual inspection results of the *sensor* samples clearly reveal damage on both the top and back faces. This indicates that the sensor was triggered at all three energy levels, with the visual damage proportionately increasing as energy levels rose. Notably, the visual damage pattern on the back face differs from that on the front face due to different damage modes. On the back face, a discernible light patch suggests sensor activation due to tensile strain from the impact loading. Within this region, a darker speckled area indicates fibre fracture within the sensing layer, while a larger, lighter area signifies delamination of the glass layer from the carbon sensing layer. The front face displays less pronounced sensor activation, though it still exhibits a discernible activated area. With increased energy, the activated area expands more prominently in a

direction perpendicular to the fibre direction. Additionally, short white lines surrounding the impacted area, aligned parallel to the sensor fibre direction, indicate matrix damage within the sensing layer. This is particularly noticeable in the case of 27J energy (see Figure 17b). For the scale, all images in this figure cover a dimension of 50 mm × 50 mm.

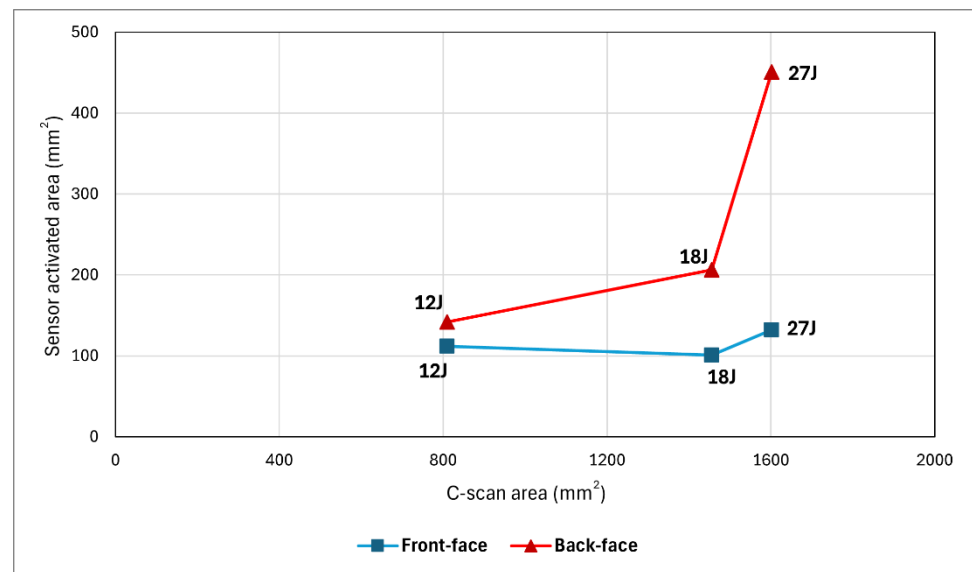
Figure 18. Comparison of the surface visible damage area and C-scan damage area at three impact energies.

Figure 18 compares the size of the visual damage area on the surface and the size of the C-scanned damage area for the *sensor* samples at the three impact energies. It is evident that as the impact energy increases, both the C-scanned and sensor-activated areas on the surface also increase. However, there is an exception with the activated area on the front face of the 18J sample. Note that the values on the vertical axis of this graph represent the activated area size, which is smaller for the front face at 18J compared to 12J due to its inconsistent elongated length but relatively shorter width, unlike the 12J sample, which covers a consistently smaller area. Nevertheless, the visible damage in the 18J sample is still more significant than in the 12J sample. Overall, this graph suggests that the activated damaged area on the surface can serve as an estimate of the severity of internal damage.
