Article

Characterisation and Application of Bio-Inspired Hybrid Composite Sensors for Detecting Barely Visible Damage under Out-of-Plane Loadings

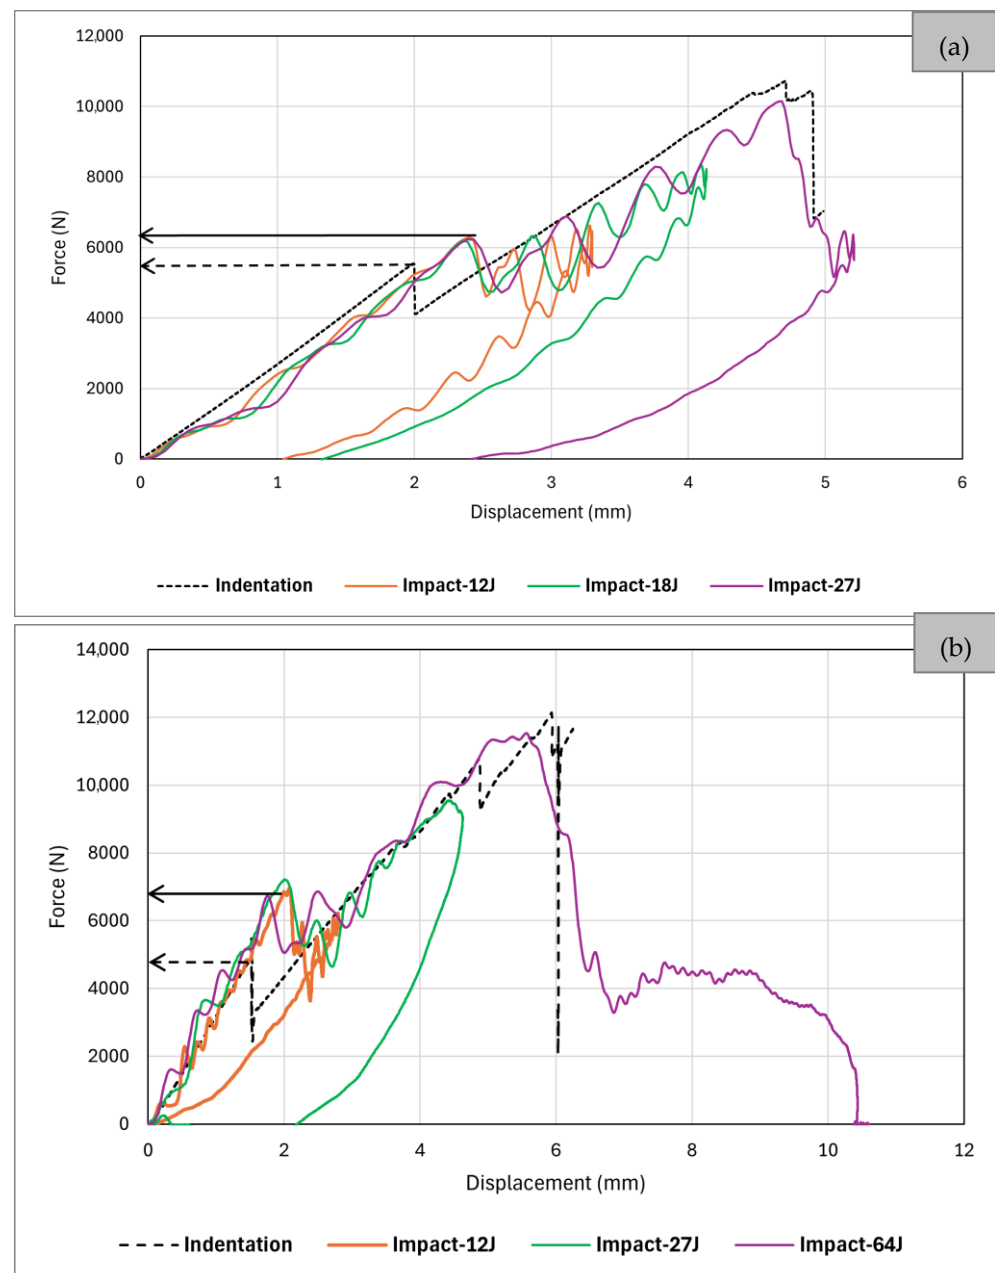
Figure 19. Comparison of indentation and impact response: (a) IM7/8552 samples of this research (*reference samples*); (b) T800/MTM49-3 samples of work by Fotouhi et al. [16].

Given the dynamic nature and short duration of low-velocity impact tests, analysing the progression and development of degradation mechanisms within a structure during such tests proves challenging and can mainly occur post-test completion. Consequently, researchers have redirected their attention to the static indentation test, which has demonstrated similar overall behaviour and resulting damage states compared to low-velocity impact tests [27–29,33,39–45]. The static indentation test offers the advantage of pausing the test at different stages, allowing for the observation of damage evolution. Nonetheless, it is crucial to thoroughly examine the similarities and disparities between these two tests to gain a deeper understanding of their correlation and the potential for substituting a low-velocity impact test with a quasi-static indentation test. Figure 19a compares force-displacement curves for the indentation and impact tests of this research. Note that the curve labelled “27J” in Figure 19a corresponds to the “27J-2” curve depicted in Figure 13a.

Both Figures 3 and 19a,b demonstrate a high level of similarity in the initial stiffness of the load–displacement curves obtained from the static and dynamic tests. This observation indicates that both displacement and force measurements obtained from static indentation and impact tests are precise. Therefore, the higher dynamic critical load observed in impact tests may not be due to misinterpretation or measurement errors. The disparity is believed to reflect the influence of loading rate on alterations in material intrinsic properties. Consequently, the increase in the critical load in the impact test is more likely a consequence of the strain rate dependence of the mode II critical strain energy release rate.

The critical load corresponding to fibre failure (second significant drop) in the indentation test closely mirrors that of impact tests in Figure 19a,b. In Figure 19a, this load drop for both indentation and impact tests occurs at a force and displacement of approximately 10,000 N and 5 mm, respectively, while in Figure 19b, these values are 12,000 N and 6 mm, respectively. The calculated absorbed energy values from the area under the

force–displacement curve of the indentation tests for both figures were slightly higher than 27J. Thus, an impact energy of 27J or higher was anticipated to result in fibre failure. Notably, the impact energy of 27J in Figure 19a has caused this damage, indicated by a recognisable drop, while in Figure 19b, the impact energy of 64J has led to fibre failure and perforation, evidenced by a force–displacement graph similar to scenario “I” in Figure 12a. When examining the trends of second load drops, it is apparent that the values associated with these drops consistently align between the indentation and impact tests. This observation suggests that forces linked to fibre failure also appears to exhibit similarities between the two tests. Overall, the comparative study presented in this section, along with the findings from the literature, confirm that static indentation properly represents the barely visible damage induced in impact tests of quasi-isotropic laminates, offering a controlled, reliable, and repeatable loading setup, as well as stable damage growth [22,29,39].
