Article

Application of Artificial Neural Networks to a Model of a Helicopter Rotor Blade for Damage Identification in Realistic Load Conditions

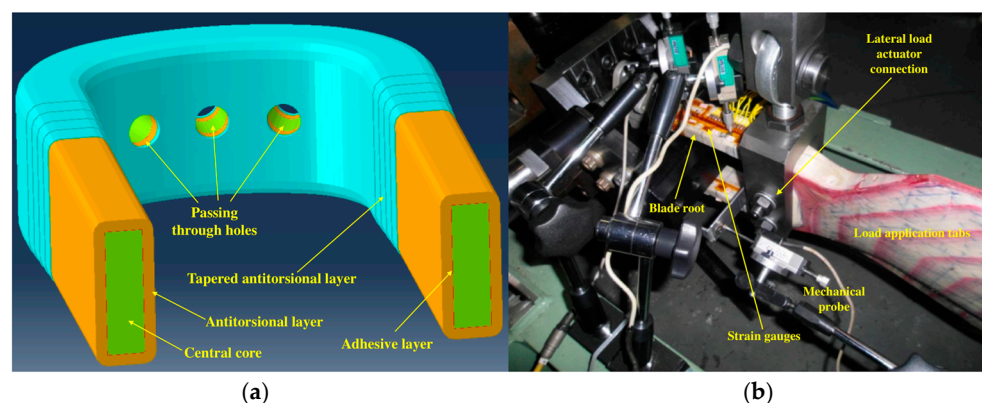
The component was represented by a composite helicopter rotor blade root, which is shown with the details including the internal features in Figure 1a, while in Figure 1b, the blade root subjected to testing can be observed. Referring to Figure 1a, the following colors were used to distinguish the main subcomponents: the color light green was used for the central core, the color orange was used for the antitorsional layer, the color light blue was used for the tapered antitorsional layer, and color red was used for the adhesive layer. The component was characterized by a composite central core that was wrapped by an antitorsional layer. The lamination sequence of the composite rotor blade root cannot be disclosed for confidentiality reasons. Three passing-through holes were positioned in the curved part of the blade root: one of them was located in the symmetry centre, and the other two were located symmetrically to the central one. Consistent with the curved part, additional layers of composite plies were co-bonded over the antitorsional layer: this produced a tapering in the cross section, which is clearly visible in Figure 1a, colored light blue.

Figure 1. Pictures describing the blade root: (a) blade root with details including its internal features; (b) blade root subjected to testing in the test rig.

The antitorsional layer was connected to the central core by means of an adhesive layer, which is depicted in Figure 1a, colored red, and represents the focus of this work, since the SHMS was aimed at monitoring its structural integrity.

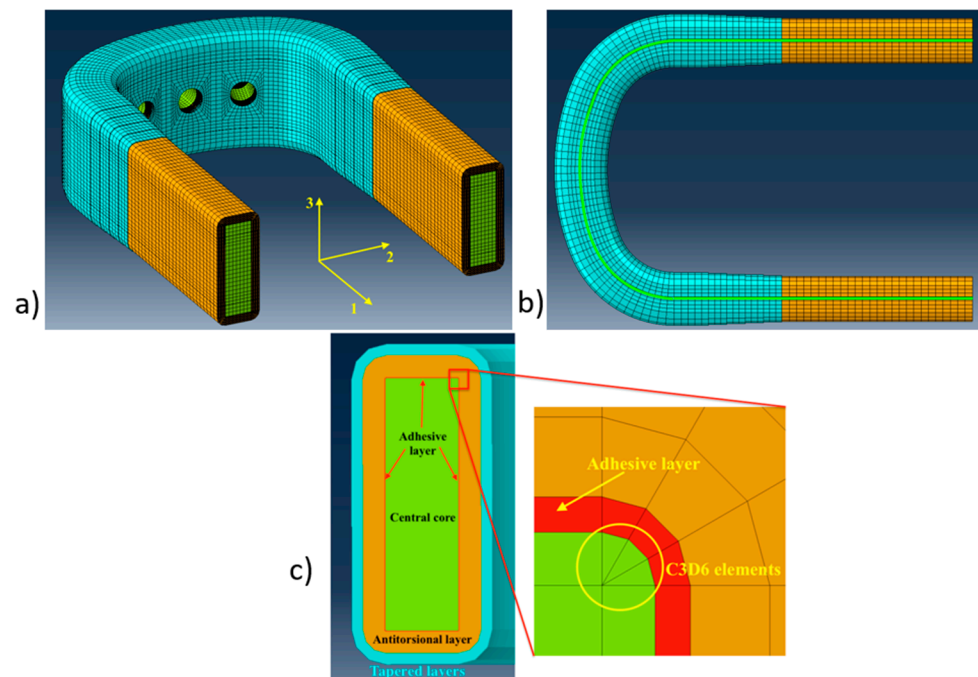
The component was modeled with the software Simulia/ Abaqus 2019, and the input file was automatically generated through a Matlab® R2022b script. In Figure 2, the mesh adopted for the component is shown, evidencing the three types of elements that were adopted: hexahedral bricks, wedge elements, and cohesive elements (respectively, types C3D8, C3D6, and COH3D8 in the solver code [43]). The antitorsional layer and the tapered antitorsional layer were modeled ply by ply, with C3D8-type elements to correctly capture the state of stress. The central core was modeled with both C3D8- and C3D6-type elements.

Figure 2. Meshing strategy adopted for the component: (a) the Finite Element model of the blade root; (b) the curvilinear path of the central core; and (c) the cross section with detail of the mesh of the corner region with C3D6-type elements.

As can be seen in Figure 2c, the C3D6-type elements were used only in the corners of the central core in order to allow the proper meshing of the fillet region, while in all the other locations, C3D8-type elements were adopted. The adhesive layer was modeled with the COH3D8-type cohesive elements having a thickness of 0.1 mm. Their penalty stiffness was set equal to the value calculated according to [44], considering, as the adherent thickness was t , the thickness of the antitorsional layer. Equation (1) related the penalty stiffness of the cohesive element to the out-of-plane stiffness and thickness of the adjacent layers:

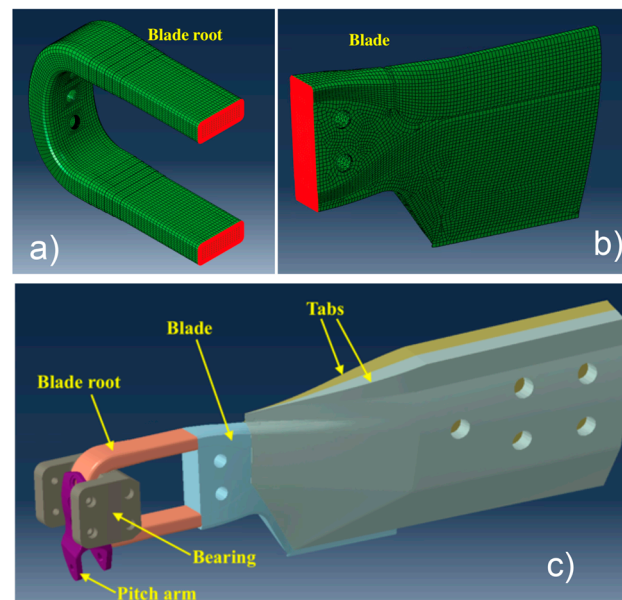
Figure 3. Blade root assembly: (a) blade root surfaces involved in the tie connection with the rest of the blade; (b) surfaces of the rest of the blade involved in the tie connection with the blade root; and (c) blade root assembly for testing.

A nonlinear static FE model was developed, in which the blade root was connected to the rest of the blade with a tie interaction; the surfaces involved in such interactions are shown in Figure 3a,b, highlighted in red color. Tabs were also connected to the blade with a tie interaction, as well as to the pitch arm and to the blade root. A contact interaction between the blade root and the bearing was modeled, introducing a friction coefficient equal to 0.1.

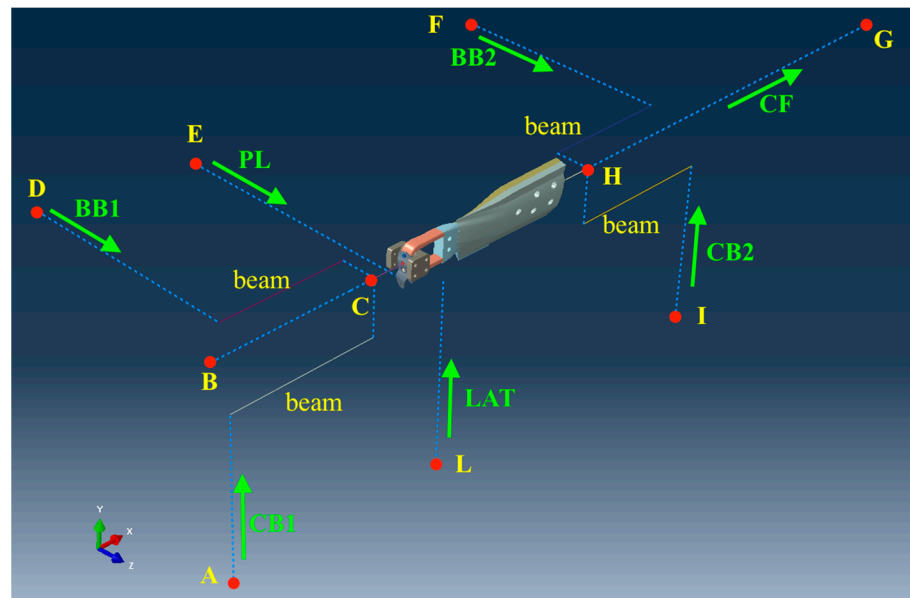
The loads applied throughout this work were defined considering the load set that is actually used to perform the fatigue testing for the blade certification, which in turn are chosen to represent realistic load conditions for the rotorcraft blade. In the experiments, the load set consisted of seven components that were applied through a proper test rig. In the FE model, such loads were applied by using connector elements (type CONN3D2 [43]). A description of the component of the load sets, as shown in Figure 4, is hereby provided:

- CF: centrifugal force, which was applied to the tabs;
- PL: force acting on the pitch link, which counterbalances the pitching moment;

- LAT: lateral load, which was applied by the lag damper connected to the blade;
- CB1 and CB2: in-plane bending loads, introduced through the bearing and through the tabs, respectively;
- BB1 and BB2: out-of-plane bending loads, introduced through the bearing and through the tabs, respectively.

Figure 4. The constraints and load set applied to the blade during the testing in the test rig.

To generate realistic load conditions for the ANN training, the parameter θ was varied in the range $0 \div 2\pi$, thus generating 100 evenly spaced load conditions, varying CF, BB1, CB1, LAT, PL, BB2, and CB2, which represent the load components presented in Figure 4.

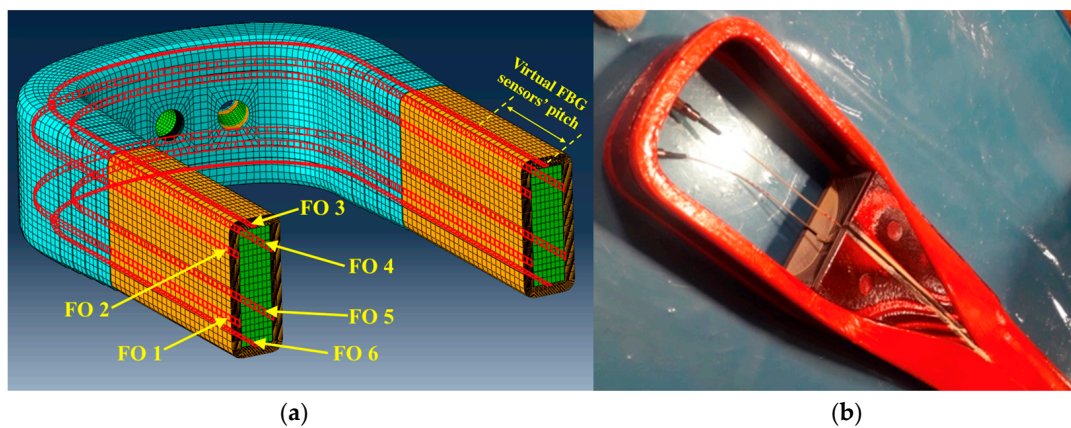
A number of 10 virtual FBG sensors per optical fiber was considered, consistent with the limitations provided by the multiplexing technique [48], so that a total of 60 virtual FBG's were employed in the SHMS. The virtual sensors were distributed equally spaced along each optical fiber with a pitch equal to 42 mm, which is highlighted in Figure 5a.

Figure 5. Virtual and real optical fiber-based sensors in a composite blade: (a) the virtual optical fiber paths chosen in this work; (b) an example of optical fibers integrated in a helicopter tail rotor blade, adapted from [1] with permission.

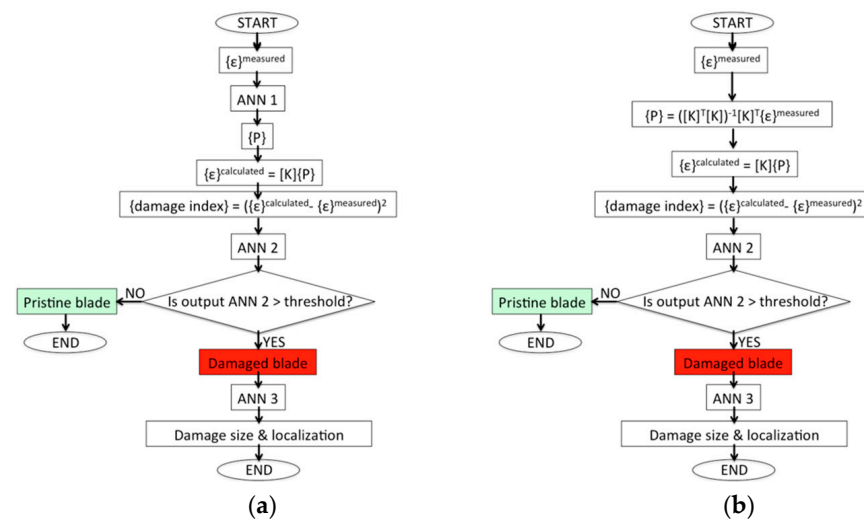
Figure 6. Flow diagrams of the damage detection algorithms: (a) Damage detection algorithm diagram for version #1 and version #2; (b) damage detection algorithm diagram for version #3.

According to the procedure previously described, and depicted in Figure 6a, the anomaly detection step was accomplished. Therefore, a damage index pattern was calculated for each virtual FBG sensor on the basis of the identified load set using Equation (4). The calculated damage index pattern was then given as the input to ANN 2, whose task was to detect the presence of anomalies. The output of ANN 2 was represented by a scalar value between 0 and 1, where 0 represented the target for the pristine blade root, while 1 represented the target for the damaged blade root. In this example, the following outputs of ANN 2 can be observed for the pristine and damaged blade root:

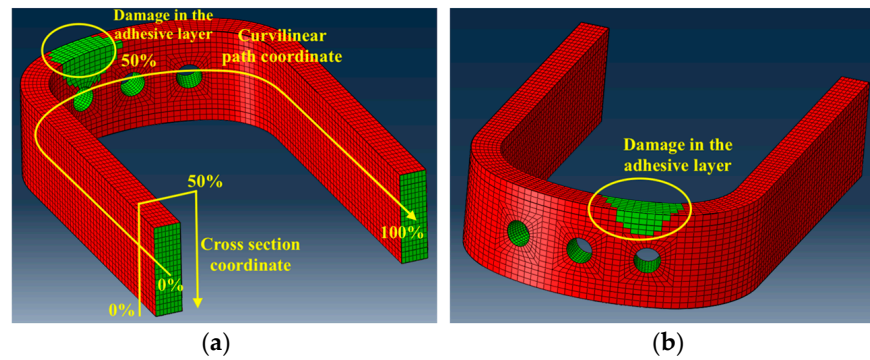
To create the virtual datasets to train and test the ANNs, different FE analyses were performed, introducing damages during the generation of the analysis' input file that deleted the cohesive elements that were included in a space described as a sphere that was located on the surface of the adhesive layer to be monitored. Such damages were introduced in 40 different locations on the adhesive: in detail, referring to Figure 7a, damages were introduced in four locations equally spaced along the cross section coordinate and 10 locations equally spaced along the curvilinear path. Only one damage per FE analysis was created in the adhesive. It must be specified that, for each combination of a curvilinear path coordinate and a cross section coordinate, nine damage dimensions were analyzed, having the following sizes: 3, 6, 9, 12, 15, 18, 21, 24, and 30 mm. A total of 360 damage scenarios were considered in this study, resulting in the combination of 10 damage locations in the curvilinear path coordinate, 4 damage locations in the cross section coordinate, and 9 damage dimensions. Figure 7a,b shows an example of damage

of 30 mm diameter, located at 44.44% of the curvilinear path, and at 50% of the cross section coordinate.

Figure 7. Damage introduction in the FE model; (a) the coordinate system for damage introduction and an example of damage of diameter 30 mm, located at 44.44% of the curvilinear path, and 50% of the cross section coordinate, better shown in (b).

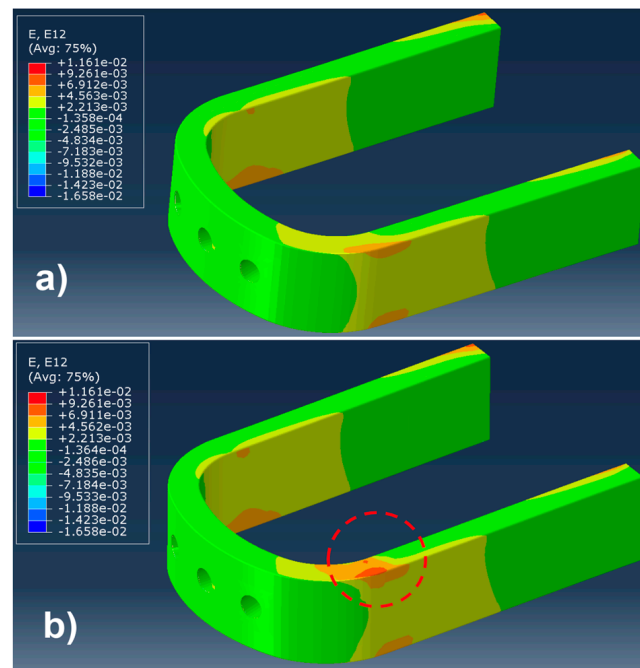
In this subsection, an example of damage identification was provided to better clarify the process through which damage was identified in the blade root. The example hereby considered consisted of two different blade roots, one without damages and the other one having damage of 30 mm size, located at a 33.33% of the curvilinear coordinate, and at 49.95% of the cross section coordinate, according to the coordinate systems presented in Figure 7a. The same load set was applied to both the damaged and undamaged blade roots, whose values were reported in the first row of Table 6, normalized with respect to the load component BB1 for confidentiality reasons. In Figure 8, the strain field contour can be observed for the case of a pristine blade root, presented in Figure 8a, and a damaged blade root, presented in Figure 8b. A difference in the contour can be observed in the red circle, where the damage was introduced, in Figure 8b.

Figure 8. An example of a strain field in the blade root: (a) strain γ_{12} field in a pristine blade root; (b) strain γ_{12} field in a damaged blade root. Both of them were subjected to the same load condition, presented in Table 6.

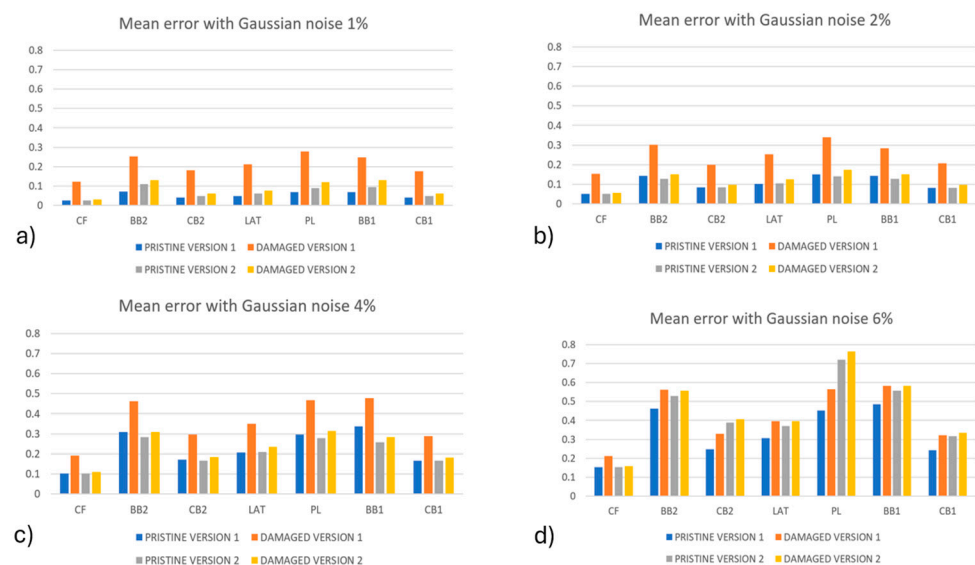
The results regarding load identification for algorithm version #1 and version #2 are provided in Figure 9, in which the average error was calculated for each load component. Moreover, a comparison between the identified loads on the pristine and damaged blades is shown. The error was normalized with respect to the maximum magnitude of each load component.

Figure 9. The mean percentage error of load identification for algorithm version #1 and version #2 for (a) 1% Gaussian noise, (b) 2% Gaussian noise, (c) 4% Gaussian noise, and (d) 6% Gaussian noise.

As expected, the error for all the load components increased as the noise level increased. For example, an increase in the maximum mean error of 0.27% for the PL load component with 1% noise level to a maximum average error of 0.76% for the same load component with

a noise level of 6% was identified. It can be observed that in all the cases, the error related to the damaged conditions was higher than the one obtained for the pristine condition, but this difference decreased when the noise level increased. This is clearly observed in Figure 9d, where the noise level reached 6%: a possible explanation for this behavior is related to the fact that damage perturbs the strain field locally, with an effect that is comparable to the effect of the noise. So, as the noise level was increased, it tended to cover the effect of the damage. In the comparison between the algorithm's versions, it can be observed that version #1 of the algorithm provided a higher difference between the errors in the pristine and damaged conditions than version #2; however, these differences decreased by increasing the noise level.

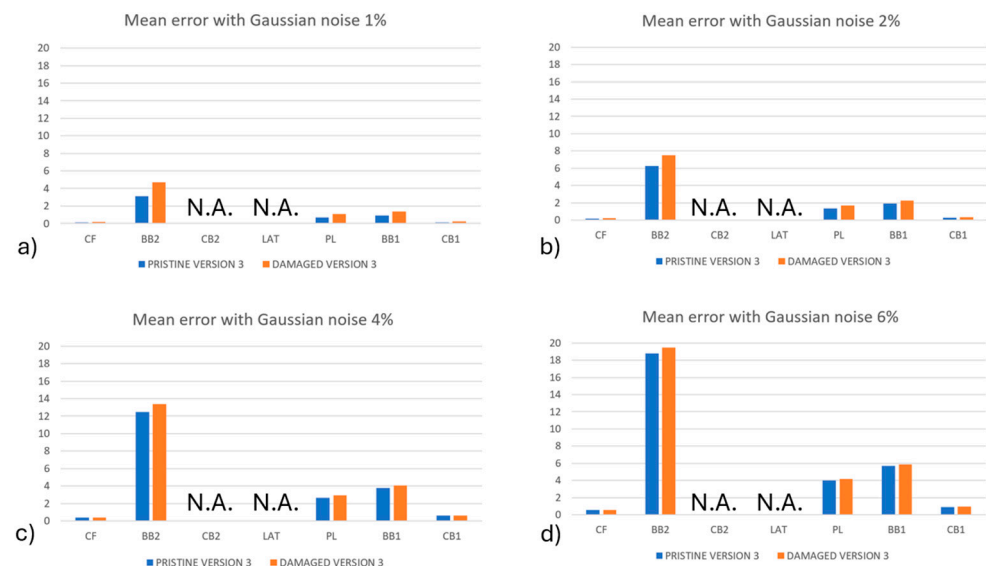
In Figure 10, the mean percentage error of load set identification for version #3 of the algorithm is shown. As already mentioned, the loads were obtained by solving for the load set $\{P\}$, as in Equation (3). Errors related to the load components CB2 and LAT were not reported because they were off-scale for the plot: the error was 5 to 20 times the maximum magnitude of the loads. Regardless, their contributions to the strain fields were verified to be one order of magnitude lower than the other loads that were acting on the blade; this may be the reason for such high errors.

Figure 10. The mean percentage error of load identification for algorithm version #3 for (a) 1% Gaussian noise, (b) 2% Gaussian noise, (c) 4% Gaussian noise, and (d) 6% Gaussian noise. Load components CB2 and LAT were not reported because they were off-scale, accordingly, the notation N.A. was added to the figures.

The same behavior for version #1 and version #2 of the algorithm was observed. By increasing the noise level, the error increased as well; moreover, for all the noise levels and for all the load components, the damaged configuration provided higher errors. It was interesting to observe that, also in this case, by increasing the level of noise, the difference between the errors in the pristine and damaged conditions were reduced. However, the load identification method of version #3 provided worse results than version #1 and version #2 of the algorithm: the load set identification by means of the ANN 1 revealed itself to be much more effective with respect to solving the inverse problem for the load set $\{P\}$, as in Equation (3).

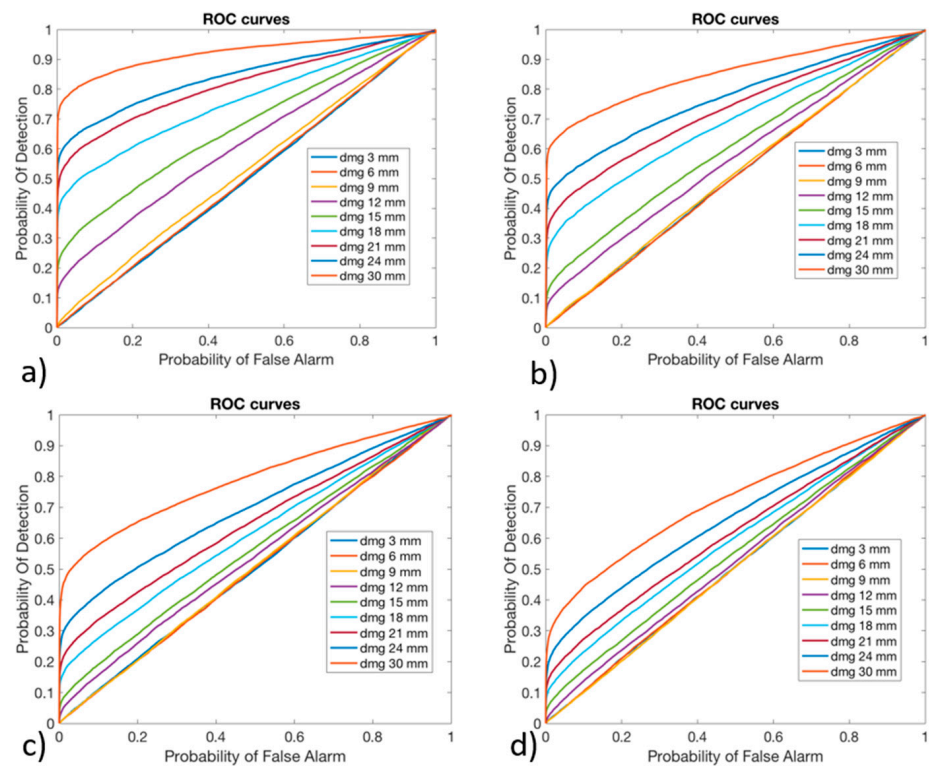
Figure 11. Receiver Operating Characteristic curves for algorithm version #1, obtained with (a) 1% Gaussian noise, (b) 2% Gaussian noise, (c) 4% Gaussian noise, and (d) 6% Gaussian noise.

As can be observed, the damages with a higher dimension were more likely to be detected: their curve is in the upper-left side of the plot. The damages with lower dimensions, like 3 mm, 6 mm, and 9 mm, could not be identified by any one of the versions of the algorithm: their curve is on the no-performance line corresponding to the segment connecting the axis origin to the point (1,1). As was expected, by increasing the level of noise, the algorithm decreases its performance, reducing the POD for the same PFA. Version #1 and version #2 of the algorithm seemed to provide comparable results in the anomaly detection, while version #3 of the algorithm provided lower performance.

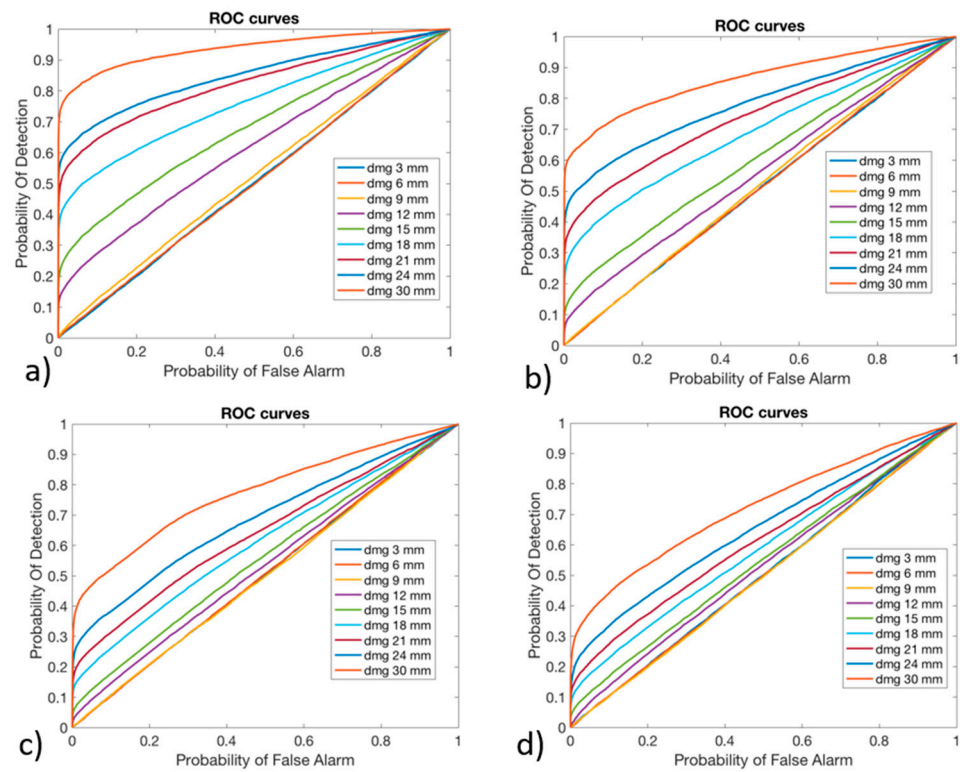
Figure 12. Receiver Operating Characteristic curves for algorithm version #2, obtained with (a) 1% Gaussian noise, (b) 2% Gaussian noise, (c) 4% Gaussian noise, and (d) 6% Gaussian noise.

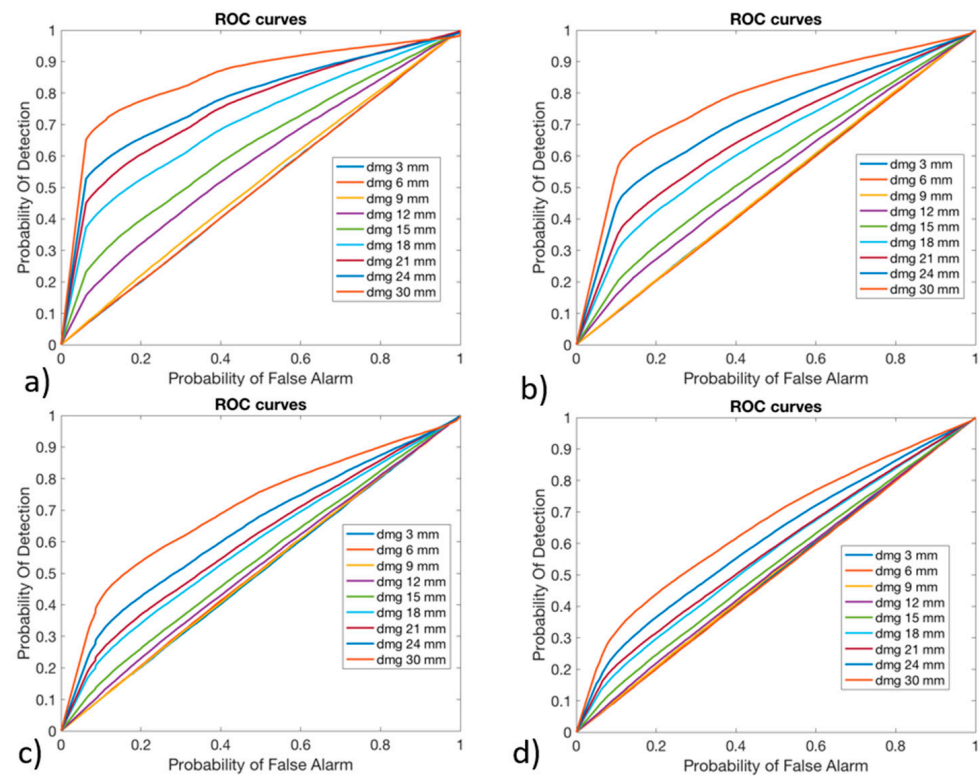
Figure 13. Receiver Operating Characteristic curves for algorithm version #3, obtained with (a) 1% Gaussian noise, (b) 2% Gaussian noise, (c) 4% Gaussian noise, and (d) 6% Gaussian noise.

In fact, especially for small values of PFA (where the optimal threshold should be chosen), the POD showed very small values compared to version #1 and version #2 of the algorithm.

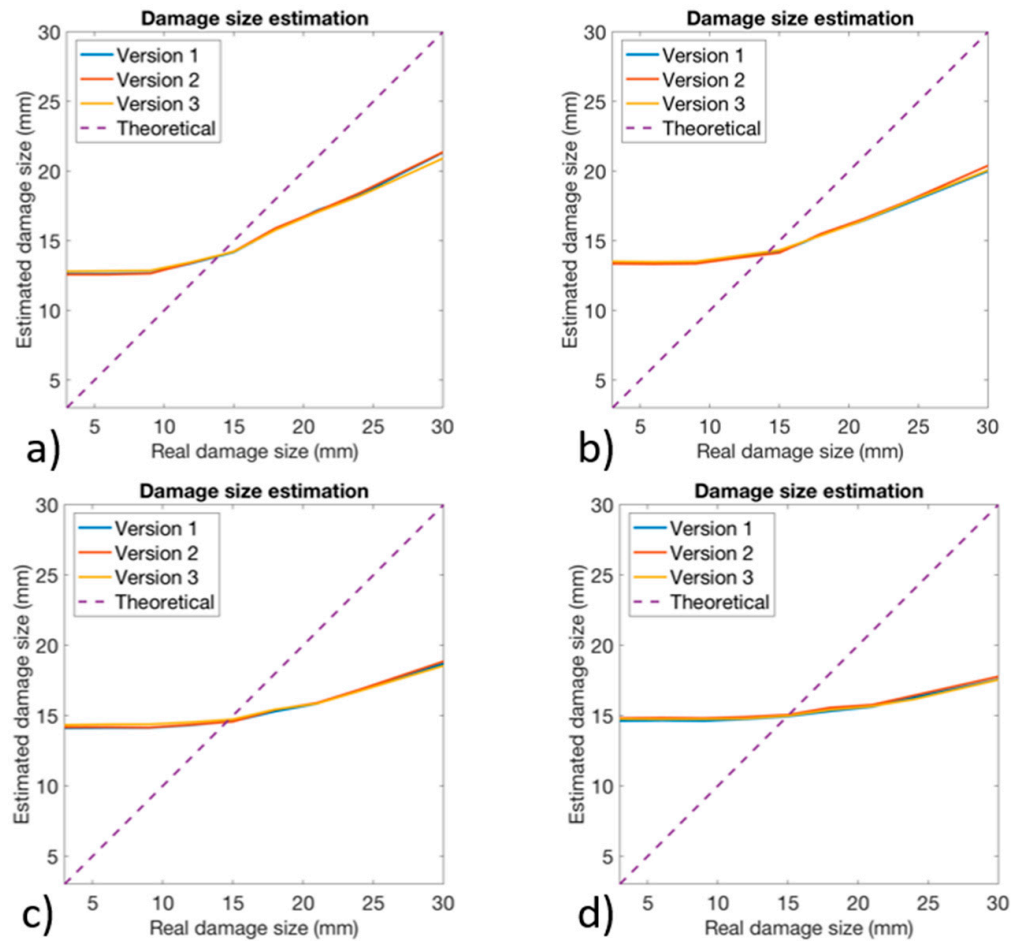
Figure 14. Damage quantification obtained for all the three versions of the algorithm with (a) 1% Gaussian noise, (b) 2% Gaussian noise, (c) 4% Gaussian noise, and (d) 6% Gaussian noise.

For damages with a reduced size, it can be seen that the algorithm overestimated the damage size, maintaining an estimation of about 15 mm; such behavior was observed for real damage that was sized below 15 mm. As the real damage size increased above 15 mm, the algorithm seemed to provide a more accurate estimation of the size of the damage. Regardless, the behavior was still far from the theoretical behavior. No significant differences existed between the three versions of the algorithm; it seemed that version #2 provided slightly better results than the others; however, this difference seemed to be very low. The main factor affecting the performance of the algorithm was represented by the noise level: as the noise level increased, the algorithm seemed to become less sensitive to the size of the damage. In particular, it was observed that the slope of the curves decreased as the noise level increased. Moreover, it seemed that the noise affected all the versions of

the algorithm in the same way. The low sensitivity to the damage size may be due to the relatively low effect that damage in the adhesive produces. Indeed, the central core was much stiffer than the antitorisional layer. Therefore, a disbonding has little influence on the strain field and, consequently, the damage size estimation resulted to be difficult. Moreover, the presence of other structural elements like the pitch arm and the bearing contributed locally to increase the stiffness of the blade root, making the estimation of the damage size even more difficult.

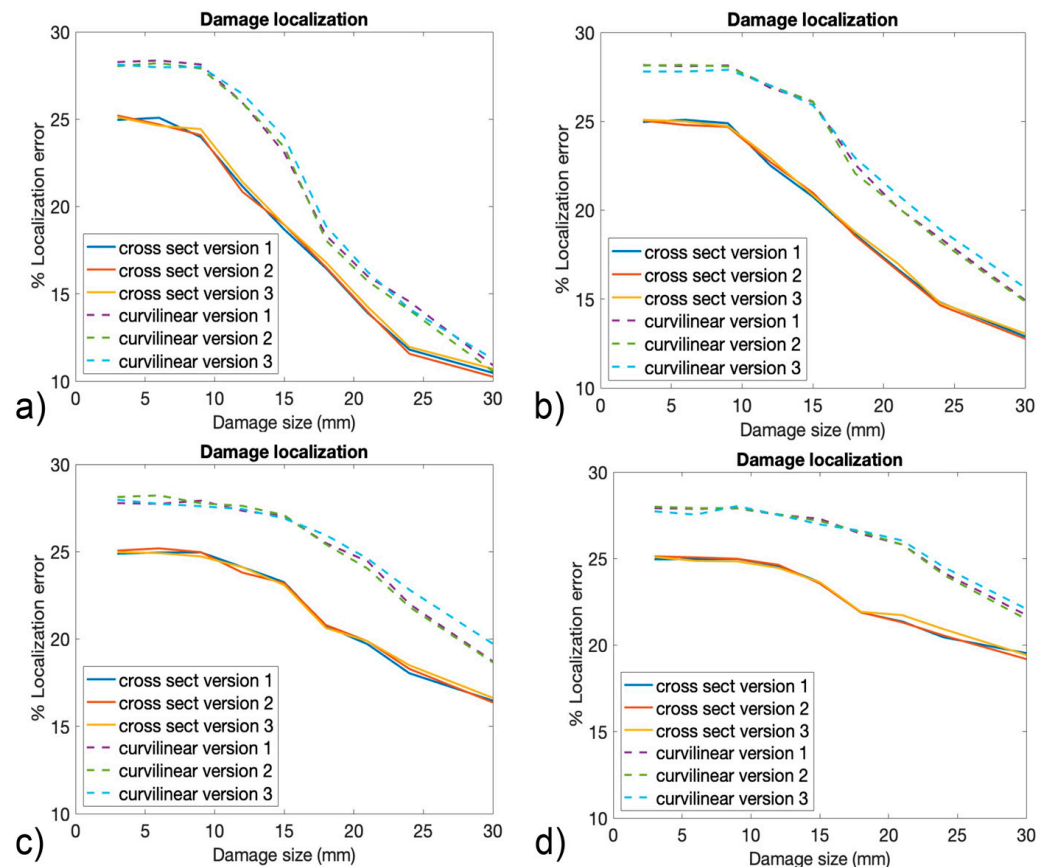
The performances of damage localization are presented in Figure 15, expressed in terms of the mean percentage errors related to the cross section and curvilinear coordinates that were represented in Figure 7a. The percentage error was calculated considering, for each of the two coordinates, the absolute value of the difference between the real damage coordinate and the damage coordinate estimated by the ANN 3. The coordinates were expressed in percentage of the total length.

Figure 15. The percentage error in damage localization obtained for all three versions of the algorithm with (a) 1% Gaussian noise, (b) 2% Gaussian noise, (c) 4% Gaussian noise, and (d) 6% Gaussian noise.

It was interesting to observe that for small damage dimensions, the localization error for both the coordinates was slightly affected by the level of noise, and it maintained a value of 28% and 25% for the curvilinear and cross section coordinates, respectively. Moreover, for small damage sizes, the performances of all the versions of the algorithm seemed to be similar. As the dimension of the damage increased, the error decreased for both the coordinates, and the algorithm seemed to provide lower performances as the noise level increased. In fact, it can be observed that for a damage size of 30 mm, the error for the cross section coordinate passed from 10–11% with a noise level of 1% to an error of 19% with a noise level of 6%. In general, no significant differences existed between the three

versions of the algorithm, especially for low levels of noise. Overall, version #3 seemed to provide slightly higher errors for the curvilinear coordinates for higher levels of noise, while version #1 and version #2 exhibited similar behavior. The oscillation of the blue dashed line, corresponding to the curvilinear coordinate and version #3 of the algorithm observed in Figure 15d, can be explained considering the low sensitivity of the algorithm to small damage sizes. For instance, in the region from 3 mm to 12–15 mm, the Gaussian noise affecting the data played a more relevant role compared to higher damage sizes, thus leading to oscillations in a region where, for low noise levels, the curve was flat.

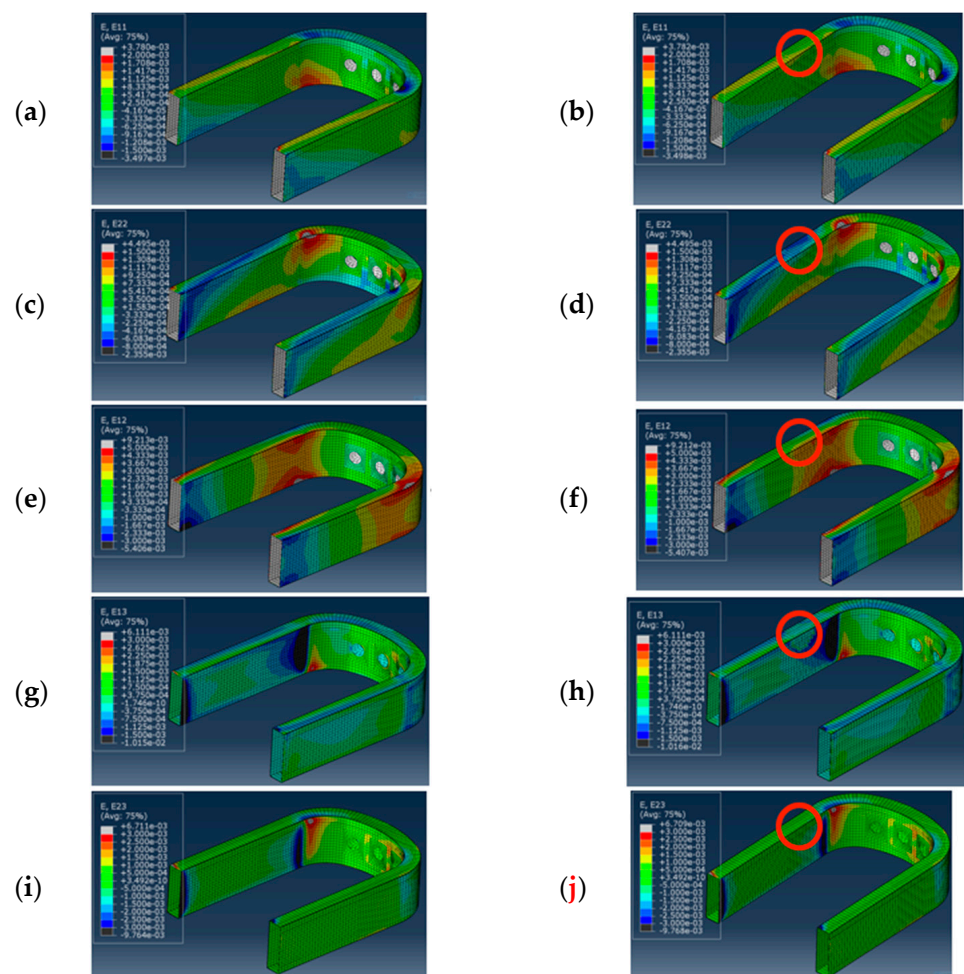
Figure 16 represents a comparison between the strain field distribution in a damaged and an undamaged blade root. The elements represented are related to the ply containing the virtual optical fibers. Considering the size of the damage, which was, in this case, equal to 30 mm, it should be observed that the strain distribution was almost not affected by the presence of the damage.

Figure 16. Strain field distribution in the elements' local reference system of pristine blade root and damaged blade root, with a damage of 30 mm diameter, located at 50% of cross section coordinate, and 22.22% of curvilinear path coordinate, corresponding to the red circle: (a) ε_{11} pristine, (b) ε_{11} damaged, (c) ε_{22} pristine, (d) ε_{22} damaged, (e) γ_{12} pristine, (f) γ_{12} damaged, (g) γ_{13} pristine, (h) γ_{13} damaged, (i) γ_{23} pristine, and (j) γ_{23} damaged.

Only one strain component seemed to be influenced by the presence of the damage, which is represented in Figure 16h, and it was the out-of-plane shear γ_{13} ; however, such a strain component is particularly difficult to measure with an FBG sensor, as they are sensitive to the deformation along the optical fiber path.
