Article

Investigation on a Novel Reinforcement Method of Grouting Sleeve Connection Considering the Absence of Reserved Reinforcing Bars in the Transition Layer

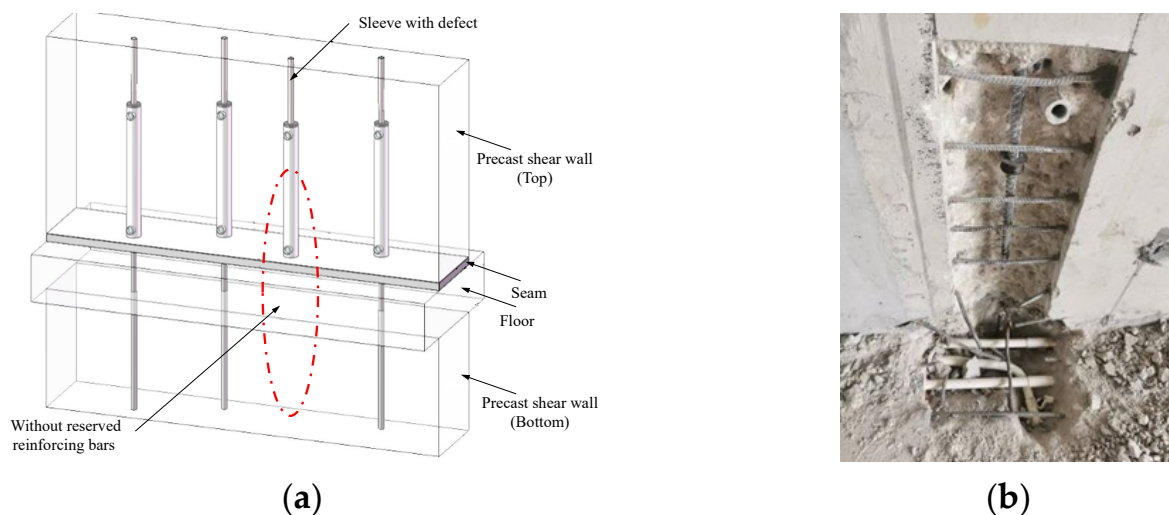
Figure 1. Component with insufficient reserved bars. (a) Schematic diagram. (b) Inspection diagram of a certain project site.

During the construction of precast concrete structures, the reserved reinforcing bars at the top of the lower prefabricated components need to be inserted into the sleeves reserved at the bottom of the upper prefabricated components and then grouted for a compact connection. However, as shown in Figure 1, with the development of grouting sleeve connection quality testing technology and the implementation of inspection work, it might be found that there are cases where the length of the reserved bars in the transition layer is insufficient, partially unreserved, or even entirely unreserved. This is because the connection between the upper section's reinforcing bars and the grouting sleeves is pre-fabricated in the factory, where it is easier to ensure construction quality. However, the connection of the lower section's reinforcing bars to the grouting sleeves during on-site construction often encounters defects due to factors such as precision in processing and worker operation. These defects can significantly impact the structural safety. In such situations, even if the sleeve is fully grouted, it cannot effectively establish a reliable connection. Therefore, reinforcing the insufficiently reserved reinforcing bars in the transition layer of precast concrete structures is deemed essential.

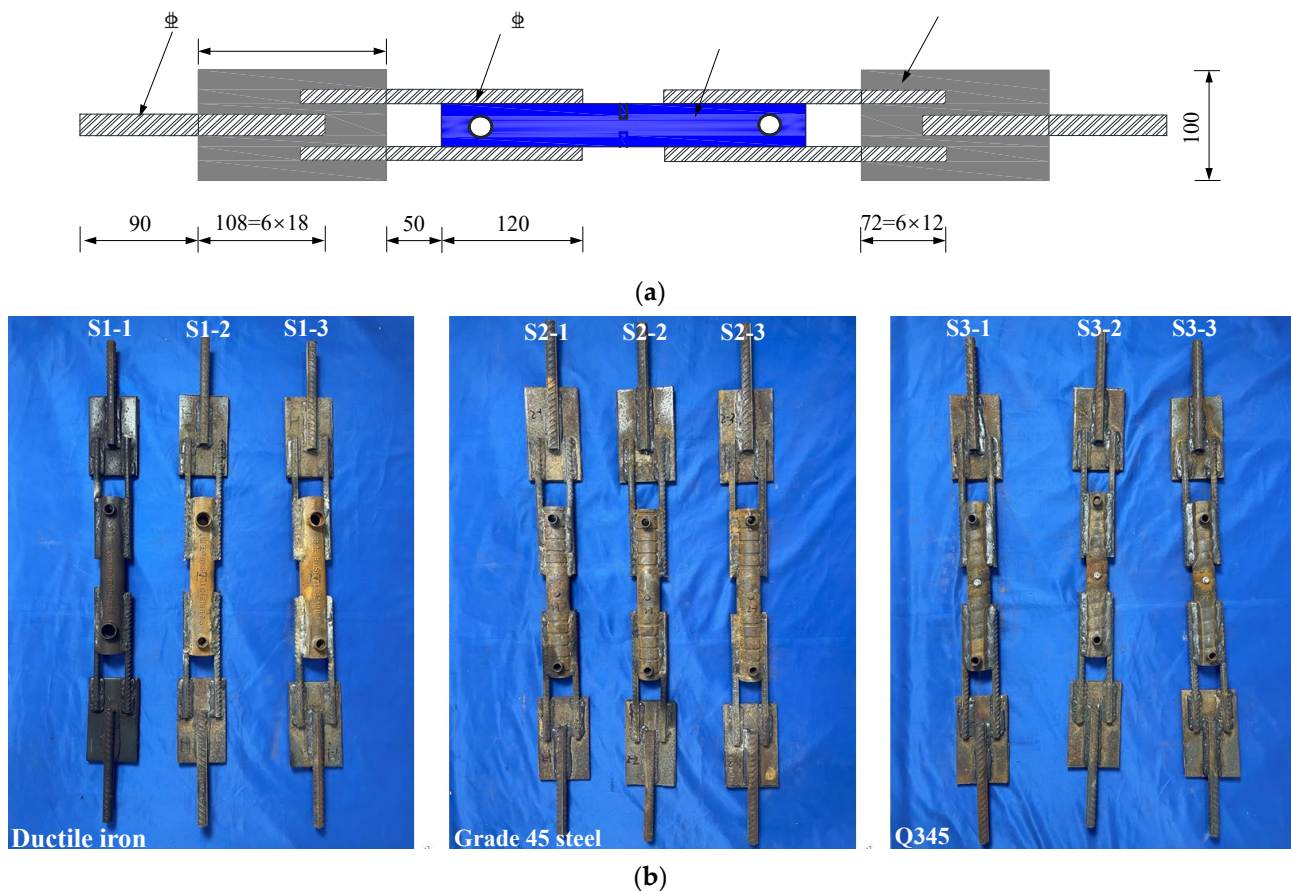
Figure 3. Specimens for the weldability test of grouting sleeves and reinforcing bars (unit: mm). (a) Dimensions and steel reinforcements of the specimens. (b) Specimens.

a tight fit when welding with the reinforcing bars. Therefore, it is necessary to verify the weldability of grouting sleeves and reinforcing bars to ensure the reliability of the novel reinforcement method. This experiment selected three types of fully grouted sleeves, ductile iron (S1-1, S1-2, S1-3), Grade 45 steel (S2-1, S2-2, S2-3), and Q345 (S3-1, S3-2, S3-3), for the fabrication of the test specimens. The specimens S1-1, S1-2, and S1-3, as well as S2-1, S2-2, and S2-3 and S3-1, S3-2, and S3-3, were indeed identical in terms of their design and material properties. The purpose of these specimens was to assess the repeatability and reliability of the experimental results. Since the original connecting reinforcing bars inside the test sleeves had a diameter of 16 mm, supplementary connecting reinforcing bars with a diameter of 12 mm were chosen. The test specimens were designed as shown in Figure 3. A total of nine test specimens were fabricated, with three specimens of the same dimensions designed for each type of grouting sleeve, as shown in Figure 3b.

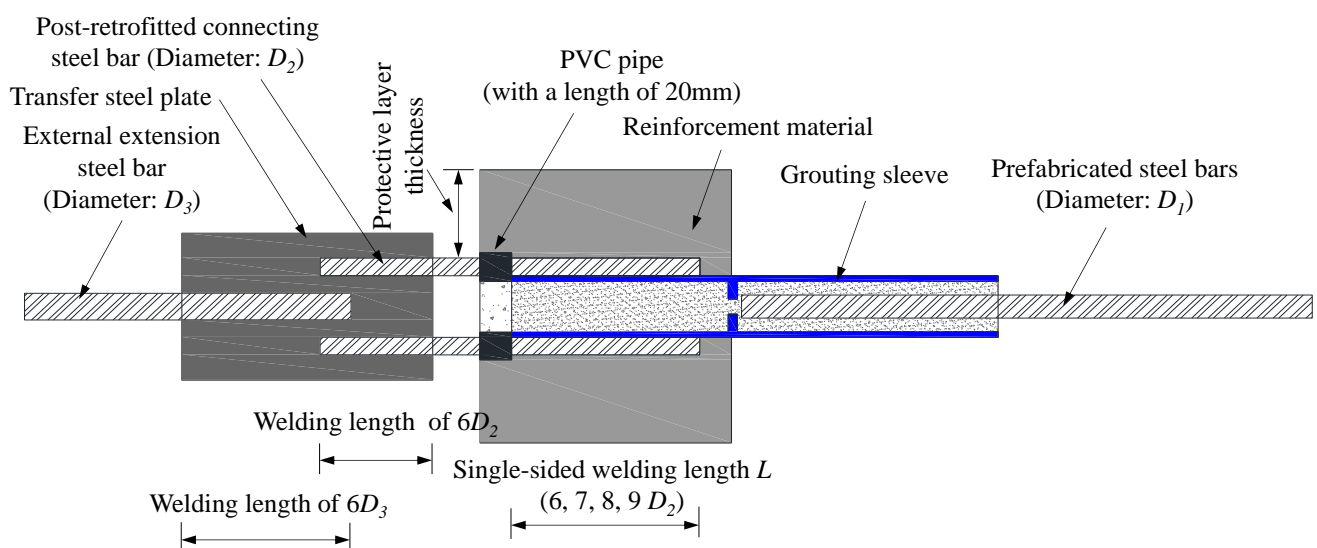
Figure 4. Specimen for the novel reinforcement method.

The connection between the grouted sleeve and the steel bar on the prefabricated side was realized by grouting materials. On both sides along the diameter direction of the post-retrofitted connecting steel, single-sided lap welding was used to weld two post-retrofitted connecting steel bars to the grouted sleeve. To ensure that both ends of the specimens were clamped at a single point during the loading process, the other end of the two post-retrofitted connecting steel bars was fixed to the transfer steel plate by double-sided lap welding. An external extension steel bar was welded onto the transfer steel plate. This ensured the uniform transmission of tension to the two post-retrofitted connecting steel bars. To investigate the influence of the one-sided lap welding length between the steel bars and the sleeves, welding lengths of $6D_2$, $7D_2$, $8D_2$, or $9D_2$ (where D_2 was the diameter of the post-retrofitted connecting steel bar) were selected to fabricate the specimens. The external extension steel bar and the transfer steel plate were fixed by double-sided lap welding, with a welding length of $6D_3$ (where D_3 was the diameter of the external extension steel bar). The diameters of the prefabricated steel bars inside the sleeves were 14 mm, 16 mm, and 18 mm for the different specimens. According to the principle of equivalent cross-section of steel bars, the corresponding diameters of the post-retrofitted connecting steel bars on both sides of the sleeves were 10 mm, 12 mm, and 14 mm, and the diameters of the external extension steel bars were 16 mm, 18 mm, and 20 mm, respectively. The details of the specimens are shown in Figure 4.

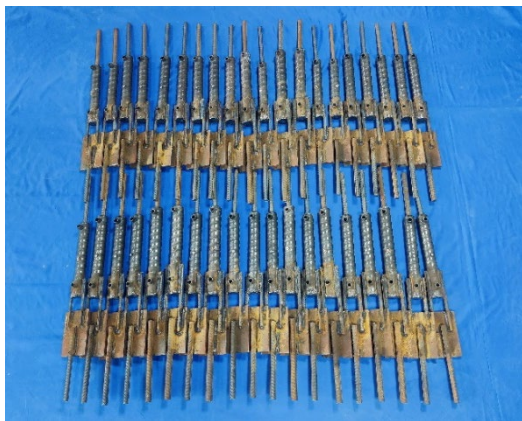
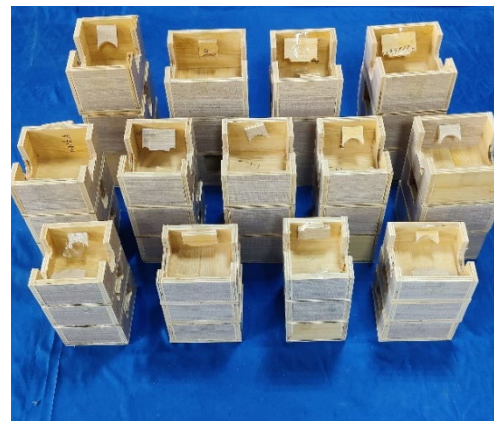
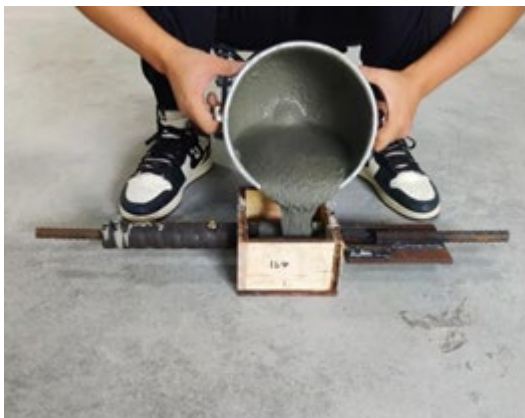
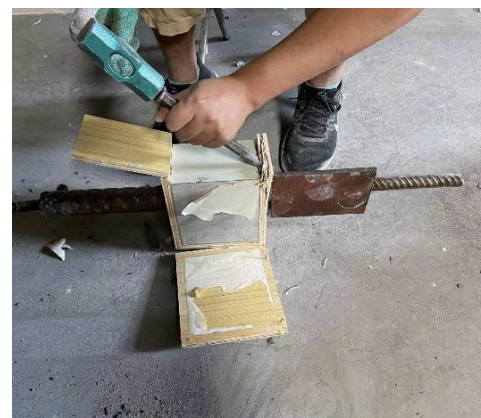
Figure 5. Preparation process of the specimens. (a) Sleeve welding. (b) Wooden mold making. (c) Injecting reinforcement materials into the mold. (d) Demolding.

The specimen preparation process, as shown in Figure 5, began with single-sided lap welding along the radial direction at the bottom installation end of the sleeve. Two post-connection reinforcing bars were welded to the sleeve and further connected to a force transfer steel plate. Subsequently, an external extension bar was welded to the steel plate. After completing the welding and allowing it to cool, sealing rings were installed at both the prefabricated and installation ends of the sleeve. The center hole of the sealing ring at the installation end was sealed with tape to prevent grout leakage. Next, the connecting steel bar inside the sleeve was inserted through the center hole of the sealing ring at the prefabricated end of the sleeve, and the completed specimen was placed into a wooden mold. The interface between the sleeve and the mold was sealed with clay to prevent grout leakage during the grouting process. To avoid local compression during loading, the two post-connection reinforcing bars were wrapped in 20-mm-long PVC isolation sleeves, and clay was packed between the sleeves and the bars to prevent grout intrusion, ensuring accurate experimental results. During grouting, the sleeve was positioned horizontally, with PVC extension pipes vertically inserted into both the grouting inlet and outlet. Grouting was performed from the outlet to prevent grout from entering the mold. The rise of grout in the PVC pipe at the inlet was monitored, and grouting was stopped once grout slowly ascended in this pipe. After grouting, the specimen was left undisturbed for approximately one hour until the grout achieved its initial set. The PVC pipes at the inlet and outlet were then removed, and reinforcement material was poured into the mold. After a 28-day curing period, the mold was removed, and the specimen was subjected to uniaxial tensile testing.

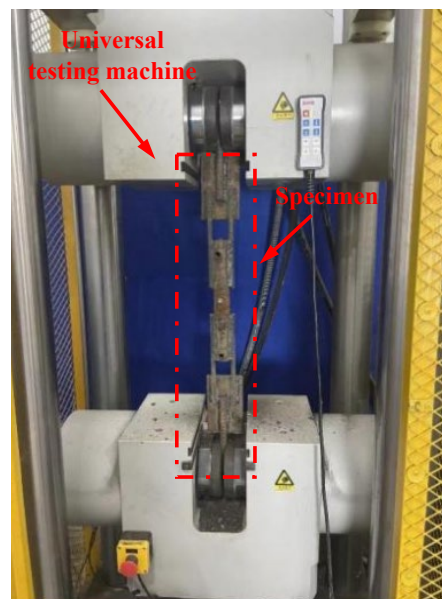
Figure 6. Test setup of the weldability test.

The tensile test was conducted using the universal testing machine at the Kunshan Construct Engineering Quality Testing Center, as shown in Figure 6. During the tests, the specimens were clamped at both ends with the two external extension steel bars. In this experiment, the distance between the fixtures of the testing machine was set at 730 mm. According to the Standard for Test Methods of Welded Joints of Steel Bars (JGJ/T27-2014) [22], the tensile process should be continuous and smooth until the specimen is pulled to fracture (or experiences constriction). The tensile rate was set as 36.5 mm/min ($V_0 = 0.05 \times 730 = 36.5\text{mm/min}$).

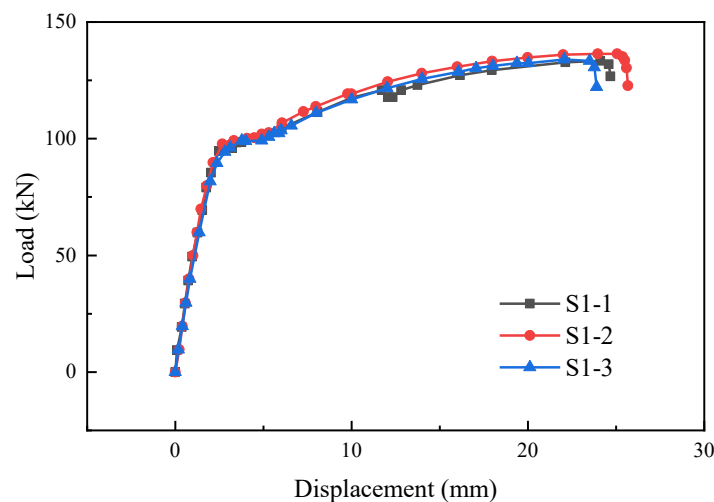
Figure 7. Load-displacement curves of specimens S1-1, S1-2, and S1-3.

The load-displacement curves of specimens S1-1, S1-2, and S1-3 are shown in Figure 7. The load-displacement curves of the specimens were generally consistent with the load-displacement curves of ordinary steel bars under tension, including the elastic stage, yielding stage, strengthening stage, and necking stage. For specimen S1-1, after entering the strengthening stage, the weld between one supplementary connecting reinforcing bar and the sleeve cracked, resulting in a brief drop in load. Then, another weld seam between the supplementary connecting reinforcing bar and the sleeve underwent contraction and subsequently fractured, with the fracture occurring in the vicinity of the weld heat-affected zone. Specimens S1-2 and S1-3 experienced fractures of the supplementary connecting steel bars during the tension process, with the fracture occurring in the vicinity of the weld heat-affected zone. The failure modes of the specimens are shown in Figure 8.

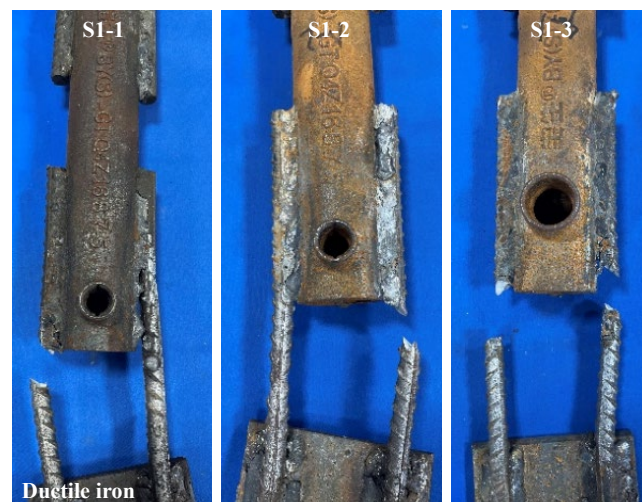
Figure 8. Failure modes of specimens S1-1, S1-2, and S1-3.

The tensile tests revealed three primary failure modes in the specimens: (1) Fracture of the supplementary connecting steel bar occurred in the weld heat-affected zone. (2) Fracture of the supplementary connecting steel bar occurred within the predetermined failure zone. (3) Failure of the weld joint occurred between the supplementary connecting steel bar and the grouting sleeve. The characteristic values of the tensile test for the specimens are shown in Table 5. The tensile strength of specimens S1-1, S1-2, and S1-3 was higher than the standard value of the steel reinforcements, but the failure zones of the specimens did not meet the regulatory requirements. For specimen S1-1, one of the supplementary connecting steel bars fractured in the weld heat-affected zone, and the weld joint suffered damage. For specimens S1-2 and S1-3, the supplementary connecting steel bars fractured in the weld heat-affected zone. According to the relevant regulations, the welded joints of specimens S1-1, S1-2, and S1-3 showed poor weldability. For specimens S2 and S3, the supplementary connecting steel bars of the specimens all fractured within the predetermined failure zone. They did not break within the heat-affected zone, and the steel bars exhibited ductile fracture. At the same time, the ultimate tensile strength of the specimens during the tensile process was greater than the ultimate tensile strength standard value of the steel reinforcements. According to the relevant regulations, the welded joints of specimens S2 and S3 showed good weldability.

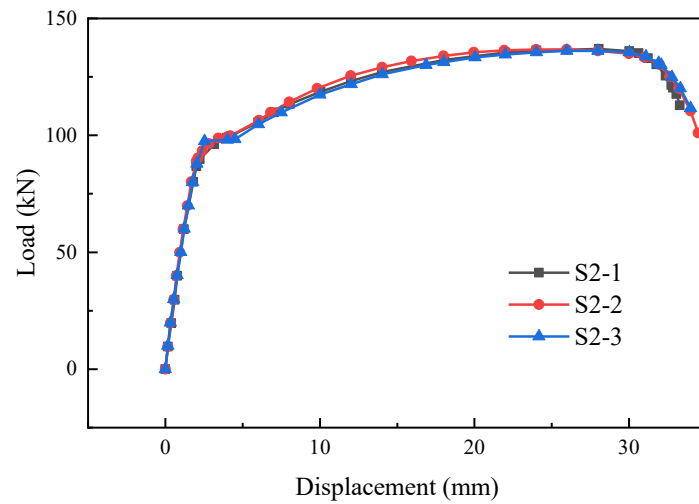
Figure 9. Load-displacement curves of specimens S2-1, S2-2, and S2-3.

Figures 9 and 10 show the load-displacement curves of specimens S2 and S3, respectively. The load-displacement curves of specimens S2 and S3 were essentially similar. In the initial stage, both ends of the specimens were subjected to force simultaneously with two supplementary connecting steel bars. As the load continued to increase, one of the supplementary connecting steel bars experienced a fracture. The loading process continued,

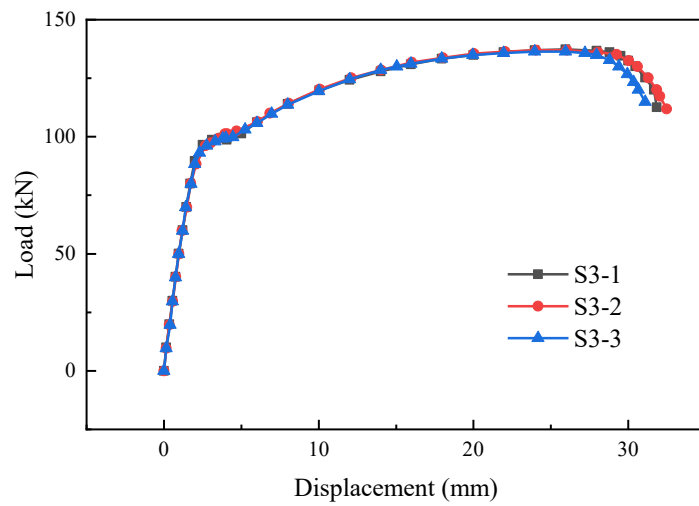
Figure 10. Load-displacement curves of specimens S3-1, S3-2, and S3-3.

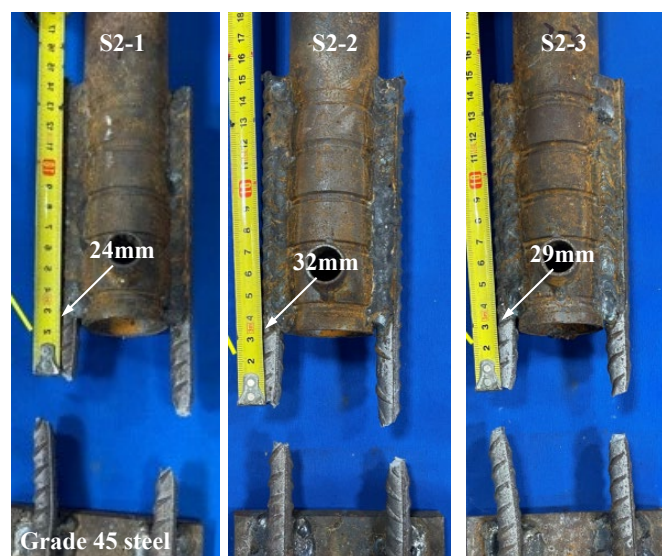
Figure 11. Failure modes of specimens S2-1, S2-2, and S2-3.

and the other supplementary connecting steel bar also fractured rapidly. The failure of the specimens occurred within the predetermined failure zone, with the fracture location approximately 24 mm–33 mm from the weld seam, as shown in Figures 11 and 12.

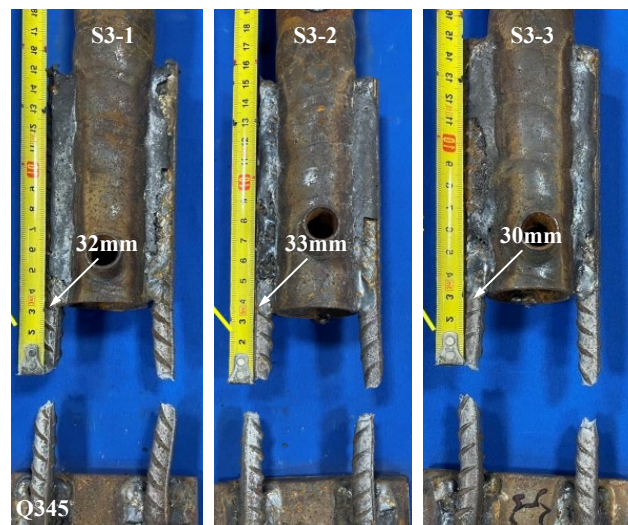
Figure 12. Failure modes of specimens S3-1, S3-2, and S3-3.

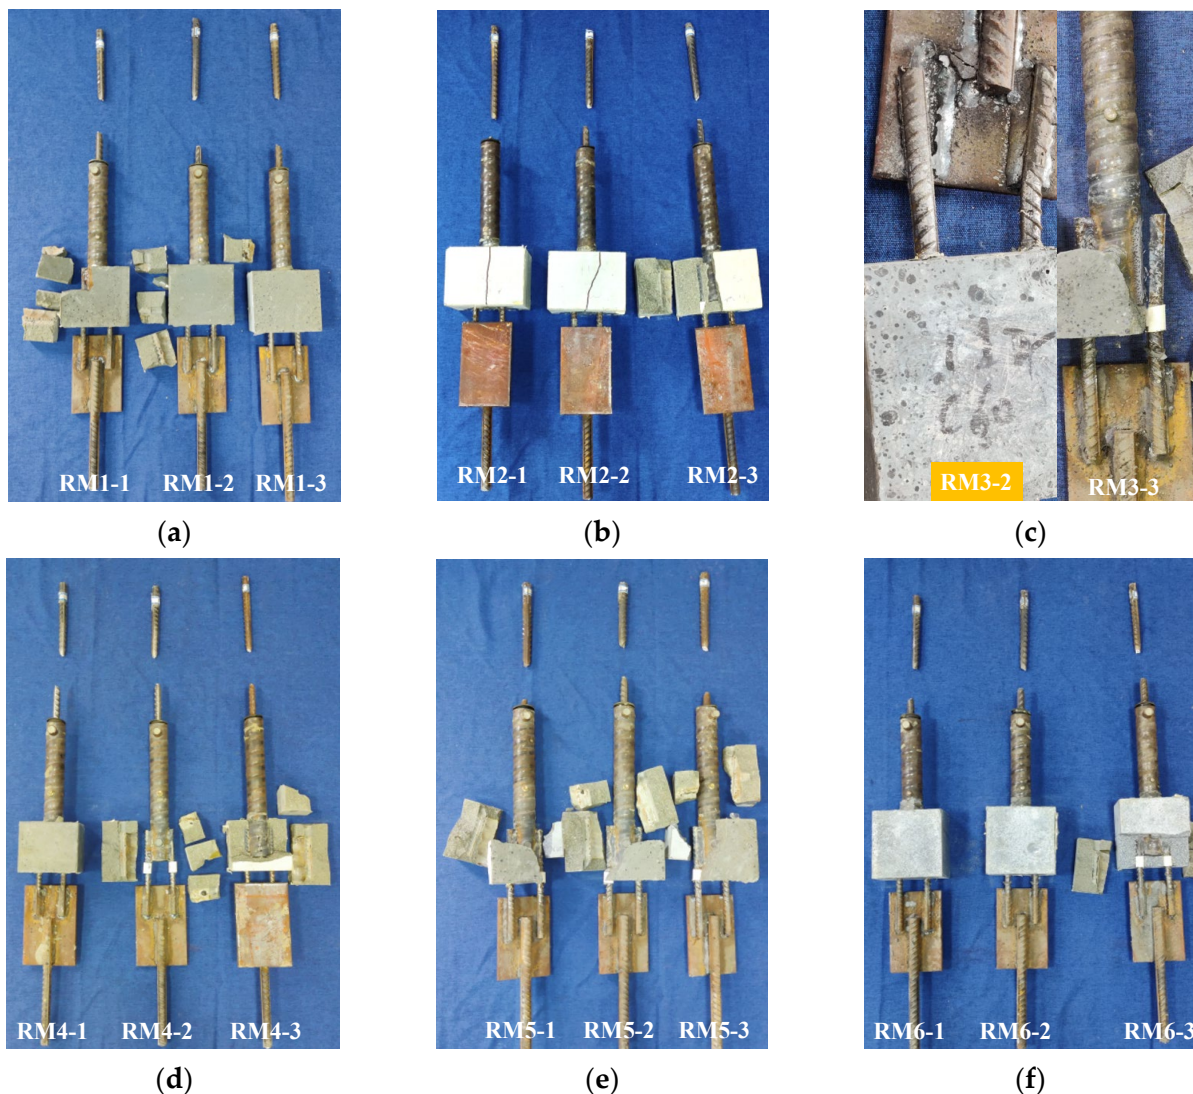
Figure 13. Failure modes of the specimens. (a) RM1. (b) RM2. (c) RM3. (d) RM4. (e) RM5. (f) RM6. (g) RM7. (h) RM8. (i) RM9. (j) RM10. (k) RM11. (l) RM12. (m) RM13. (n) RM14. (o) RM15.

As shown in Figure 13c,o, Specimen RM3-2 experienced a failure at the weld joint between one of the post-retrofitted connecting steel bars and the transfer steel plate, and Specimen RM15-1 suffered a failure at the weld joint between the external extension steel bar and the transfer steel plate. Figures 14 and 15 show the load-displacement curves of specimens RM3-2 and RM15-1, respectively. In the elastic phase, the load-displacement curves showed a linear increase. During the loading process, a slight sound could be heard coming from the weld joint. When the tensile force approached the yield point of the specimens, a sudden failure occurred at the weld joint. The entire weld joint between the transfer steel plate and the post-retrofitted connecting steel bars was pulled apart. The ultimate load for specimens RM3-2 and RM15-1 were 92.86 kN and 90.13 kN, respectively, which was below the ultimate tensile load standard value of 108.59 kN for the HRB400 steel bar. The main reason for this discrepancy was attributed to inadequate welding by the workers.

As shown in Figure 13c, specimen RM3-3 experienced weld failure between the grouting sleeve and the post-retrofitted connecting steel bars. Figure 16 shows the load-displacement curves of specimen RM3-3. It can be seen that in the initial stage of the tensile test, the load-displacement curve exhibited a linear increase. When the force reached 84.13 kN, a failure occurred at the weld joint. At the moment of failure, the grouting material around the weld joint broke apart.

As shown in Figure 13, except for specimens RM3-2, RM3-3, and RM15-1, the other specimens exhibited fracture failure of the prefabricated steel bar. When the single-side welding length was larger than $6D_2$, and the grouting material strength was higher than C40, the specimens generally experienced fracture failure of the prefabricated steel bar. Throughout the entire tensile process, there were no significant changes observed in the load-displacement curves of the specimens. As shown in Figure 17, the typical load-displacement curve during the tensile test of the specimens matched the load-displacement curve of a reinforcement tensile test. Both curves exhibited the elastic stage, yield stage, strengthening stage, and necking stage. After entering the necking stage, the external extension steel bars suddenly fractured. Simultaneously, the grouting material at the connection point between the grouting sleeve and the post-retrofitted connecting steel bars was crushed, causing detachment of the grouting material around the weld joint. However, all specimens retained their weld joints intact.

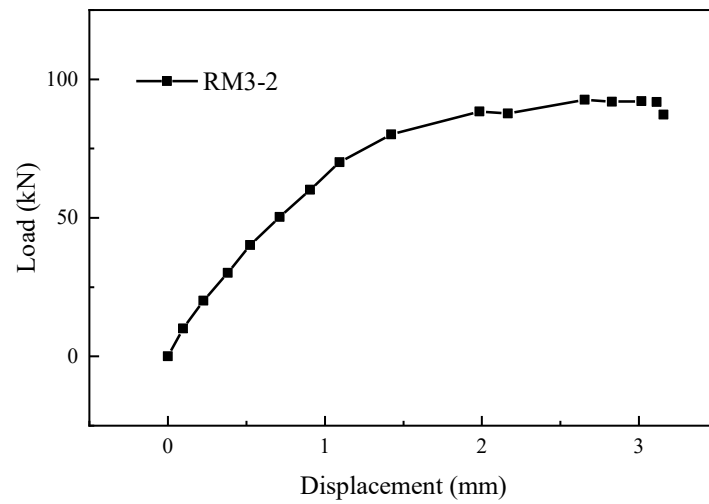
Figure 14. Load-displacement curve of specimen RM3-2.

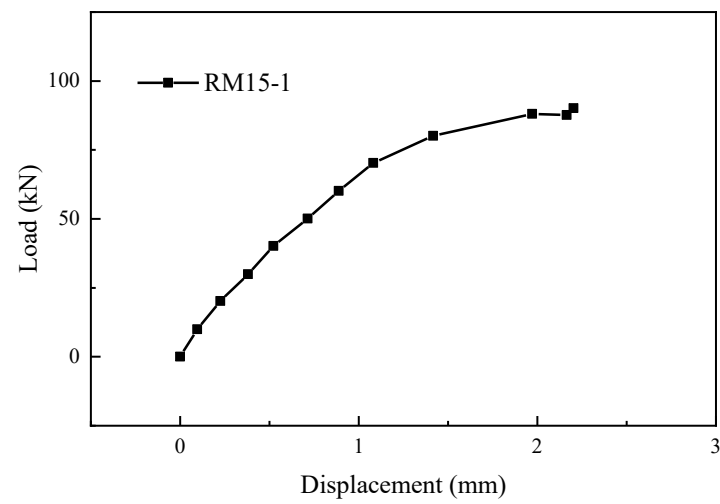
Figure 15. Load-displacement curve of specimen RM15-1.

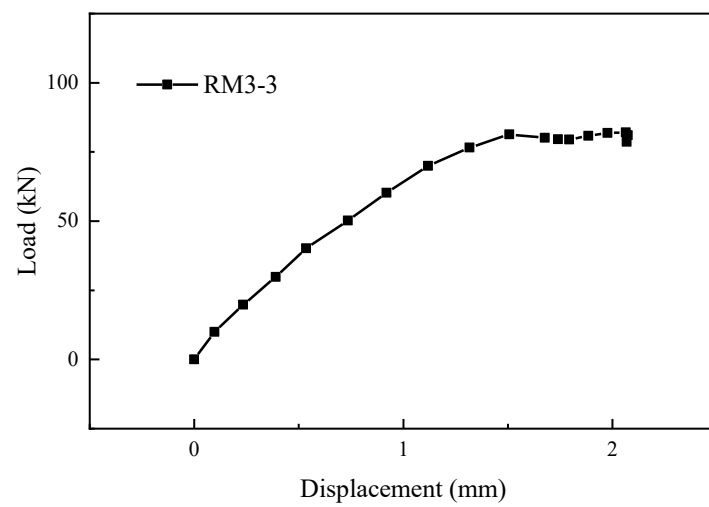
Figure 16. Load-displacement curve of specimen RM3-3.

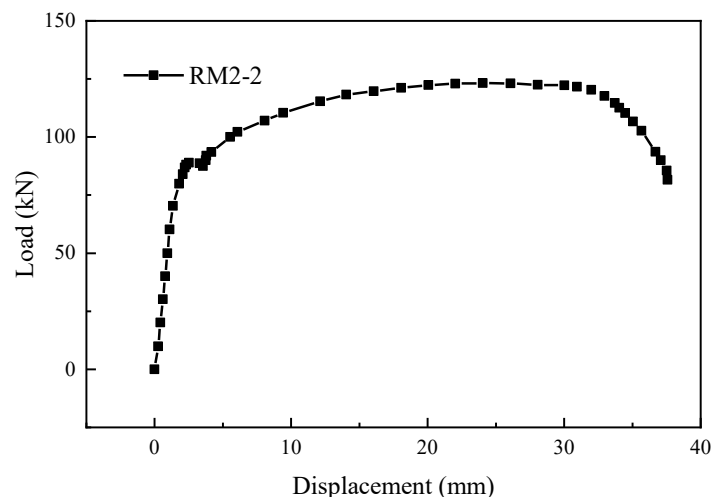
Figure 17. Typical load-displacement curve.

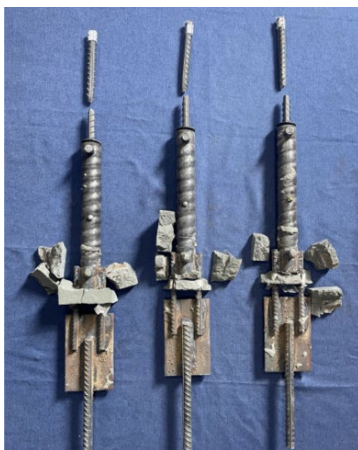
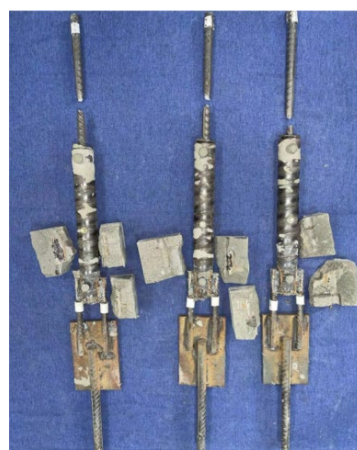
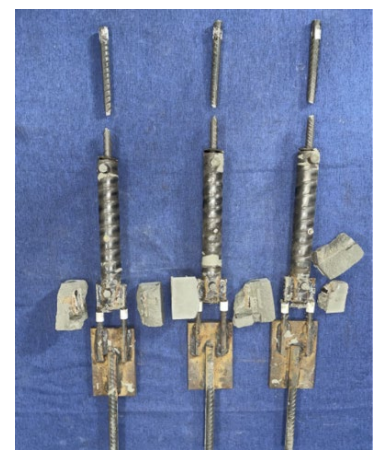
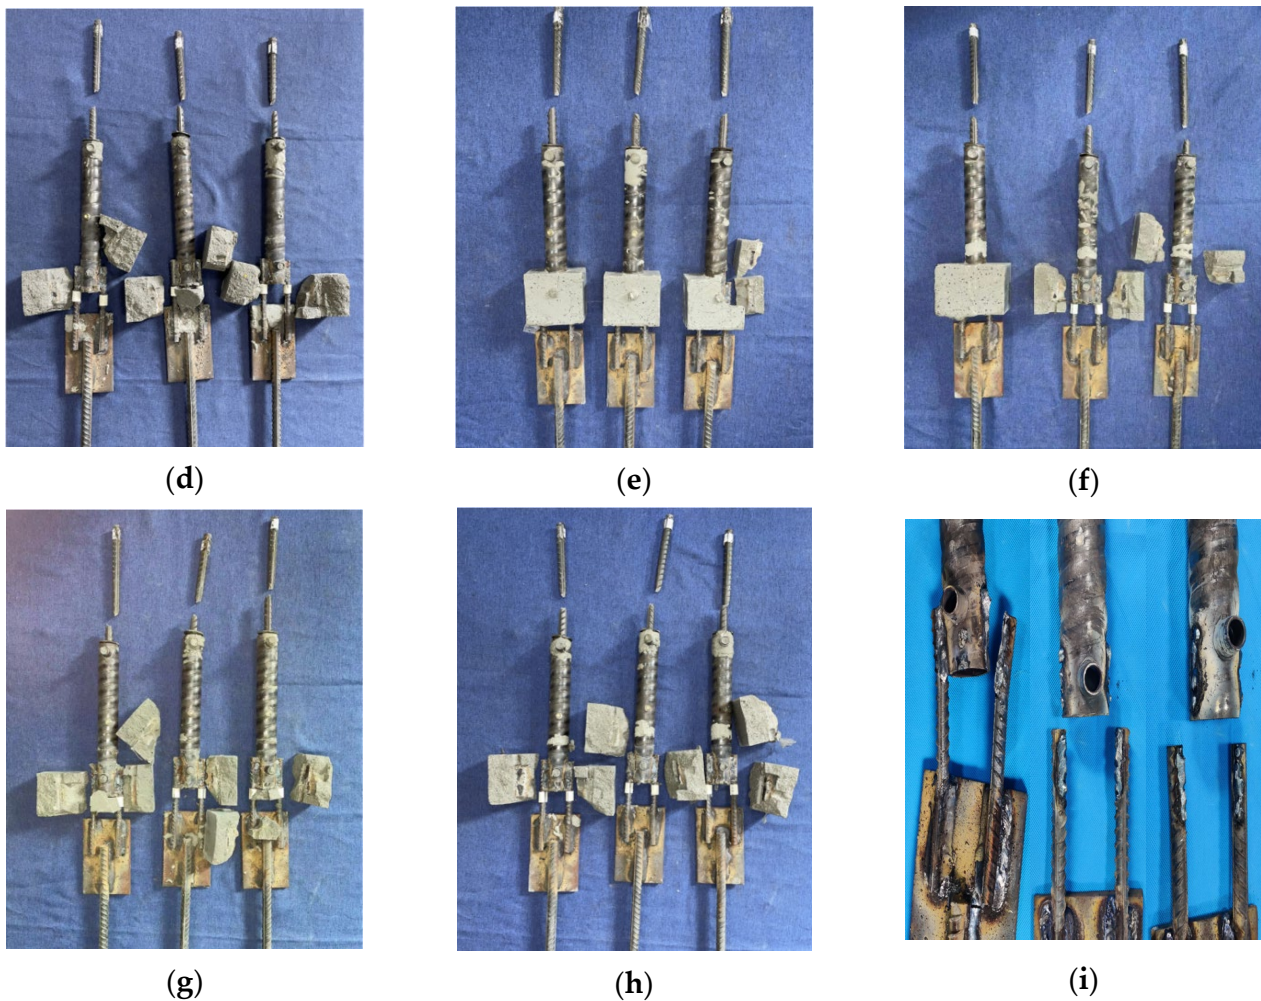
Figure 18. Failure modes of the supplementary specimens. (a) S-RM-1. (b) S-RM-2. (c) S-RM-3. (d) S-RM-4. (e) S-RM-5. (f) S-RM-6. (g) S-RM-7. (h) S-RM-8. (i) S-RM-9.

The test results of the supplementary specimens are shown in Table 8 and Figure 18. Except for specimens S-RM9-1, S-RM9-2, and S-RM9-3, the other specimens exhibited fracture failure of the prefabricated steel bar. During the tensile testing of the specimens, there was no apparent surface damage observed. At the moment when the prefabricated steel bars fractured, the grout material around the weld seam was shattered, but the weld seam between the sleeve and the post-retrofitted connecting steel bar remained intact. When the single-sided welding length between the post-retrofitted connecting steel bar and the sleeve was $4D_2$, and there was no grout material encapsulation around the weld seam, the specimens experienced weld failure between the grouting sleeve and the post-retrofitted connecting steel bars. However, the specimens with a single-side welding length of $4D_2$, and the C60 reinforcement material with a relative protective layer thickness of $2D_2$, exhibited fracture failure of the prefabricated steel bar. This indicated that the presence of grout material encapsulation around the weld seam provided a certain reinforcement. At

the same time, this combination represented the critical condition for failure of type N. To ensure the quality of the reinforcement, it is suggested that the single-sided welding length should be no less than $5D_2$.
