REVIEW

Analysis of prosthetic cardiac devices: a guide for the practising pathologist

J Butany, M J Collins

J Clin Pathol 2005;58:113–124. doi: 10.1136/jcp.2004.020271

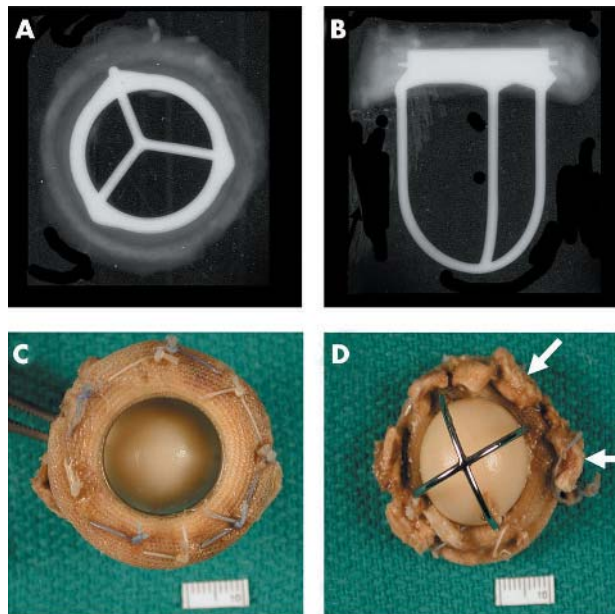
Figure 3 (A) Anteroposterior and (B) lateral x rays of a Starr-Edwards mechanical valve (Model 1000) shows the intact “three leg cage”. (C) Flow surface and (D) non-flow surface of a “four leg cage” Starr-Edwards (Model 6400) valve. The struts are intact and the occluder (or poppet) has a pale yellow/brown colour. The non-flow surface shows tissue (arrows) still adherent to the sewing cuff.

Although numerous MHV prostheses have been designed and used over the years, among the most widely used have been the Starr-Edwards ball in cage valve (fig 3), the Bjork-Shiley valve (figs 4, 5), the Medtronic Hall tilting disc valve, the St Jude Medical bileaflet valve (fig 7), and the CarboMedics bileaflet valve (fig 6). The ball in cage valve, among the first MHVs to be used, is still manufactured and sold in some regions of the world—although only in small numbers (Edwards Life Sciences, personal communication,

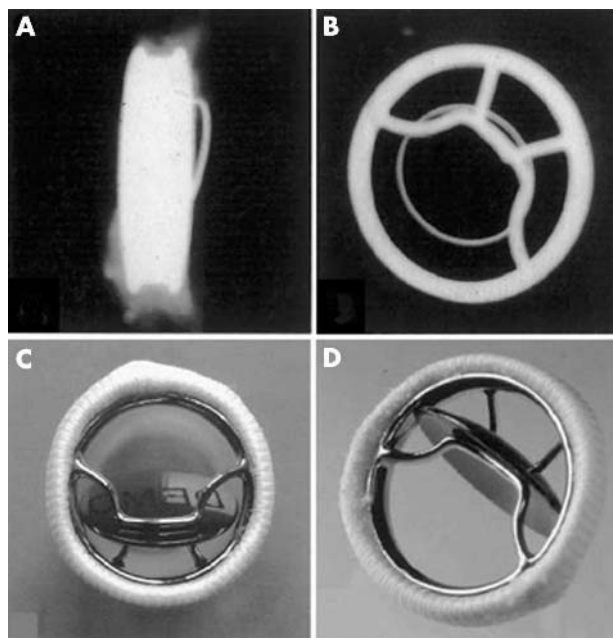
Figure 4 Bjork-Shiley concavo-convex valve. (A) x Ray of profile (lateral) view and (B) anteroposterior view showing the large (inflow) strut and the small (outflow) strut. Gross appearance of the valve; (C) valve partially closed with the disc in the oblique position and (D) valve open (disc or occluder is nearly vertical).

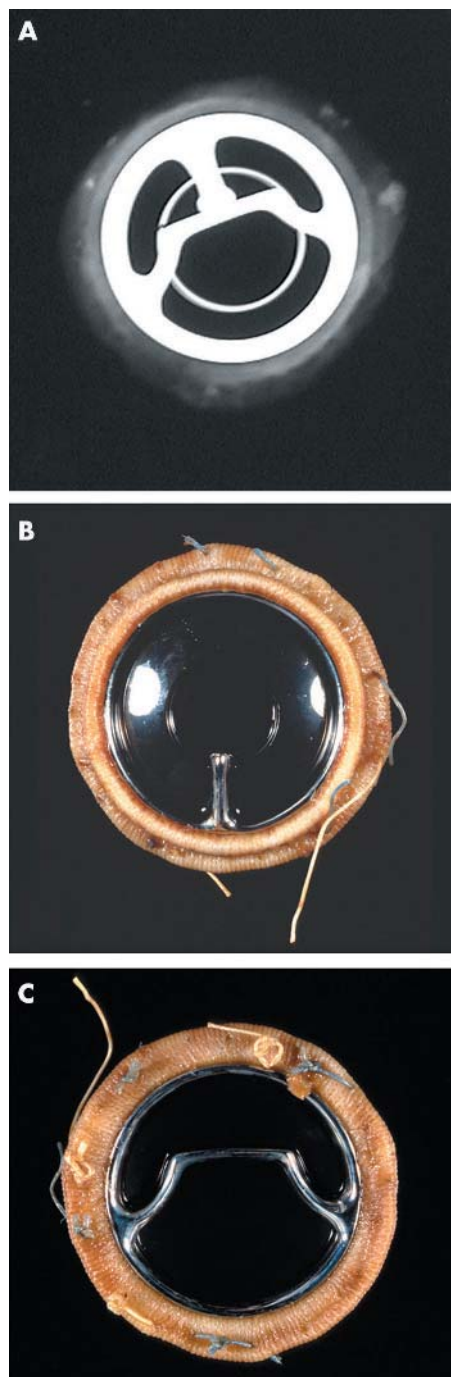
Figure 5 (A) x Ray (anteroposterior) of a Bjork-Shiley Monostrut valve. (B) Outflow surface showing the single outflow strut and (C) inflow surface of the Bjork-Shiley monostrut valve. The struts and the disc are intact.

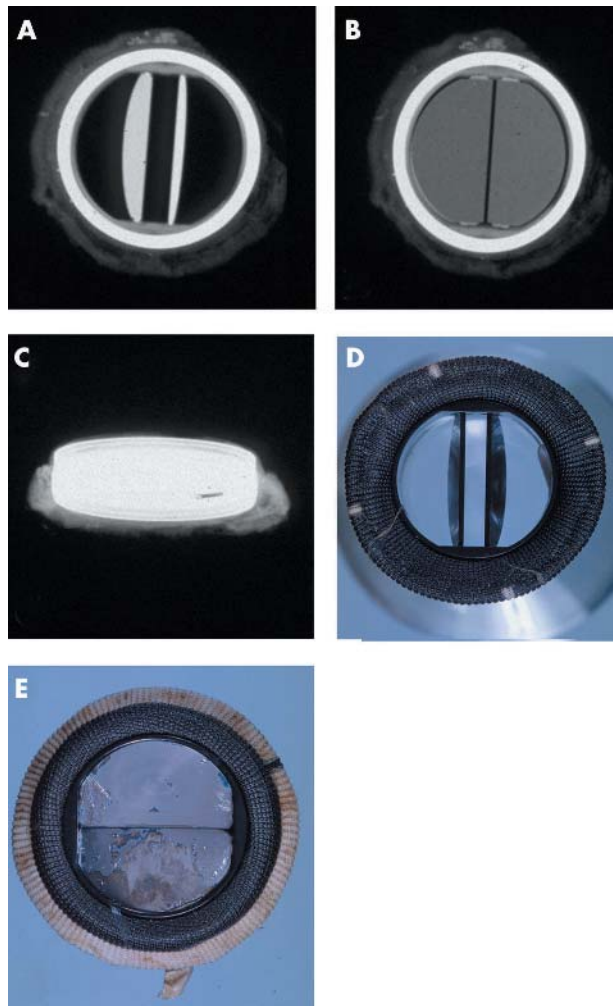
Figure 6 (A–C) x Rays of a Carbomedics bileaflet valve prosthesis with the discs open, discs closed, and profile of the prosthesis, respectively; x rays also show the radio opaque prosthesis housing. (D) The flow surface (discs open) and (E) the non-flow surface of the Carbomedics bileaflet prosthesis. The flow and non-flow surfaces of the sewing cuff are carbon coated (black).

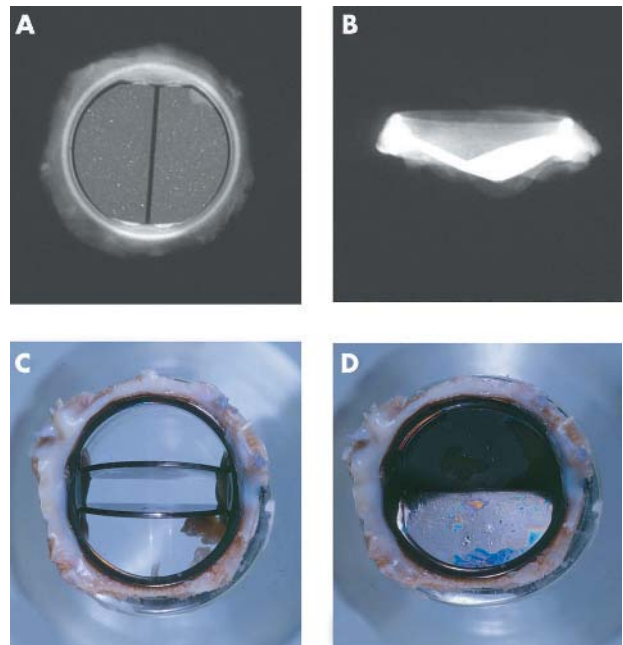
Figure 7 (A, B) x Rays of the flow surface and profile of the St Jude Medical bileaflet prosthesis. Views of a St Jude Medical bileaflet prosthesis with (C) the leaflets open and (D) the leaflets closed. A thick layer of grey/white pannus is seen on the flow and the non-flow surfaces of the sewing ring.

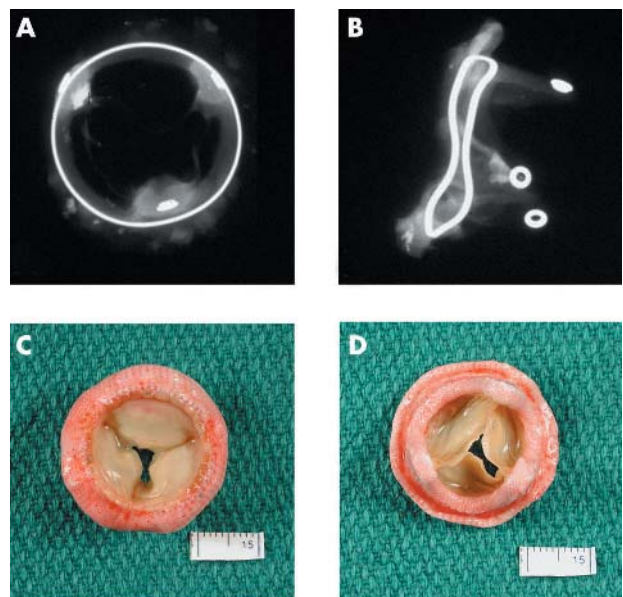
Figure 8 (A, B) Anteroposterior and lateral x rays of a Hancock porcine valve show a radio opaque valve ring and small eyelets in each of the stent posts. (C) The flow surface and (D) the non-flow surface of the porcine valve. The cusps are soft, pliable, and intact.

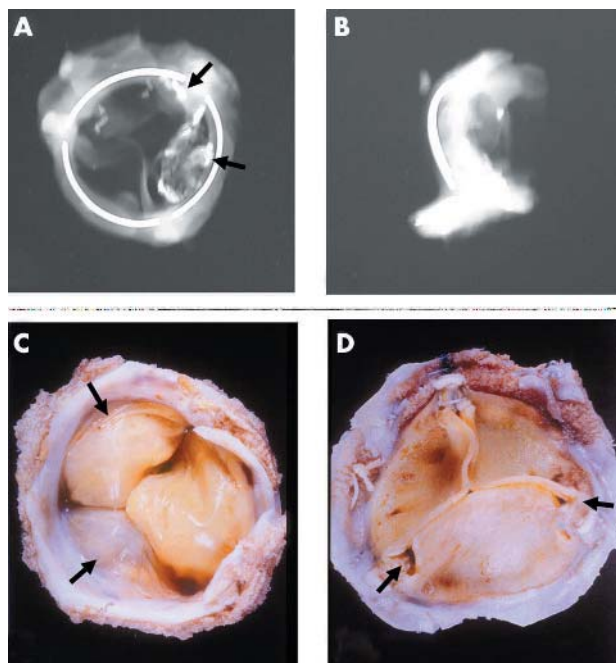
Figure 9 Anteroposterior and lateral x rays of an Ionescu-Shiley pericardial bioprosthesis showing the valve ring in three parts. Two of the three cusps show radio opaque areas of calcification (arrows). (C) The flow surface and (D) the non-flow views of an Ionescu-Shiley bovine pericardial valve. Pannus (arrows) is seen on the flow surface.

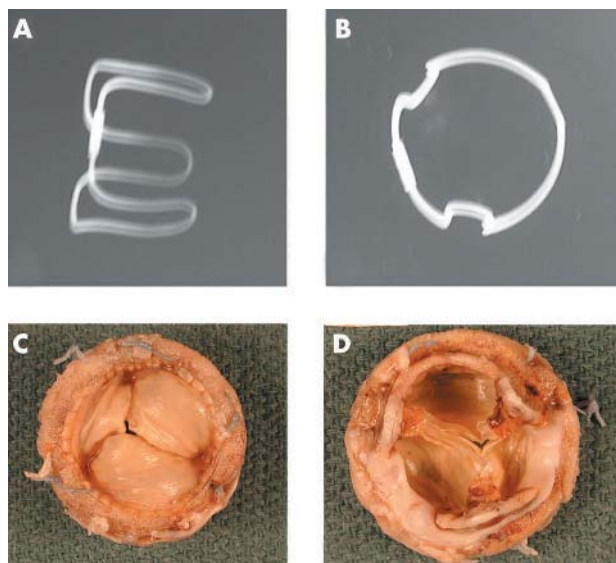
Figure 10 Anteroposterior and lateral x rays of a Carpentier-Edwards porcine bioprosthesis. (C) The flow surface and (D) the non-flow surface of a Carpentier-Edwards porcine valve. The cusps are pliable and intact. However, all three commissural regions show detachment from the stent posts.

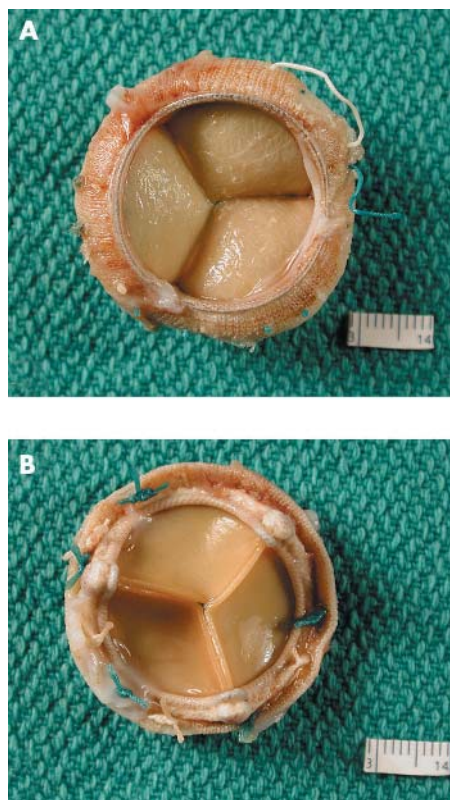
Figure 11 (A) The flow surface and (B) the non-flow surface of a Carpentier-Edwards pericardial bioprosthesis. The cusps are soft, pliable, intact, and they co-apt well.

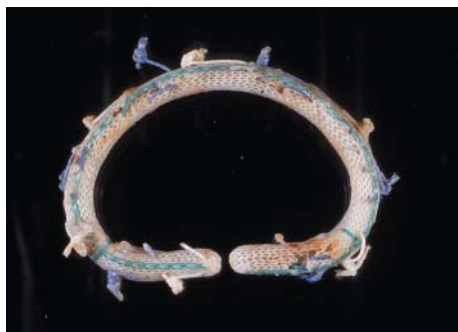
Figure 13 A Carpentier-Edwards annuloplasty ring. This D shaped ring has a hard metal core.

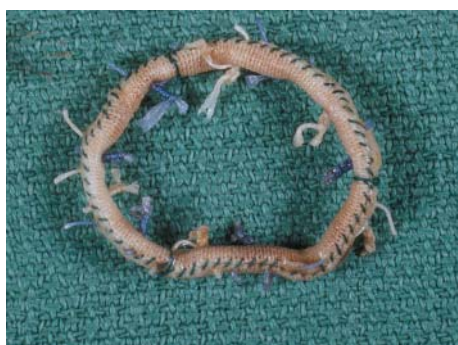
Figure 14 A soft Edwards-Physio annuloplasty ring. It has a soft, synthetic core covered with synthetic fabric.

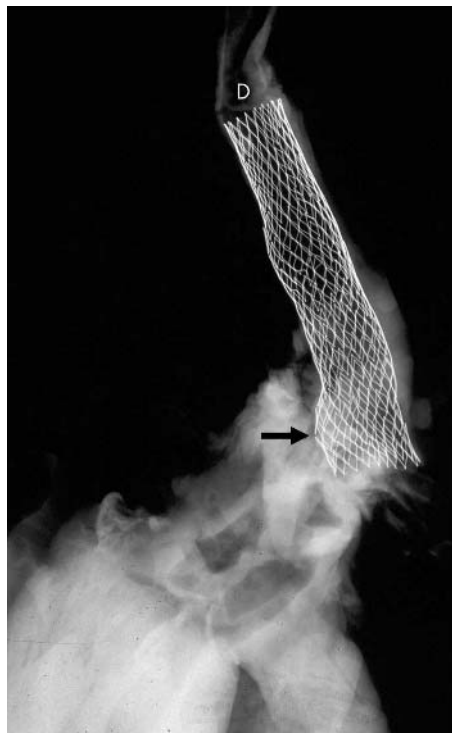
Figure 15 X Ray of an aortic arch and descending segment with a stent in place (D). Two of the stent struts show fractured segments (arrow).

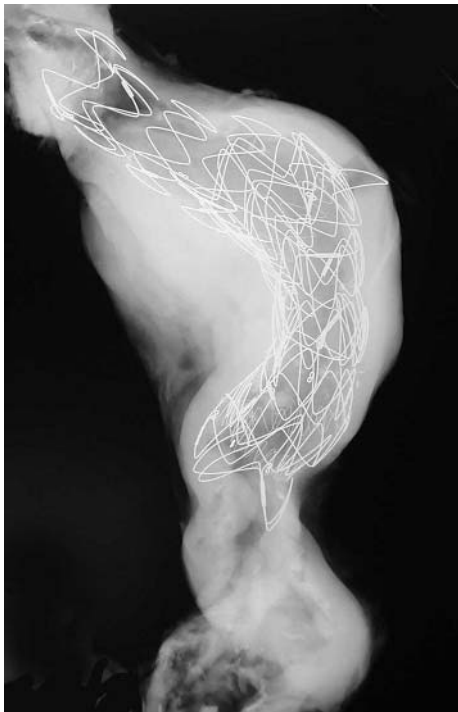
Figure 16 X Ray of an abdominal aorta shows a large stent in place. The most proximal segment shows an open cone (the rest of the stent is lined by fabric).

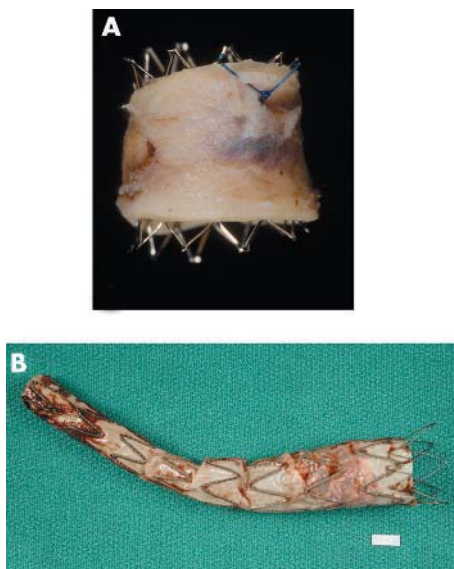
Figure 17 (A) An open (no fabric) stent in an aorta that had a coarctation treated with this stent. (B) An aortic stent or endograft, showing the fabric lining the stent (on its inside (luminal) surface).

proliferation). Covered stents often have a fabric lining (that is, they are endografts; fig 17). Covered stents are increasingly used as aortic endografts to treat aortic aneurysms.²⁷

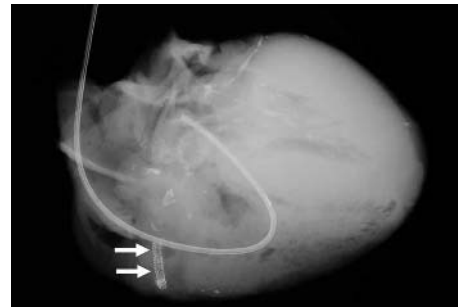
Figure 18 A heart obtained at necropsy shows stents in a right coronary artery (arrows). The left coronary artery shows extensive calcification. A Swan-Ganz catheter is seen in the right side of the heart (right atrium, right ventricle, and pulmonary artery).

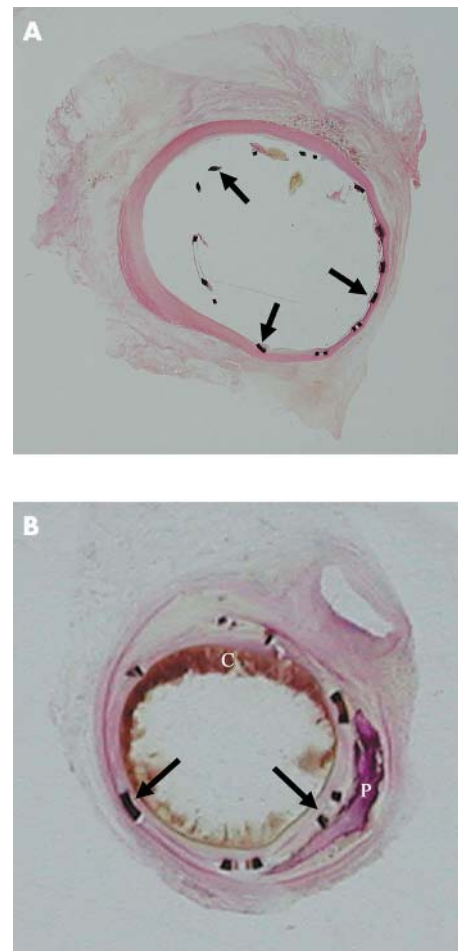
Figure 19 (A) Segment of coronary artery with a stent in place and embedded in GMMA, sectioned with a special lathe, surface polished, and stained with haematoxylin and eosin. This stent was in place for two weeks. The stent struts (arrows) and their relation to the vessel wall are seen. A minimal tissue reaction is seen focally. (B) This intracoronary stent was in place for seven weeks and was processed in the same manner as the stent in panel A. The stent struts are well placed and a good lumen is still evident. A circumferential tissue reaction is seen. Atherosclerotic plaque, blood clot (C), and calcification (P) are also seen.

The primary objective in the examination of blood vessels, coronary arteries, and aortas with these devices is: (1) to exclude the possibility of rupture of the vessel wall during implantation; (2) to look for changes on the inner or flow aspect of the device, that is intima (neointima) proliferation and development of restenosis; (3) to look for changes around the stent metal to assess reaction to the metal; and (4) to look for changes in the coronary artery wall. In an effort to answer these questions, the segment of the coronary artery with the device is best embedded in plastic (methyl-methacrylate) and then sectioned in the same manner as listed under PHVs. With this, transverse sections should be taken through the device at one or more points and if possible longitudinal sections from the ends, for a length of at least 5.0 mm, with a segment of native vessel attached (fig 19).
