Case Report

Superficial Femoral Artery Injury Resulting From Cerclage Wiring During Revision THA

Thomas Aleto MD, Merrill A. Ritter MD,
Michael E. Berend MD

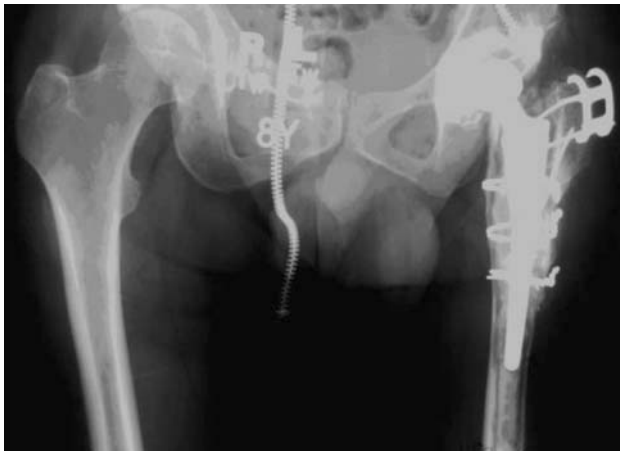
Fig. 1 A preoperative anteroposterior radiograph of the pelvis shows a well-fixed cemented acetabular component and a loose subsided cemented femoral stem with a healed trochanteric osteotomy.

A 48-year-old man with a history of Perthes disease and an osteotomy during childhood presented for evaluation of a painful left hip. Ten years earlier, he had a primary arthroplasty, which consisted of a cemented acetabular component and femoral stem. Secondary to the retained hardware and the femoral deformity, an extended trochanteric osteotomy was performed. The preoperative neurovascular examination showed full motor and sensory function with palpable dorsalis pedis and posterior tibial pulses. The patient's medical history was otherwise normal. Preoperative anteroposterior radiographs of the pelvis showed a well-fixed cemented acetabular component and a loose subsided cemented femoral stem with a healed trochanteric osteotomy (Fig. 1).

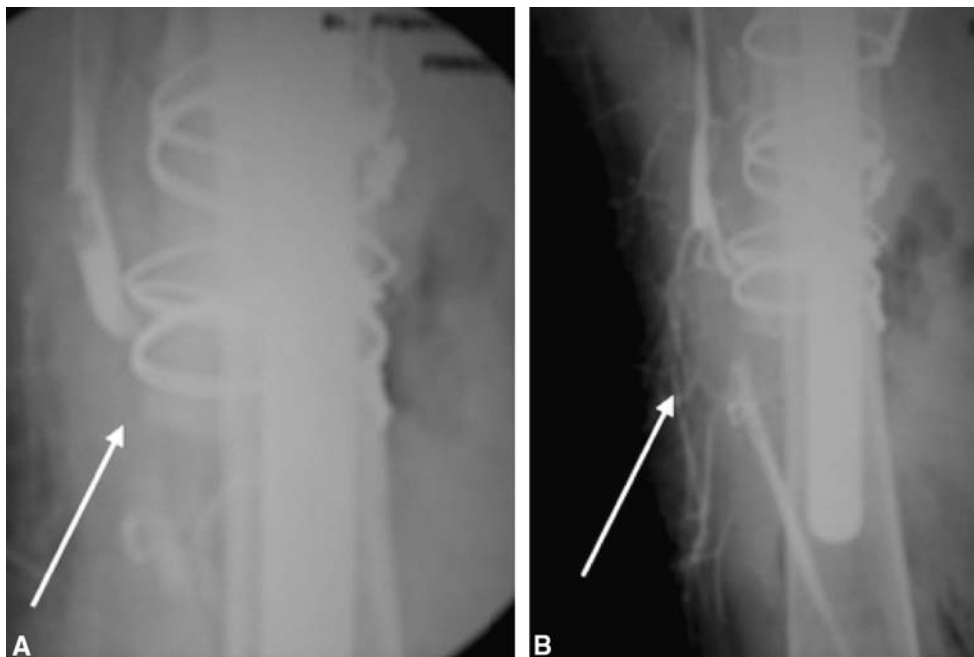
Fig. 2A–B Intraoperative arteriograms of the left lower extremity show (A) the superficial femoral artery obstruction before removal of the thrombus (arrow) and (B) the occlusion of the artery at the distal-most cerclage wire after thrombus removal (arrow).

In the recovery room, the patient had diminished sensation on the dorsal and plantar aspect of his foot and was unable to perform dorsiflexion or plantar flexion. His vascular examination showed palpable pulses with a somewhat cool foot. At this point, the patient was returned to the operating room for a suspected sciatic nerve injury. Exploration of the sciatic nerve from the greater sciatic notch to the knee found the nerve free and without signs of contusion, compression, or laceration. After completion of the exploration, perfusion to the limb came into question, as there were signs of impaired circulation: distal pulses no longer were palpable and we were unable to obtain Doppler signals. An emergency vascular surgery consultation was obtained and an intraoperative arteriogram revealed complete obstruction of the superficial femoral artery at the level of the distal-most cerclage wire with impaired distal runoff (Fig. 2). The vascular surgeon performed a thrombectomy and placed an endovascular stent, which relieved compression of the superficial femoral artery (Fig. 3). Once perfusion was restored to the limb, the offending cerclage

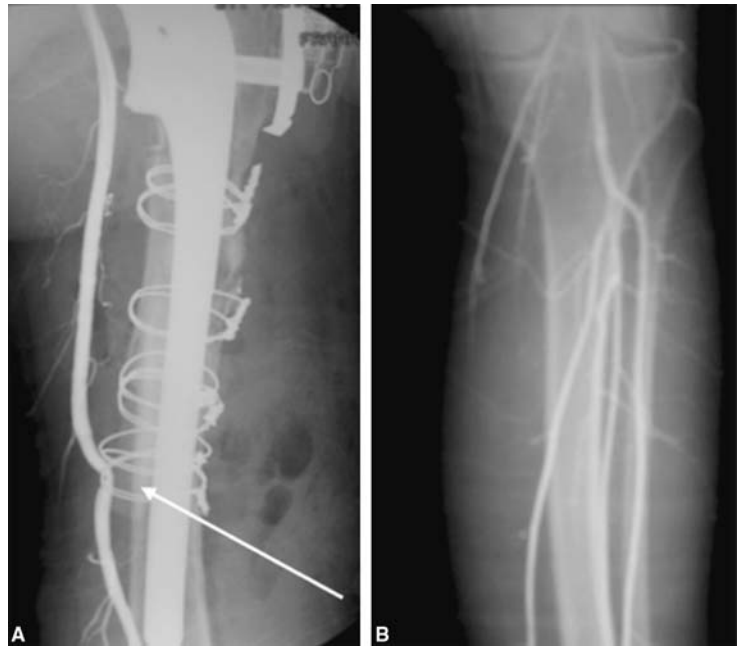
Fig. 3A–B An intraoperative angiogram shows (A) the cerclage wire before removal around the femoral artery (arrow). (B) After endovascular stent placement the occlusion of the superficial femoral artery is now relieved and normal distal runoff has been restored.

wire was removed without complications (Fig. 4). After the procedure, the patient had palpable pulses and a well-perfused foot.

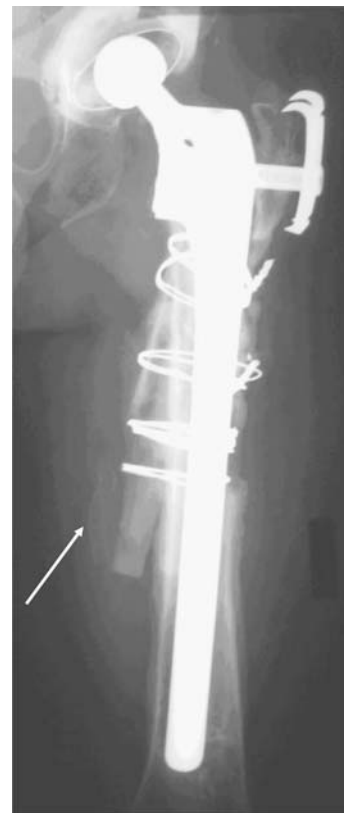
Fig. 4 An anteroposterior femoral radiograph taken 2 months post-operatively shows the endovascular stent (arrow) and its proximity to the medially placed strut allograft.

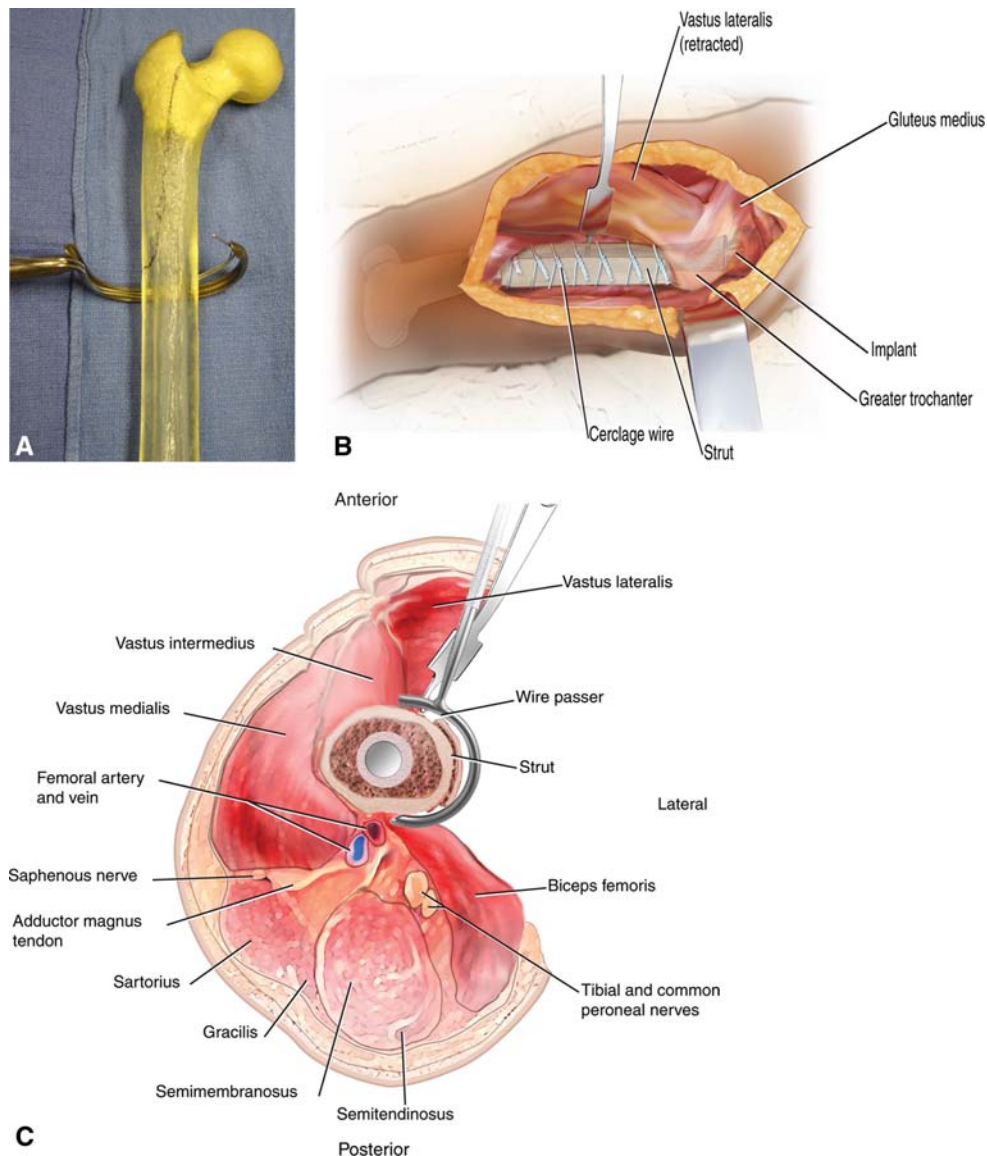
Fig. 5A–C Great care is necessary when passing cerclage wires around the femur, particularly when using strut allografts. The cerclage wires should be placed around the femur first and then passed around the strut grafts to protect the nearby neurovascular structure. **(A)** A photograph shows the wire passer used in our case.

(B) A lateral view shows the cerclage wires around the strut graft. Care should be taken at the distal extent of the wound where the neurovascular bundle is closest to the femur. **(C)** A cross section shows the proximity of the wire passer to the neurovascular bundle after strut application.

the importance of passing cerclage wires in this region cannot be overemphasized. Our case shows the great care necessary when passing cerclage wires around the femur, particularly in the middle shaft to distal third of the femur near Hunter's canal. When using strut allografts, one must be even more diligent when passing cerclage wires, as the bulk of these grafts can change the contour of the femur and thus place the surrounding soft tissues at risk. In this situation, it is best to place the cerclage wires first around the femur and then pass them around the strut grafts to protect the nearby neurovascular structure (Fig. 5).
