A. Grose · A. González Della Valle · P. Bullough ·  
S. Lyman · I. Tomek · P. Pellicci

## High failure rate of a modern, proximally roughened, cemented stem for total hip arthroplasty

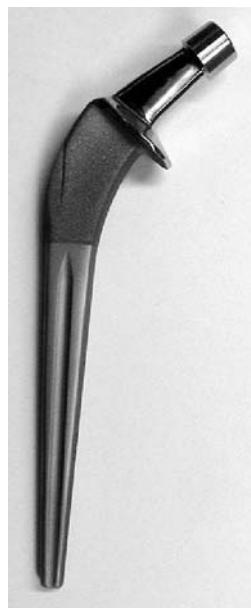
**Fig. 1** The proximally rough Spectron EF stem

The satin Spectron stem ( $Ra: 0.76 \mu\text{m}$ ) (Smith & Nephew, Memphis, TN, USA) is one of the best performing stems in the Swedish National Hip Arthroplasty Register, with survivorship of 100% at seven years and 98.4% at ten years [24]. In 1989, a modified version of the stem was introduced (Spectron EF, Smith & Nephew, Memphis, TN, USA), with the addition of a distal centraliser, head modularity, and a rough surface finish ( $Ra: 7.3 \mu\text{m}$ ) in the proximal third of the stem (Fig. 1).

Despite its excellent track record, the satin, non-modular Spectron stem underwent a design modification in an attempt to improve centralization and enhance stem-cement bonding. This led to the creation of the Spectron EF. The EF design has a circumferentially roughened proximal area with an Ra of 7.3  $\mu\text{m}$ . In the 2002 report of the Swedish Hip Arthroplasty Register, the survivorship of both the original and the EF version of the Spectron stems was similar [24]. We were unable to find other studies evaluating the performance of this modified, rough stem.

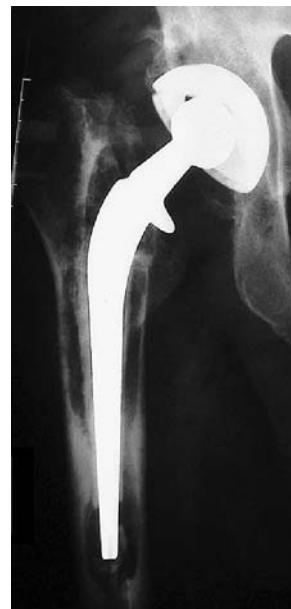
**Fig. 2** Stem loosening subsidence and severe proximal femoral osteolysis observed in a patient, 6 years after surgery

Of the 20 patients with a minimum two-year follow-up, six have been revised. One patient was revised for deep infection 48 months after surgery. The remaining five (25%) were revised for aseptic loosening with extensive femoral osteolysis at an average of 5.2 years of follow-up (range: 2.9–7.8 years) (Fig. 2). One additional patient with the same radiographic findings is scheduled for revision. Three additional patients with six, seven, and eight years of follow-up, respectively, have progressive femoral osteolysis and are being closely monitored. Using radiographic loosening or osteolysis as an endpoint, nine of 20 patients available for follow-up had a failed reconstruction. All cementless cups were well fixed at last follow-up and none of them required revision. The single cemented cup was revised when it was found to be loose during stem revision.

**Radiographic analysis** Of the 19 patients available after exclusion of the one who developed deep infection, nine patients (including the five who required revision) demonstrated radiographic loosening and/or ballooning osteolysis (Fig. 2). The location of the osteolytic lesions/radiolucent lines is depicted in Table 2. The cement mantle in these nine failed cases had been rated A in five and B in four [2]. These nine failed arthroplasties correspond to patients 1, 5, 13, 17, 21, 23, 24, 26, and 33 in the series. In comparing the stems that failed versus those that remain stable, there is no significant difference among quality of bone [8], cement mantle [2], linear wear rate of polyethylene [23], or stem alignment (Table 1).

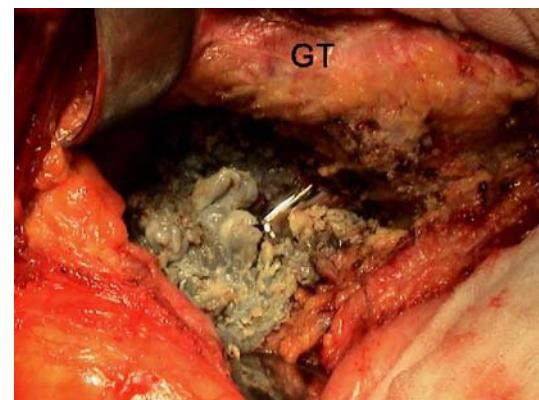
**Fig. 3** Intraoperative metallosis due to fretting of the loose stem with the cement mantle (GT greater trochanter)

**Analysis of retrieved implants and interface pseudomembrane** During revision surgery, macroscopic metallosis was present in all hips (Fig. 3). Three femoral components were available for analysis. We examined the four facets of this rectangular stem, assessing macroscopically the surface fretting and polishing according to a previously designed protocol [12]. The three stems with subsidence had polishing in all four facets (Fig. 4). The damage in the surface of the stems was predominantly located in the posteromedial and anterolateral corners as the stems were forced into retroversion after loosening, thus fretting with the cement mantle [7, 14, 17]. The microscopic examination of the femoral pseudomembrane consistently revealed an inflammatory reaction characterised by the presence of multinucleated giant cells and metallic, cement, and polyethylene deposits.

The macroscopic findings in our retrievals are consistent with those of our earlier study of other 13 failed Spectron EF stems, which required revision for aseptic loosening in our institution [12]. As micromotion occurs at the implant cement interface and the stems subsides, metallic and cement particles are generated due to fretting between cement and the rough surface of the implant. This process releases biologically active cement and metallic particles that we detected in our microscopic analysis and also diminishes the conformity between the implant and the cement, which leads to further loosening and loss of bone stock [17].

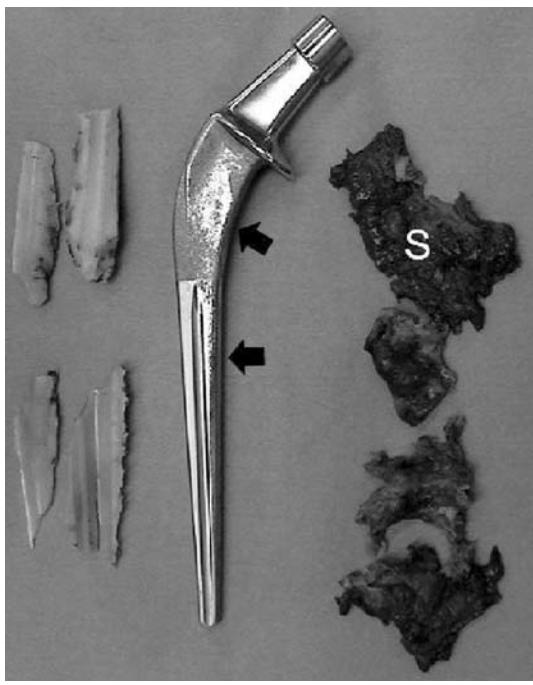
**Fig. 4** A retrieved implant demonstrates loss of surface roughness (black arrows). There is abundant metallic stained synovium (S)
