Mitral valve-sparing procedures and prosthetic heart valve failure: A case report

NA Khan, J Butany, SW Leong, V Rao, RJ Cusimano, HJ Ross. Mitral valve-sparing procedures and prosthetic heart valve failure: A case report. *Can J Cardiol* 2009;25(3):e86-e88.

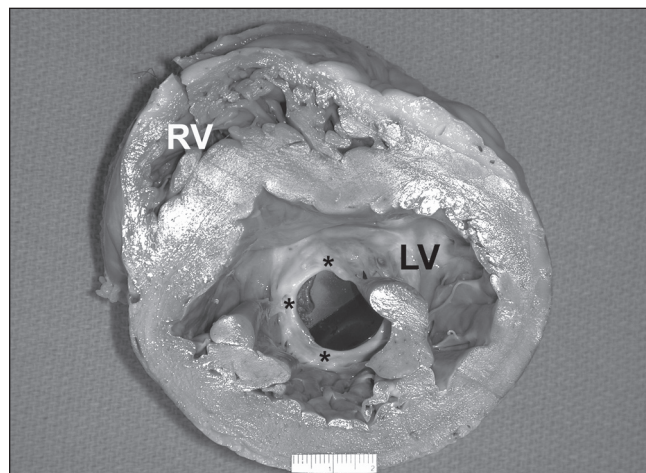
Figure 1) Cross-section of the left ventricle (LV), showing significant dilation. The mechanical mitral valve prosthesis (ventricular surface) shows significant pannus (asterisks), which covers the entire circumference of the valve and is markedly pronounced in the region of the anterior leaflet. The valve is oriented nearly in the ante-anatomic position. RV Right ventricle

The explanted heart showed cardiomegaly with biventricular hypertrophy and dilation, interstitial fibrosis and mitral valve replacement with a CarboMedics bileaflet mechanical valve (Sulzer CarboMedics UK Ltd, United Kingdom). There was pannus on the atrial surface, covering the sewing cuff (Figures 1 to 4), and thrombus on one leaflet, which was 'fixed' in the nearly closed position (Figure 2A). The other leaflet was freely mobile. On the nonflow surface, the posterior and a part of the native anterior mitral leaflets had been conserved, along

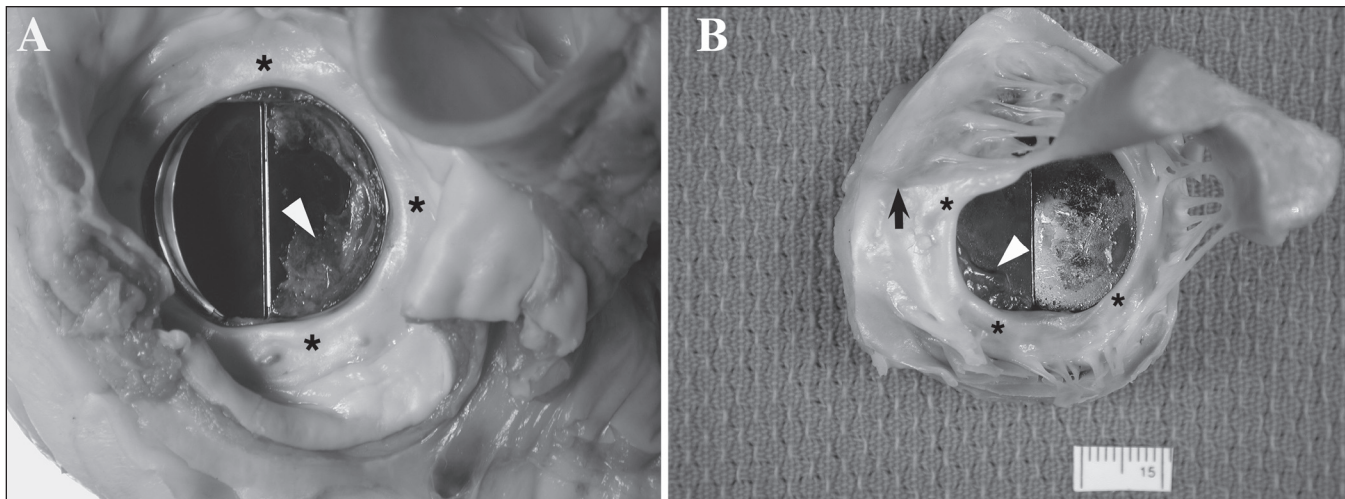
Figure 2 The mechanical prosthesis in the mitral site in the explanted heart. **A** The flow surface shows pannus (asterisks) covering the sewing cuff and extending into the surrounding regions. A significant degree of thrombus (arrowhead) is seen covering the right hemi-leaflet, restricting its mobility. **B** The ventricular surface shows the native mitral apparatus in place. Pannus (asterisks) is seen covering the apparatus and extending onto the base of the mechanical valve prosthesis. Synthetic chordae (arrow) and thrombus (arrowhead) adherent to one leaflet are also seen

with most chordae tendinae (Figure 2B). In addition, two synthetic chordae had been used to resuspend the papillary muscles. These, as well as a knot at the tip of the papillary muscle, were covered with pannus (Figures 3, 4 and 5). The thrombus found on this prosthesis was likely related to the significant degree of pannus seen on the flow and nonflow surfaces. Pannus covered the sewing cuff completely, and overhung the nonflow surface of the orifice by 1.0 mm to 3.0 mm. The overhang was greatest in the region of the thrombus and on the side of the fixed leaflet (Figure 2A). There was no evidence of inflammation other than around the synthetic fabric of the sewing cuff. The aortic valve leaflets were soft and supple, with no evidence of calcification. Finally, the ascending aorta did not show any signs of clinically significant atherosclerosis.

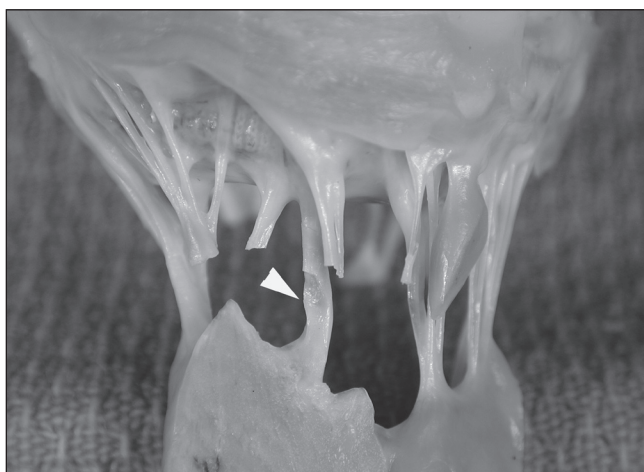
Figure 3 A magnified view of the explanted prosthesis with the synthetic chordae tendinae (arrowhead). The synthetic chordae show extensive fibrosis and thickening but are otherwise unremarkable (original magnification $\times 1.6$; Movat pentachrome stain)

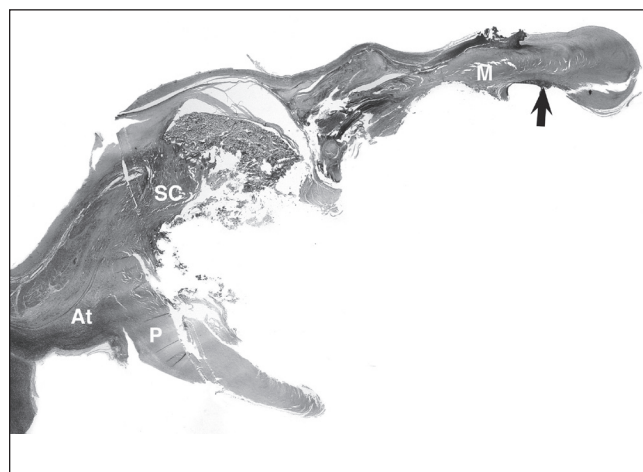
Figure 4 Histological section of the mechanical valve sewing cuff (SC), atrial endocardium (At) and native mitral (M) leaflet tissue. A significant degree of pannus (P) deposition is seen covering the SC region, and extending into the surrounding atrial and native mitral leaflet tissue. Thrombus (arrow) is also seen close to the mitral leaflet region (original magnification $\times 1.6$; Movat pentachrome stain)

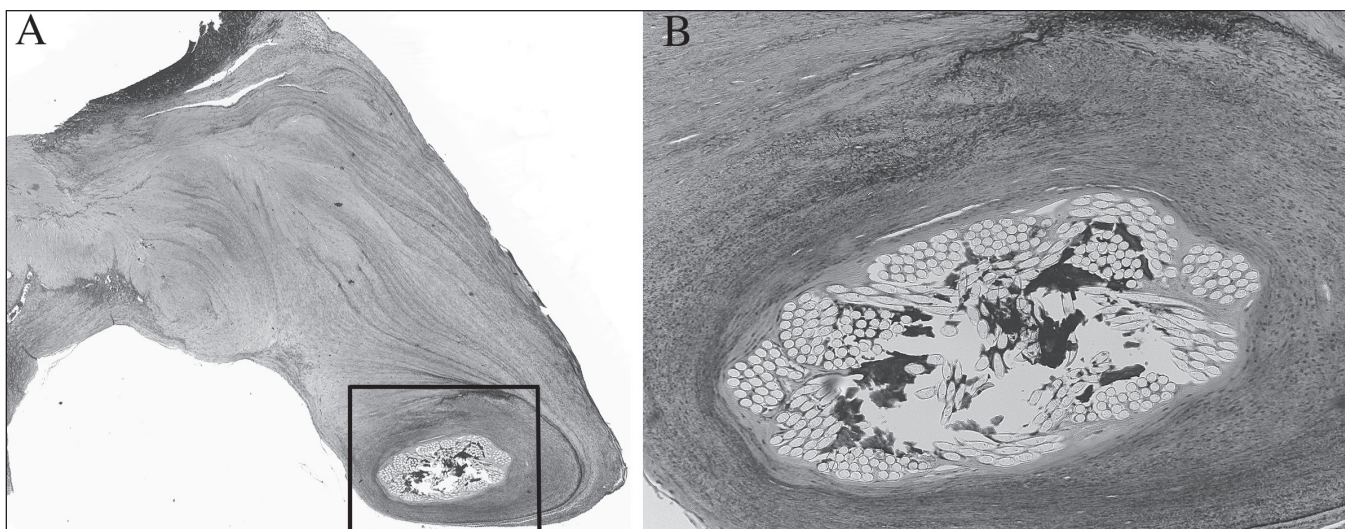
Figure 5) A Histological section showing the synthetic chorda surrounded by tissue fibrosis (original magnification $\times 2.5$; hematoxylin and eosin stain). **B** Higher magnification (box from **A**) showing intact synthetic chorda with collagen deposition in the interstices of the Dacron sutures. There was no evidence of chorda degradation. No inflammatory cells were seen (original magnification $\times 10$; Movat pentachrome stain)
